CHRONOLOGY OF LOST STRUCTURAL INTEGRITY INITIATED FROM MANUFACTURING DEFECTS IN WELDED STRUCTURES

Originalni naučni rad / Original scientific paper

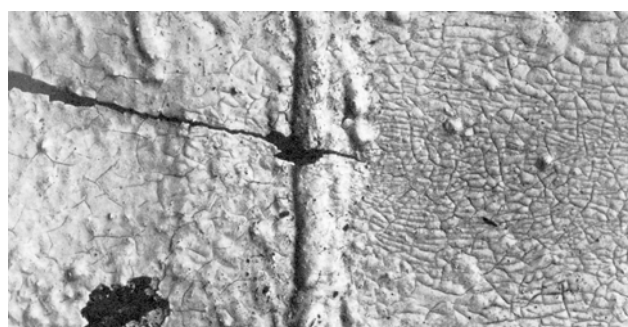
It was noted that cracks arrested in service when entering a new plate in regions of uniform low stress (Fig. 4). The painted surface had crazed at the arrest point due to higher fracture toughness of new plate, indicating yielding level.

Figure 4. Arrested ship fracture. Crazing of paints indicates yielding in the crack arrest region, /2/.

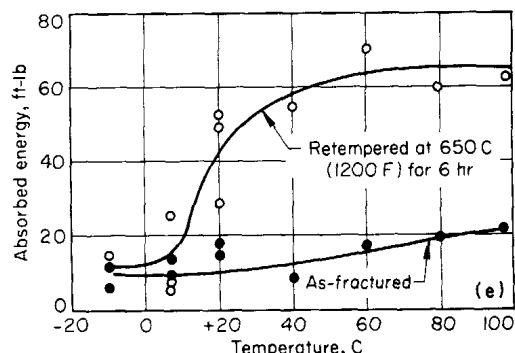
To further investigate the effect of stress relief on the properties of the vessel, standard Charpy V-notch specimens were prepared from the flange forging, plate, and weld. All specimens were oriented with their length parallel to the circumference of the vessel so that induced fractures would be parallel to the main fracture. Tests were performed on as-received vessel material over the temperature range from 10 to 100°C. Impact values met specifications for the forging and plate, but the weld metal was of inferior impact strength (lower curve, Fig. 8). None of the materials displayed a sufficient capacity for energy absorption (41 J for the forging; 69 J for the plate; and 16 J for the weld) to have arrested the crack growth that led to failure of the pressure vessel. Other weld metal specimens, re-tempered at 650°C for 6 h and tested over the same temperature range, showed an improvement in impact strength at or above 20°C (upper curve, Fig. 8). This confirmed the previous conclusion that stress relief of the vessel was at a lower temperature than specified.

Figure 8. Absorbed energy in Charpy V specimen test: lower curve—weld metal of fractured part; upper curve—after heat treatment at 650°C for 6 h.

Recommended final normalizing temperature was $Ac_3 + 50^\circ C$, and tempering temperature 650°C, where Ac_3 is the temperature for complete transformation of ferrite to austenite. After completion of each seam weld, preheating should be continued for a short distance along the seam. Forging practice should eliminate the banding in the flange.

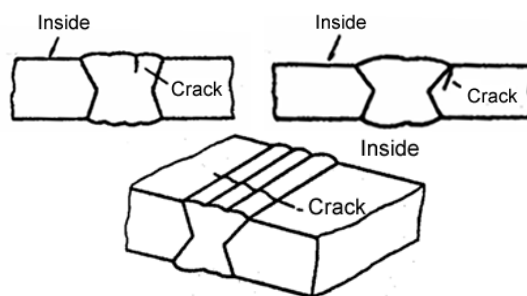
Figure 14. Longitudinal (up) and transverse (down) cracks.
Slika 14. Podužne (gore) i poprečne (dole) prsline

Several spherical tanks are in service at HIP-AZOTARA, Pančevo. Regular in-service inspection in 1993 revealed many defects, mostly cracks (Fig. 14) on the inner side of a sphere, /7/. Crack occurrence is particularly expressed in fine-grain microalloyed high strength steels, but cracks were also detected in tanks of carbon steels after long-term service. On one of the tested vessels, cracks were detected at the joint between mantle and lid on the outer side, on one

During regular inspection of spherical tanks for storage of vinyl chloride monomer (VCM), volume 2000 m³, introduced in 1977, a great number of cracks of different directions and sizes (Fig. 14, Tables 4 and 5) were detected by NDT in 1986-90 and in 1996 on inner wall side, in welded joint regions, /11/. In three cases, the cracks were detected in the parent metal, and their origin is probably the tack welding of temporary holders during sphere assembly. In some cases during grinding it was confirmed that the crack ends in the pore or the inclusion, involved in the manufacture. In all tested spheres, cracks most frequently occurred in radial welded joints (R, Fig. 10), typically in its middle (upper) part, at the liquid and gas phase border.

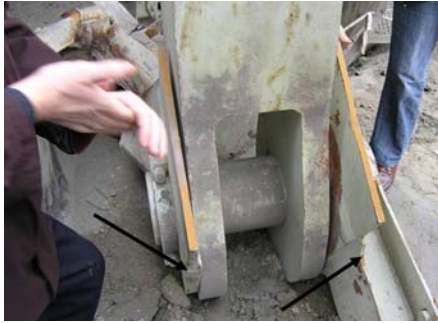
Figure 17. Fracture of two lugs caused the rotor excavator collapse.
Slika 17. Lom dve uške izazvao je kolaps rotornog bagera

In-situ visual examination was sufficient to recognize fracture scenario. Cracks originated in T welded joints, connecting lug and web. Starting from these cracks, in a determined time period variable service loads produced fatigue cracks on both sites of lug plate (upper part in Figs. 18 and 19). At the end of fatigue crack, stable crack growth in plane stress condition with clearly recognized shear lips started after crack tip blunting and developed final stretch zone (Figs. 19, 20a). On both sides from the T weld, stretch zones developed at the end of stable cracks (ZP, Figs. 19, 20c; CA, Figs. 19, 20b). Final stretch zone in position ZP developed in one stage before final brittle fracture took place. On the other side, at position CA, stretch zone partly

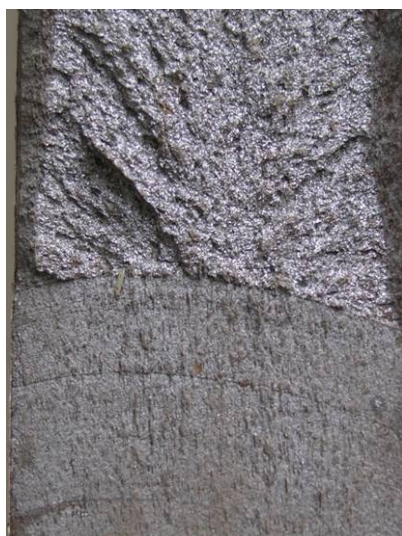
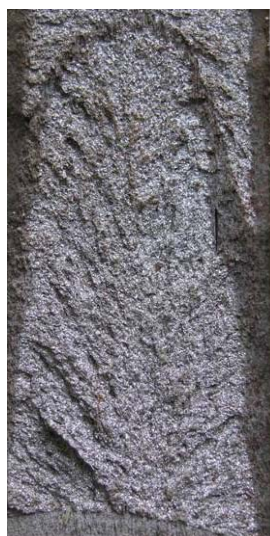
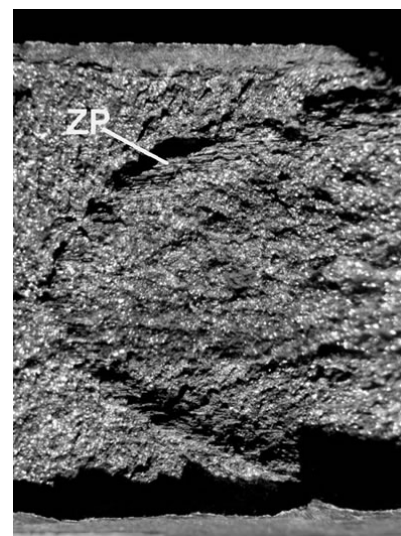
Figure 20. Typical regions in fracture process, indicated in Fig. 19.

a) Transition from fatigue to stable crack growth, shear lips visible (IP) b) Extend of crack till formation of first final stretch zone (CA) c) Second final stretch zone (ZP) before final brute fracture
