## KRTOST ANTIČKOG SREBRA IZAZVANA KOROZIJOM CORROSION-INDUCED EMBRITTLEMENT OF ANCIENT SILVER

Originalni naučni rad / Original scientific paper  
UDK /UDC: 620.18:669.22 620.193:669.22

*Corrosion-induced embrittlement of ancient silver is a complex phenomenon that can cause severe cracking and fragmentation of valuable objects. This damage may require irreversible methods of restoration and conservation. Detailed case studies to characterize the embrittlement are important for selecting the optimum methods to ensure conservation with a minimum of intervention. The paper describes the types of, and models for, corrosion-induced embrittlement in different ancient silver artefacts, and discusses the remedial measures that are or could be used.*

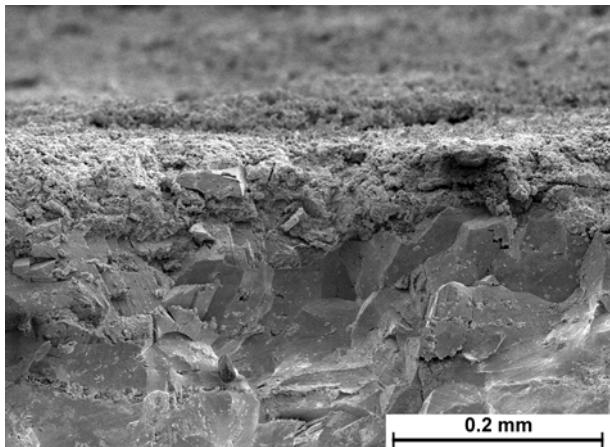
The silver chloride forms a brittle, finely granular layer, Fig. 1, but does not affect the remaining metal's integrity. On the other hand, unfavourable environmental conditions and longevity of interment (burial) may result in an object being completely converted to silver chloride, sometimes retaining its shape, sometimes not, /4, 15/.

Figure 1. SEM fractograph of general corrosion overlying intergranular fracture in an Egyptian vase, /8/: see Fig. 2b also.

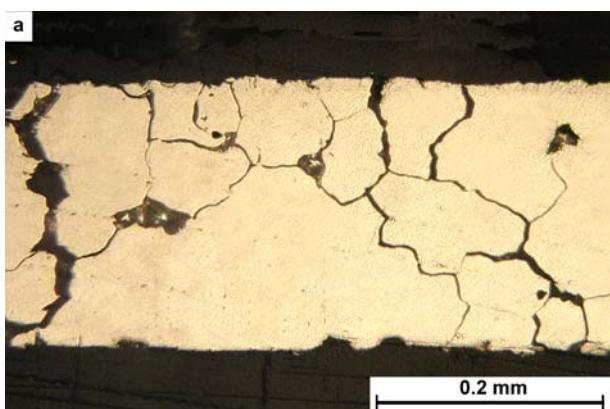
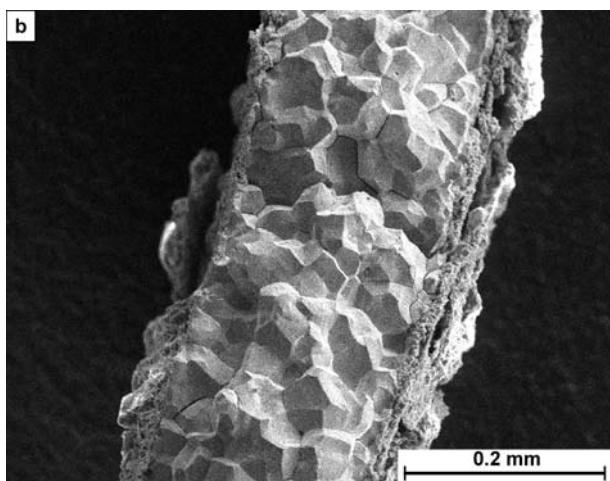
Intergranular corrosion is the most common type since it occurs in mechanically worked and annealed ancient objects, which constitute the majority of recovered artefacts. This type of corrosion has been attributed partly to low-temperature segregation of copper (often present in ancient silver), /2, 3, 6, 13, 14/. In particular, so-called discontinuous precipitation of copper can be very detrimental, /2/. This precipitation actually looks amorphous, not discontinuous, and sometimes causes the grain boundaries to appear meandering. However, intergranular corrosion need not occur along the meandering grain boundaries, while it does occur along boundaries with no evidence of discontinuous precipitation, /12-14/. Another important factor is residual (retained) cold-work, which can increase the susceptibility to both intergranular and transgranular corrosion, /8, 12/. Examples to illustrate all these points are given in Figs. 2-5.

Figure 2. Optical metallograph (a) and SEM fractograph (b) of corrosion-induced intergranular fracture in a kaptorga (container for relicts or amulets), /13/. There was no discontinuous precipitation of copper at grain boundaries. Note the general (surface) corrosion in the fractograph, cf. Fig. 1.

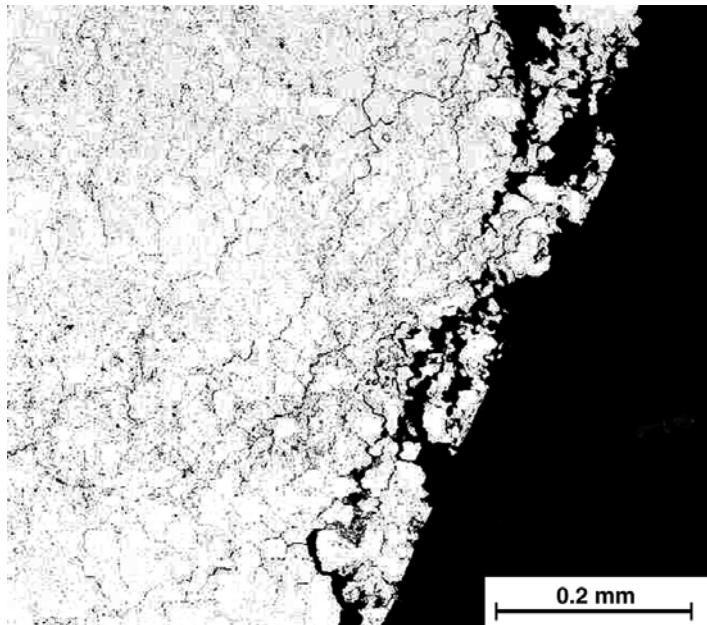
Figure 3. SEM metallograph of corrosion-induced intergranular fracture in a Byzantine paten (altar plate), /12/. There was extensive discontinuous precipitation of copper at the grain boundaries, not visible at this magnification.

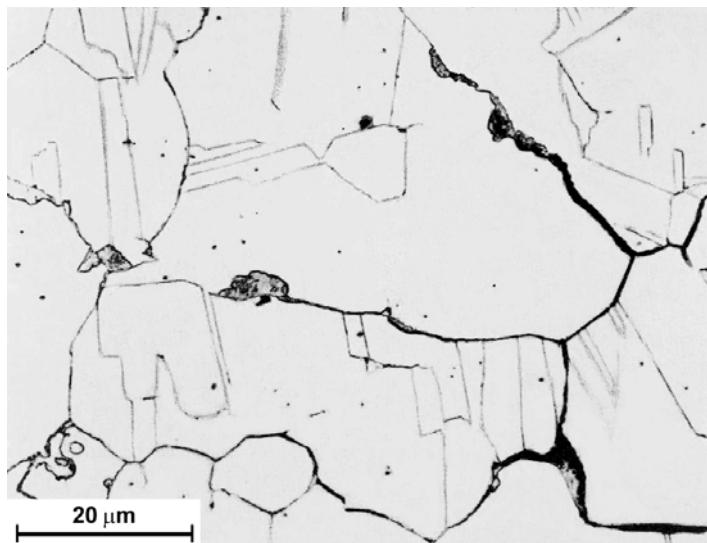
Figure 4. Optical metallograph of corrosion-induced intergranular fracture in a repoussé Sassanian head, /2/. Note the cracking associated with discontinuous precipitation of copper at some grain boundaries.

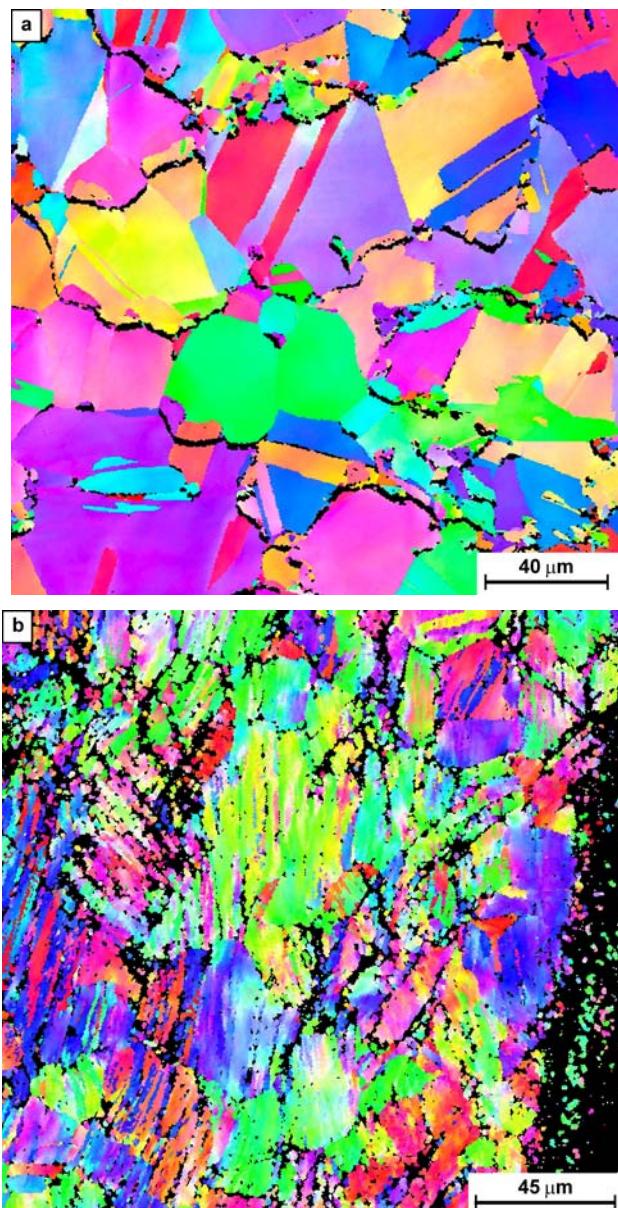
Figure 5. Electron Backscatter Diffraction IPF (Inverse Pole Figure) colour-coded maps of (a) annealed and (b) heavily cold-worked samples from the Gundestrup cauldron, /12/. The annealed sample was uncorroded despite extensive discontinuous precipitation of copper (delineated by the black dots) at grain boundaries. The cold-worked sample had no discontinuous precipitation of copper at grain boundaries but there was extensive corrosion-induced intergranular and transgranular fracture (the internal black-dotted areas).

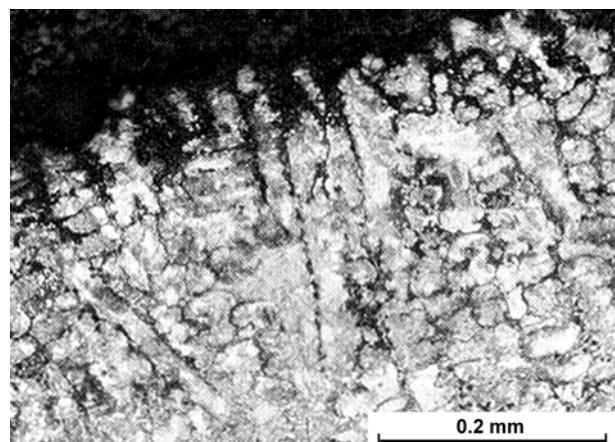
Interdendritic corrosion can occur in castings, which are uncommon, especially in the Old World. An example from pre-Incan Peru is shown in Fig. 6.

Slika 6. SEM metalografija interdendritske korozije koja prodire u virtualni liveni uzorak obrednog tumi noža Sika, /16/  
Figure 6. SEM metallograph of interdendritic corrosion penetrating into a virtually as-cast sample from a Sican tumi (knife), /16/.

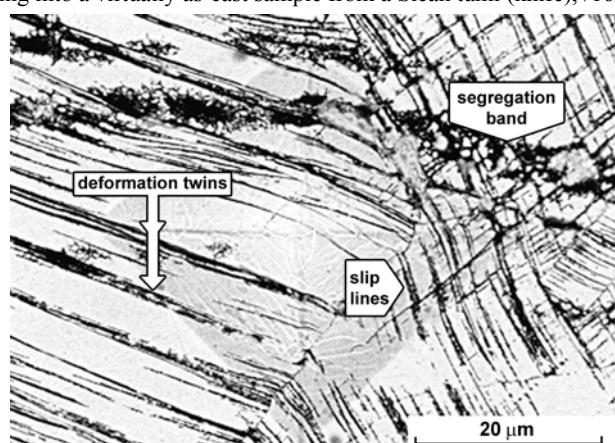
Inside the metal these types of corrosion can lead to additional corrosion along segregation bands. These are the much-modified remains of high-temperature solute element segregation (coring) and interdendritic segregation that occurred during solidification of an ingot or cupelled button. Examples to illustrate these types of corrosion in an Egyptian vase, are given in Figs. 7 and 8. General corrosion has attacked the left-hand fracture surfaces.

Slika 7. SEM snimak korozije duž linija klizanja, deformacija dvojnika i traka segregacije u egipatskoj vazi, /8, 12/. Korozija se bolje vidi i zbog senke otiska od izmerene mikrotvrdoće  
Figure 7. SEM metallograph of corrosion along slip lines, deformation twins and segregation bands in an Egyptian vase, /8, 12/. The diamond-shaped shadow is due to a microhardness indentation that rendered the corrosion more visible.

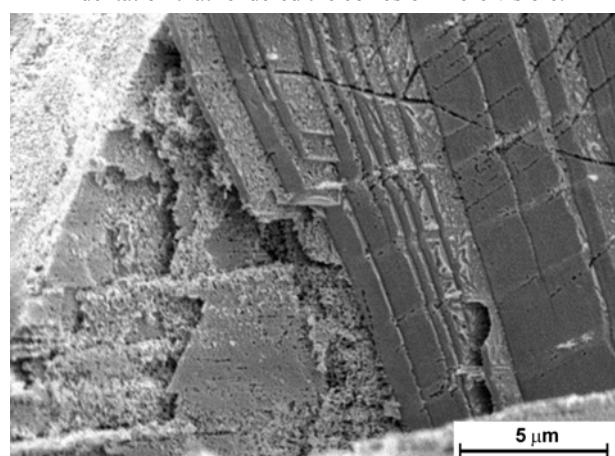
Slika 8. SEM snimak loma od korozije duž ravni klizanja i dvojnica deformacije egipatske vase, /8, 12/. Opšta korozija je napala i delimično razorila levi deo površine preloma  
Figure 8. SEM fractograph of corrosion along slip planes and deformation twins in an Egyptian vase, /8, 12/. General corrosion has attacked and partly destroyed the left-hand fracture surfaces.

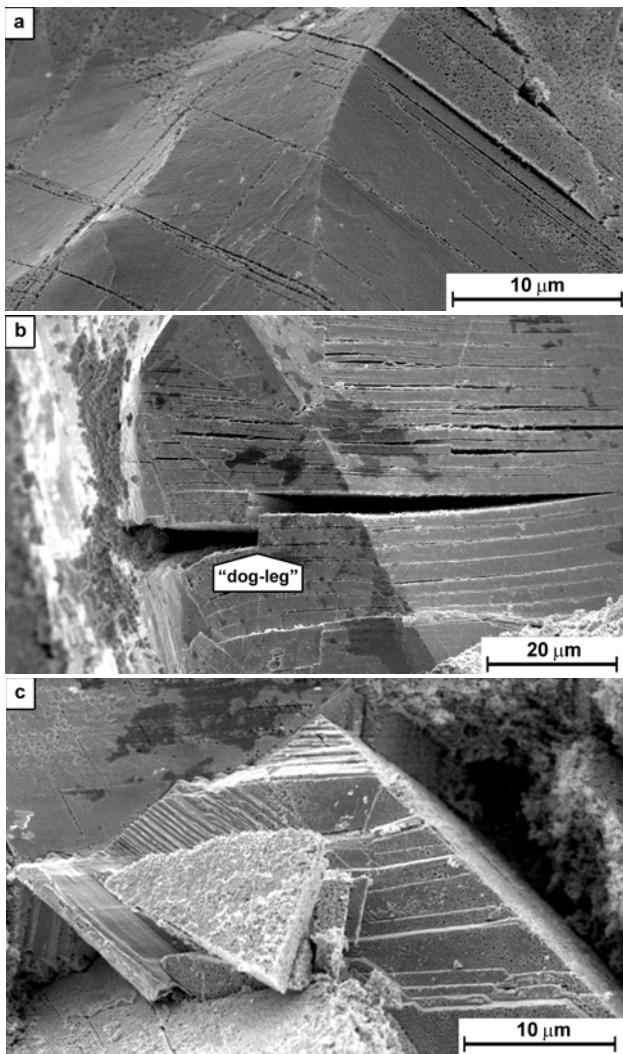
Figure 9 illustrates: (a) slip line corrosion, (b) cracking, and (c) the resulting crystallographic fracture observed for an Egyptian silver vase, /8, 9/. The vase was also microstructurally-embrittled, which enabled the observation of transgranular cracking superimposed on intergranular fracture, as in Figs. 9a and 9b.

Figure 9. SEM fractographs of (a) slip line corrosion, (b) slip plane dissolution and cracking, and (c) crystallographic fracture topography in an Egyptian vase, /9/.

The models are “corrosion-assisted cleavage”, /18-20/; its successor, “strain-enhanced dissolution”, /23/; and “corrosion-enhanced plasticity”, /21, 22/. A detailed discussion of the models and their applicability to ancient silver has been given previously, /9/. Since the corrosion-assisted cleavage model was abandoned, /23/, and the corrosion-enhanced plasticity model requires hydrogen generation, which does not occur when silver corrodes, /25/, only the strain-enhanced dissolution model remains to try and explain the features shown in Fig. 9.

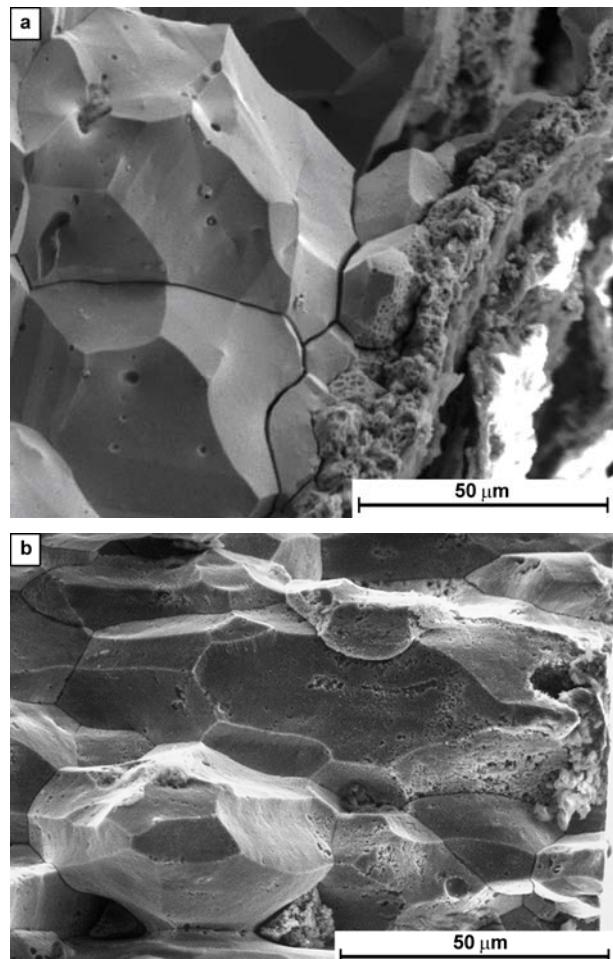
Figure 10. SEM fractographs of (a) corrosion-induced intergranular fracture and general corrosion in a silver kaptorga (detail of Fig. 2b) and (b) the boundary between SCC and intergranular corrosion in an aluminium-lithium alloy, /27/.

Figure 10a shows a transition caused by general corrosion destroying the corrosion-induced intergranular fracture in a silver kaptorga, /13/. The intergranular fracture is very clean-looking, with only isolated pits. Figure 10b shows a transition from intergranular corrosion with corroded (pitted) facets to intergranular SCC with facets hardly attacked by pitting, /27/. Other fractographs showed more pitting attack, mainly affected the intergranular corrosion area, /27/.

Although the fracture surfaces and transitions in Figs. 10a and 10b do not look identical, their similarity suggests that the corrosion-induced intergranular fracture in Fig. 10a is SCC. In this case the source of the necessary stresses and strains is external force due to intermetal rather than residual cold-work, since the kaptorga had a recrystallized microstructure with large annealed grains, /13/.
