Szabolcs Szávai, Tibor Köves

## RELIABILITY AND LIFETIME ANALYSIS FOR A CRACKED CYLINDER OF AMMONIA UNIT COMPRESSOR

Original scientific paper  
UDC: 621.51-192  
Paper received:

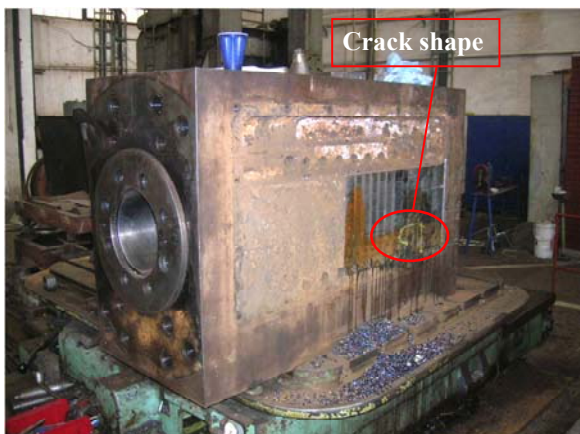
A crack was found between one of the inlet valve seats and the cooling pipe row (Figs. 1 to 3) of a giant gas compressor. The crack face was situated almost in the plane of symmetry. The crack was dangerous, because it reached the cooling pipe and in this case H<sub>2</sub> would get into the cooling system, what could cause a fatal explosion. Since the customer did not have another cylinder, and its replacement with a new cylinder would take about one month, the interruption of production would lead to significant loss of income and the unit operator asked how to keep the unit in production until eventual replacement. The consequences of a potential accident increased the importance of safety issues. Although hydrogen leakage had been stopped by closing the two nearest cooling pipes by applying through-wall bolts, the safe operating conditions and possible life-

Figure 1. The 3<sup>rd</sup> stage cylinder and crack location and shape detected by ultrasound  
 Slika 1. Cilindar trećeg stepena i oblik prsline, otkriven ultrazvukom

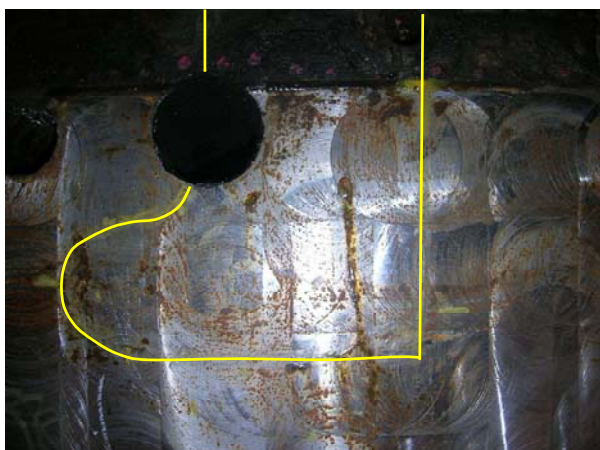
Figure 2. Crack on cylinder surface  
 Slika 2. Izgled prsline na površini cilindra

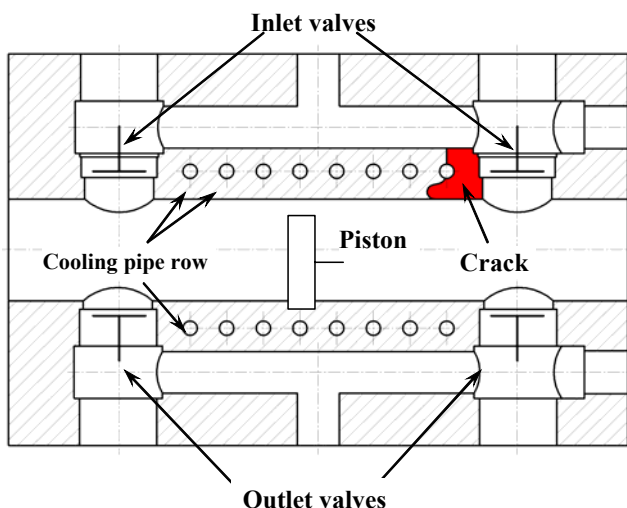
Figure 3. Cross-section of cylinder with marked crack  
 Slika 3. Poprečni presek cilindra sa označenom prslinom

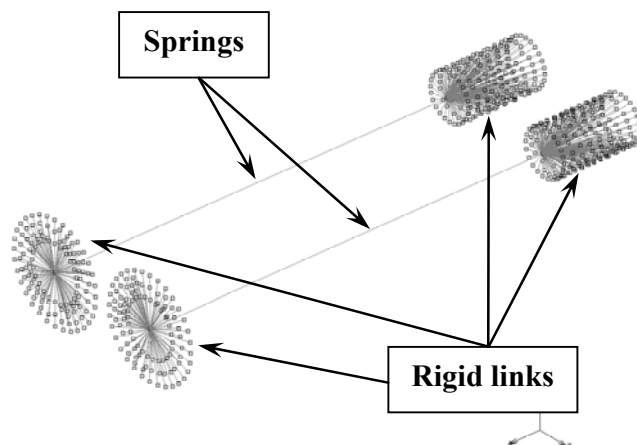
Figure 4. Reinforcement (springs and rigid links)  
 Slika 4. Ojačanje (opruge i krute veze)

Geometry data are given by the customer, who recommended to repair the cracked part by tighten joint increasing screw force. The cracked and adjacent cooling pipes had been enclosed, new bores drilled, threaded, and reinforced by M33 bolts. The reinforcement model is given in Fig. 4.

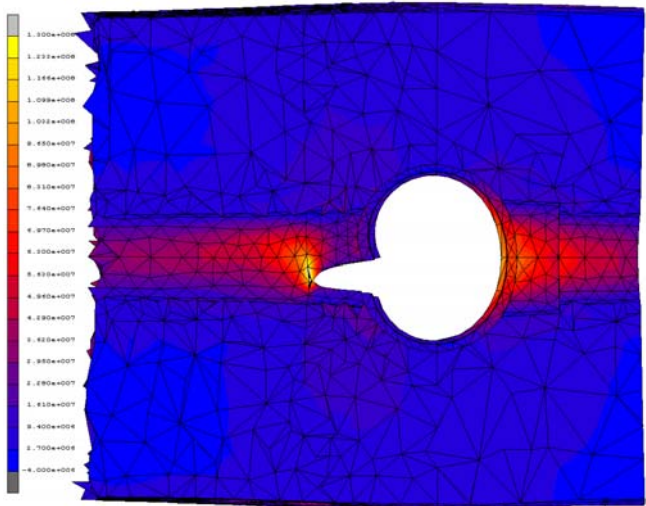
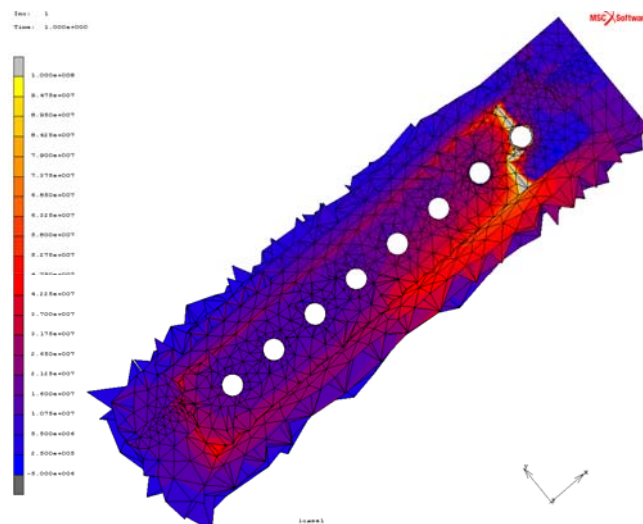
Reinforcements have been taken into consideration for the next calculation. As an illustration, these results for the equivalent von Mises stress, calculated for normal operational pressures around the crack and cooling pipe row with crack and reinforcement are shown in Figs. 7 and 8. It was found that the stress decreases about 6–8% near the crack due to the reinforcement, but this is not enough to close the crack so further crack propagation could take place.

Figure 7. Equivalent von Mises stress around the crack with reinforcement.  
Slika 7. Ekvivalentni Mizesov napon oko prsline sa računatim ojačanjem

Figure 8. Equivalent von Mises stress around the cooling pipe row with crack and reinforcement.  
Slika 8. Ekvivalentni Mizesov napon oko niza cevi za hlađenje sa prslinom i računatim ojačanjem

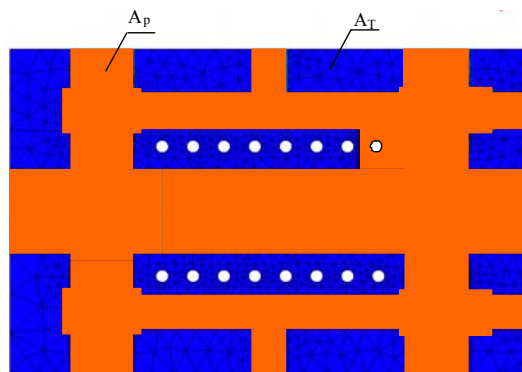
Figure 11. Scheme for brittle fracture evaluation  
Slika 11. Shema za ocenu krstog loma

Applying proof pressure test  $p_{test} = 284$  bar the risk of brittle fracture is evaluated (Fig. 11). Obtained value for stress intensity factor  $K_I = 47.5$  MPa√m is below minimum fracture toughness value,  $K_{Ic} = 60-100$  MPa√m (Table 1), indicating that brittle fracture is not probable.

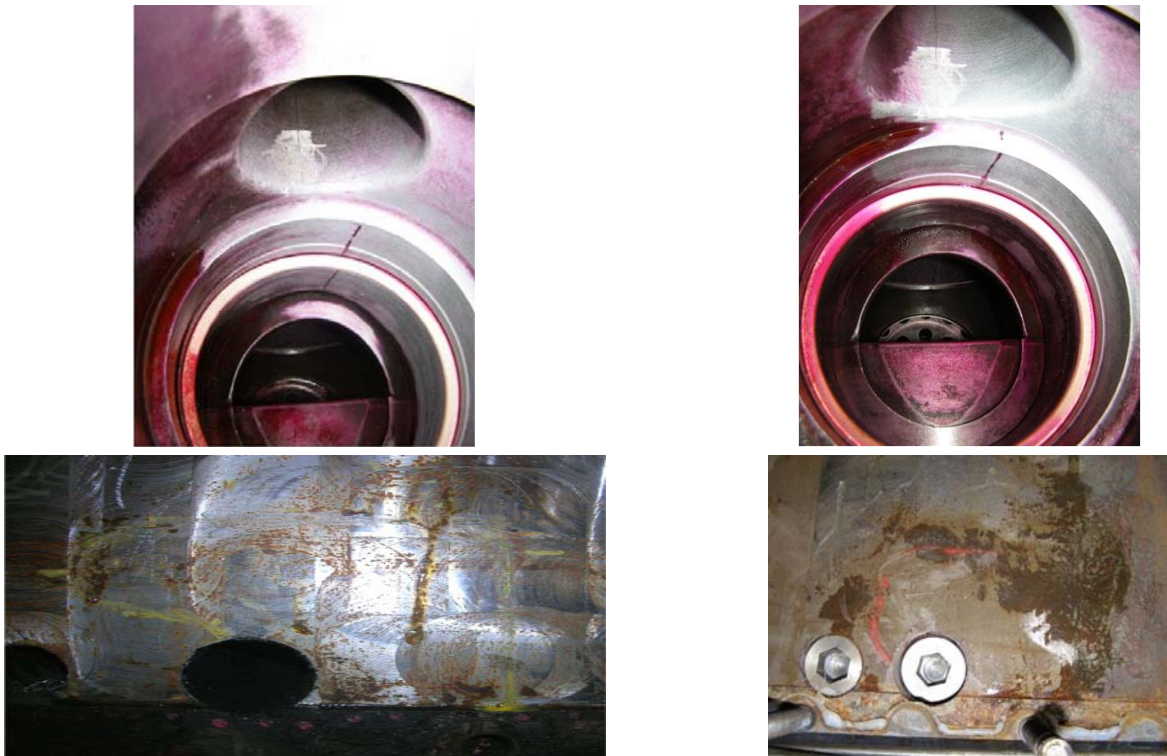
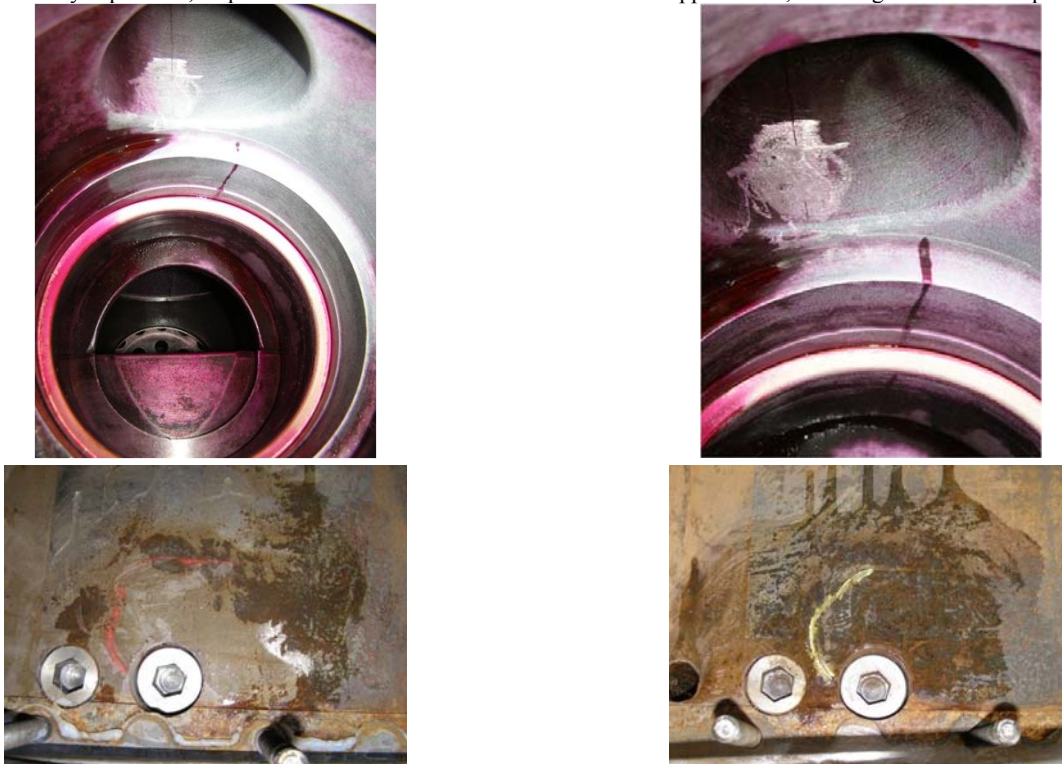
Figure 16. Experimental verification of crack growth.

At minimal operating pressures (120/60 bar) crack growth is not expected since  $\Delta K$  is only  $4.58$  MPa√m  $< \Delta K_{th}$ , although the threshold value is uncertain. Operation at these pressures is not economical, so investigation is carried out after 15 days to check the crack size and position (Fig. 16): crack did not grow, so some load increase is possible, and a minimum economical operating condition (150/80 bar) is analysed, with  $\Delta K_{th}$  about  $5$  MPa√m, enabling acceptable

crack length increase  $\Delta l = 6.5$  mm. Since  $\Delta K_{th}$  value is uncertain, the longer operation should be based on next ultrasonic tests, which have shown that the crack is stable, and real  $\Delta K_{th}$  is higher than the applied one.

After 15 days operation, inspection has validated the calculations and the applied data, checking crack size and position.

After the next 15 days of operation, ultrasonic tests verified the crack is stable.
