FAILURE PREVENTION OF ROTATING EQUIPMENT BY VIBRODIAGNOSTICS PREDUPREĐIVANJE OTKAZA OBRTHNIH MAŠINA POMOĆU VIBRODIJAGNOSTIKE

Originalni naučni rad / Original scientific paper

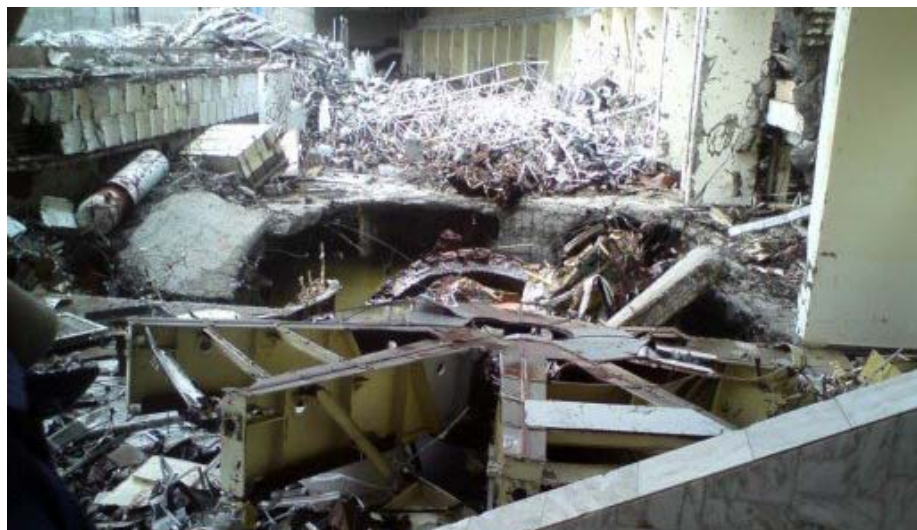
In the year 2009, turbine 2 of the Sayano–Shushenskaya hydroelectric power station failed violently, /1/. Before the accident, it was the largest hydroelectric power station in Russia and the sixth largest in the world by average power generation. The turbine hall and engine room were flooded, the ceiling of the turbine hall collapsed, 9 of 10 turbines were damaged or destroyed, and 76 people were killed. The report states that the accident was primarily caused by turbine vibrations which led to the fatigue damage of the mounting components for the cover of turbine 2.

It was found that at the moment of the accident, at least six nuts of the mounting were missing from the bolts securing the turbine cover. After the accident, 49 bolts found were investigated for fatigue cracks. For 8 bolts, the fatigue damage area exceeded 90% of the total cross-section area.

It is clear that this catastrophe could have been avoided by proper control and shut down of turbine 2 in due instant.

Figure 1. Scene of the Sayano-Shushenskaya hydroelectric power station after the accident, /1/.

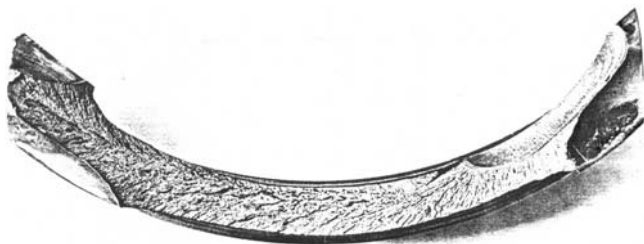
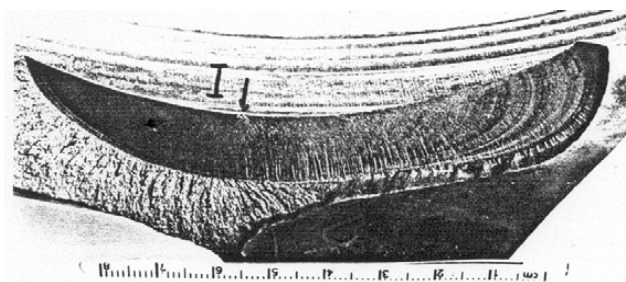
examined in detail after the casing was opened. The turbine failure was attributed to blade fracture. Simultaneous fracture of three blades in one flux produced unbalance in the turbine and caused an overloading, which could not be sustained by the rotor shaft. Steam turbine blades are

exposed to high variable loading, and sometimes also to corrosive environment. In the low pressure turbine, three successive blades are found fractured. The initial fatigue crack in one blade was 1100 mm^2 or 14% of cross section area (Fig. 2). The rest of the fractured surface is brute, dominantly ductile. Probably this blade had broken first. Due to the redistributed loading after the first blade had fractured has increased the stress in the second blade with initial fatigue crack of 280 mm^2 or 4% of cross section. The third blade broke 40 mm above the root by overloading.

Figure 2. Blade fracture from fatigue crack A in upper corner (left) and development of striations during fatigue process (right).

The initiation site is marked by an arrow.

The critical cross section of blade, shown in Fig. 2, had been continuously reduced during the fatigue process. As a consequence, stiffness of the blade was reduced, affecting the vibration state. When vibration behaviour corresponded to resonant regime, the cross section of blade could not sustain the applied stress state, and the critical blade failed. Misbalance induced by the fractured first blade produced fracture of second blade with critical cross section reduced by 4% in fatigue and after that the third blade, which was not exposed to fatigue, had fractured. Eventually, even a very small crack might change the vibration state sufficiently to be recorded by a sensitive device and indicate a critical situation. Proper application of vibrodiagnostics monitoring in this case might be helpful, since this failure can be prevented after detecting the occurrence of resonance.

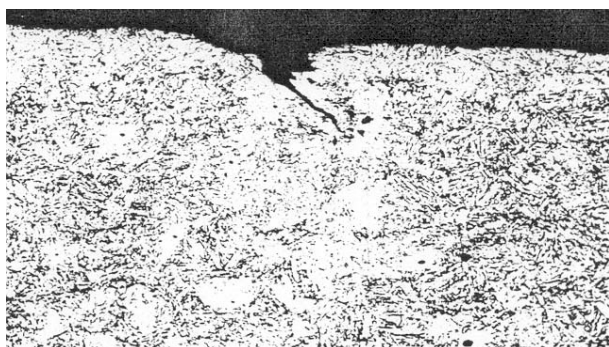
Corrosion attack due the improper water preparation took place in the blades, where fatigue cracking initiated (Fig. 3), and this contributed to introduce initial damages, followed by the fatigue process, /2/.

Figure 3. Corrosion attack as initial fatigue crack.
