Radomir Jovičić¹, Aleksandar Sedmak¹, Stojan Sedmak², Ljubica Milović², Katarina Jovičić²

LEAKAGE OF AN AUSTENITIC STEEL CO₂ STORAGE TANK CURENJE POSUDE ZA SKLADIŠTENJE CO₂ OD AUSTENITNOG ČELIKA

Originalni naučni rad / Original scientific paper
UDK /UDC: 621.642.34:669.15-194.56
Rad primljen / Paper received: 21.01.2012

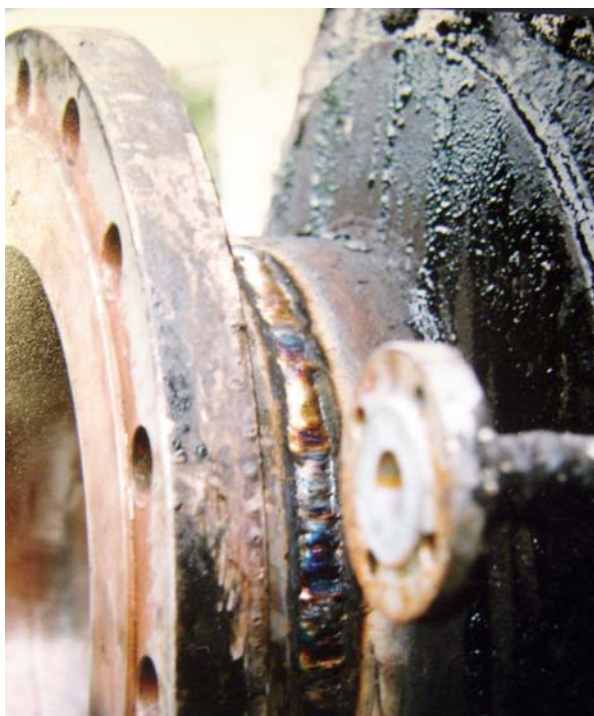
After removing the thermal insulation from the manhole, the moisture is located around the welded joint between the mantle and flange neck. The manhole consisted of mantle, produced of P 460NL1 steel, 10 mm thick, and a flange casting of high alloyed austenitic steel X10CrNi18.10, /2/. The manhole and welded joint at which the leakage is detected are presented in Fig. 2.

Figure 1. Manhole and welded joint where leakage occurred.
Slika 1. Revizionni otvor i zavareni spoj, gde se pojavilo curenje

The welded joint between the flange and manhole mantle had been performed as a butt joint. Flange necking towards the welded joint ended by a cylindrical part of diameter and thickness that are equal to the diameter and thickness of the manhole mantle, of width 30 mm, [1]. The cracking network had been detected in this cylindrical part of the flange neck in a clearly limited zone.

All cracks are located in the zone starting about 3 mm from the fusion line of the weld metal and ending on the transition from the cylindrical to the conical part of the flange neck. The orientation of cracks is approximately in the manhole axis direction, i.e. the tank's axis. Crack density is different on the joint periphery, ranging from very expressed in a zone about 250 mm in length, to extra small in the zone covering about one half of joint periphery. In the zone of high crack density, they cross each other,

producing a network. Mostly they extend 25 to 27 mm in length. In the zone of individual cracks, only short cracks, 1 to 2 mm long, are detected.

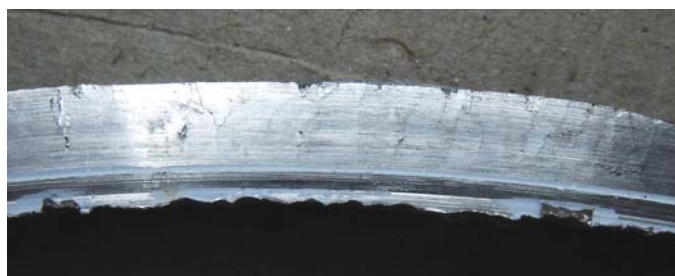
The cross section of the middle of the zone with the highest cracking density is shown in Fig. 3. A large number of cracks, approximately perpendicular to the flange surface, are visible. Testing by dye penetrants through the zone axial section indicates a large number of cracks penetrating to different depths, some of them through the thickness.

Figure 3. Cross section of the middle of zone with the highest cracking density.

According to the appearance, number and location, the detected cracks are likely to be that occurring in austenitic steels due to intercrystalline corrosion. Since the flange outer side is in contact with air, i.e. the flange material is not in contact with an aggressive medium, there is no condition for the development of intercrystalline corrosion. It might be concluded that the cracking has occurred due to some other mechanism of brittleness, typical for the steel X10CrNi18.10. The chemical composition of the steel X10CrNi18.10 is given in Table 1, and its tensile characteristics in the as-casting condition are given in Table 2, /3/.

Cracks in the flange made of austenitic material had occurred due to the brittleness induced by the segregation of the brittle phases, mostly carbides, influenced by the welding heat cycle in the welded joint, specifically in a region between the flange and manhole mantle.

It is concluded that the detected cracks affect the safety operation of the tank, and hence **retrofitting** is required /5–9/. The only economical way for retrofitting is complete elimination of the damaged zone. The same flange with the removed dissolved carbides is now re-welded with the manhole mantle, and the applied welding procedure has prevented the precipitation of brittle phases.

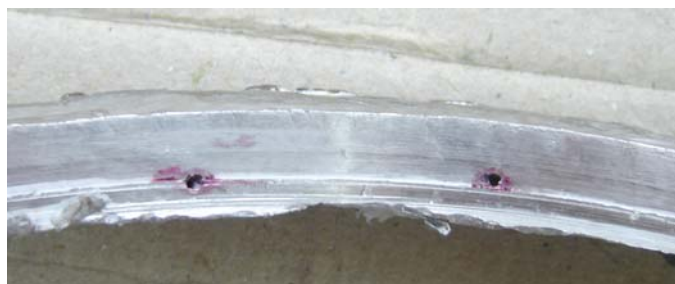
Figure 4. Two pores on inner side of manhole present the initial part of through cracks.

In Fig. 4 the cross section close to the pores detected on the inner side of a manhole is presented. Two pores, which are in fact the continuation of pores detected on the inner side of the manhole, can be clearly recognised. Most intensive leakage on the outer side of the manhole is revealed just opposite of these pores, since they are followed by cracks, penetrating to the outer surface of the tank.

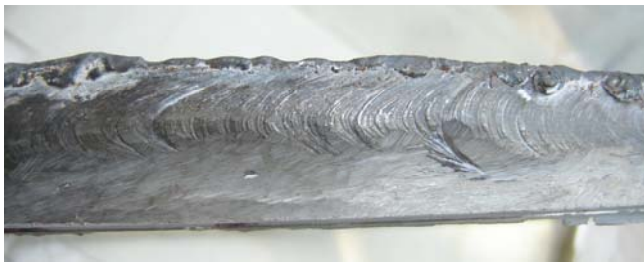
The cylindrical part of the flange and the welded joint between the flange and mantle of a manhole are presented in Fig. 5. This part is cut out from a manhole in the repairing procedure. The flange is separated, first together with the welded joint, by applying gas flame cutting, and then the segment with cracks is separated by machining. The lower edge in Fig. 5 is uneven as a residue of machining by lathe.

Figure 5. Cylindrical part of the flange and welded joint between the flange and mantle of the manhole.
