## CASE STUDY ON THE BREAKING OF A RAIL AXLE SLUČAJ LOMA VAGONSKE OSOVINE

Originalni naučni rad / Original scientific paper  
UDK /UDC: 629.467.083  
Rad primljen / Paper received: 22.09.2014

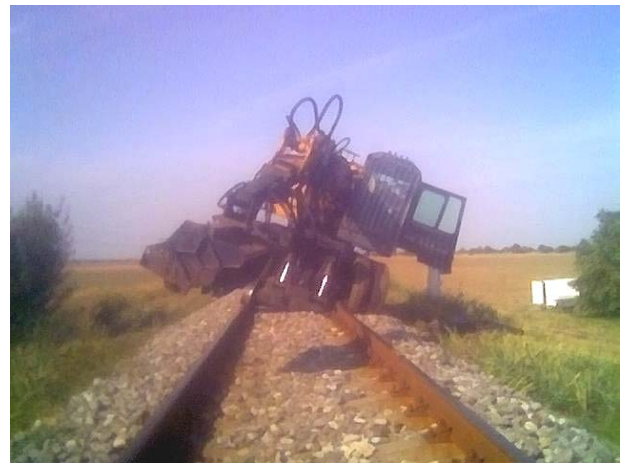
During the travelling for construction works in railway mode of a multifunctional machine, a breakage of the left rail axle had occurred in the direction of movement (Fig. 4).

Figure 4. Overall position after the breaking of front left rail axle.  
Slika 4. Položaj nakon loma prednje leve vagonсke osovine

The machine, with a weight of 173000 N, was moving with a speed of 9 km/h, with the working articulated arm in front of it, having installed a working accessory (milling) for cutting vegetation, with a weight of 4000 N.

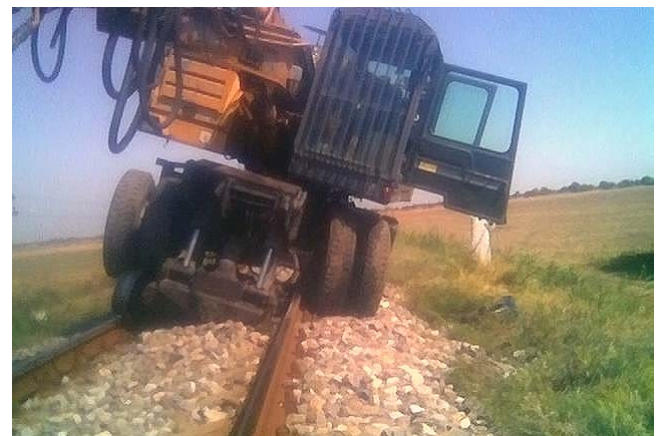
After the breaking of the rail axle the machine falls off the railway and rests on rubber automobile wheels and broken end of the rail axle in limited equilibrium position (Fig. 5). Through specific technical measures (repositioning and balancing of loads, of masses which are not in equilibrium) the turning over and damaging of the machine is avoided. The machine is placed back on its rubber wheels for traveling by road.

Figure 5. Position after the left rail axle failure – front view.  
Slika 5. Položaj nakon loma leve vagonсke osovine – s preda

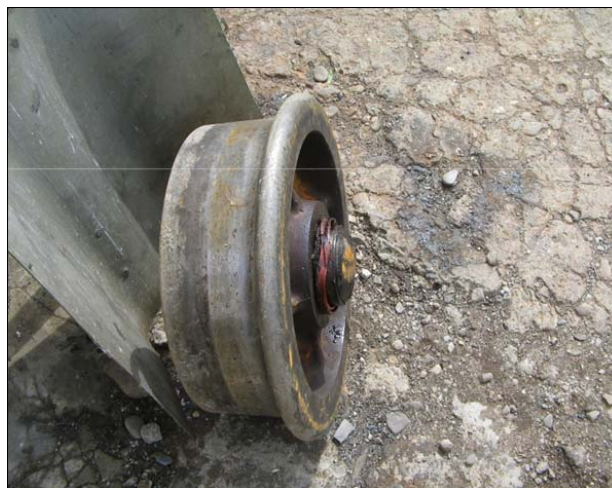
The breaking of the rear left rail motor axle occurred in the zone between the rail wheel and the nearby bearing, (Figs. 10-12).

Figure 10. Fracture of the rail axle, near to the rail wheel.  
Slika 10. Lom vagonke osovine, blizu vagonkog točka

A tension concentrator is noticed in the fracture zone of the rail motor axle, identified as a variation zone for sizes (size steps) with a very small connection radius (2 mm),

between the cylindrical step with smaller diameter (for the bearing) and the cylindrical step with larger diameter (the passage area from the bearing to the rail wheel).

This is non-compliance from a technological point of view, because the tool tip produced a channel (ditch).

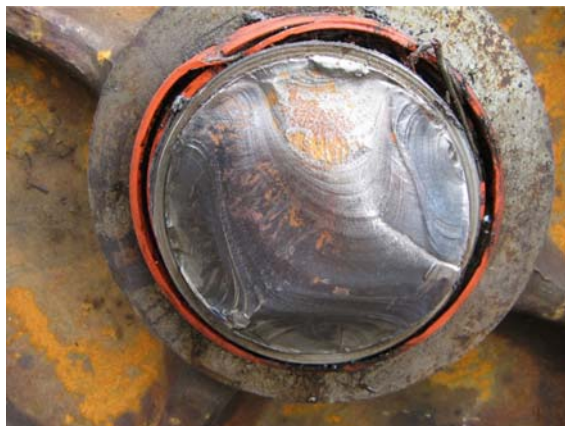
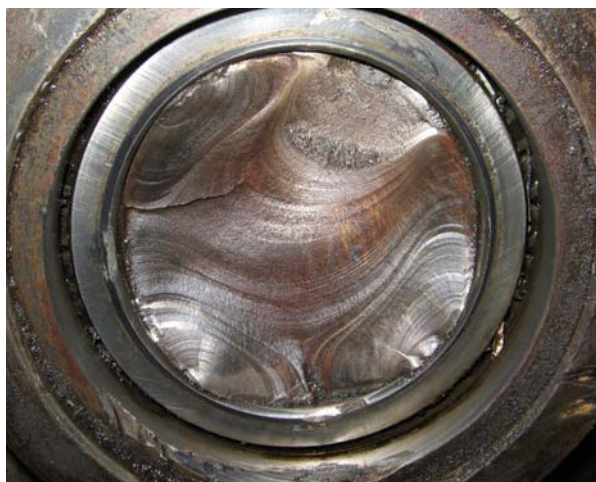
Figure 11. Section of fracture towards the rail wheel.  
Slika 11. Presek loma prema vagonском тоčku

Figure 12. Failure section towards the bearing.  
Slika 12. Presek loma prema ležištu

In the breaking section (Figs. 11 and 12), several crack initiation could be identified, placed at angles of approximately 90 degrees, with an evolutionary behaviour.

The breaking section could not be observed from outside without completely removing the rail axle, since it occurred in the inner ring of the outer bearing. The technical state of the axle cannot be verified without complete disassembly.

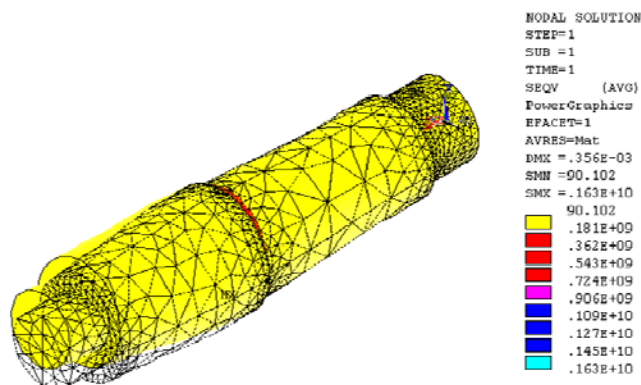
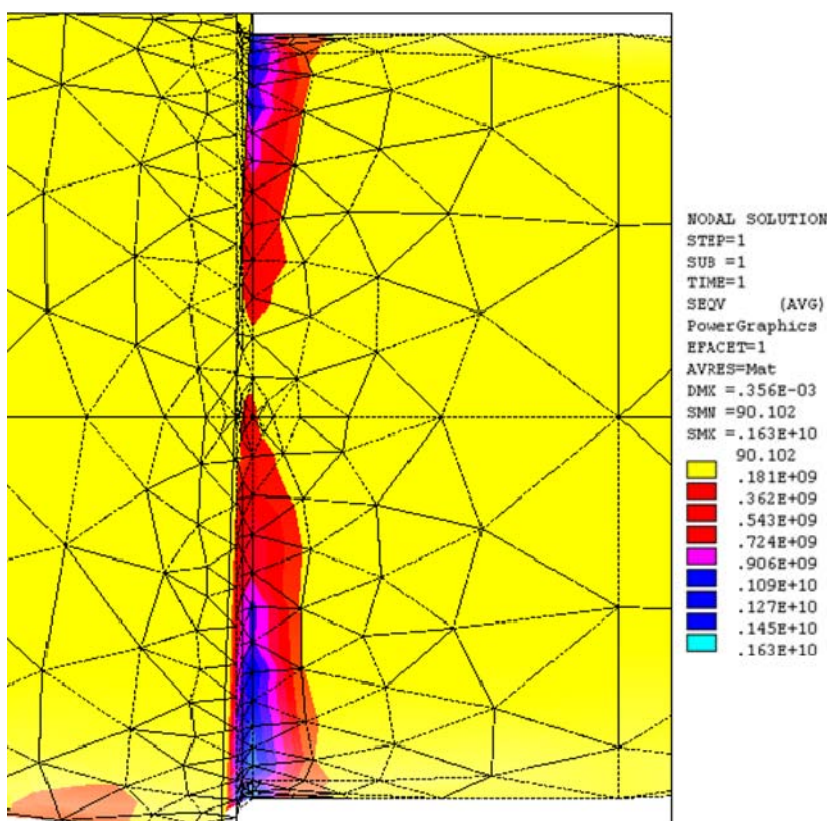
Figure 14. Equivalent tension state (von Mises) – stress case 1.  
Slika 14. Ekvivalentno stanje napona (fon Mizes) – slučaj 1

Figure 15. Equivalent state (von Mises) – stress case 1- detail.  
Slika 15. Ekvivalentno stanje (fon Mizes) – slučaj 1 - detalj

The analysis of this case shows the occurrence of critical areas of tension in the same position where the rail axle has failed (Figs. 14-15).

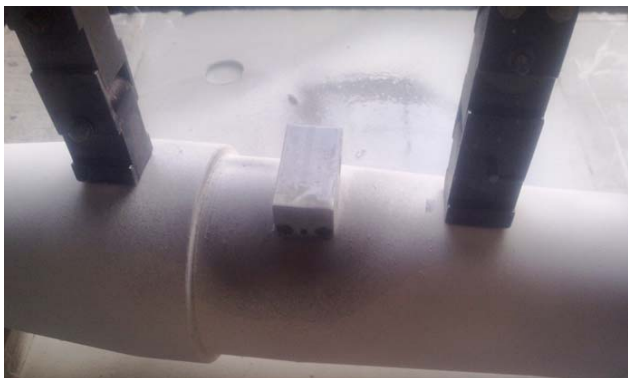
Figure 16. Magnetic particle inspection of T3500 railway axles.  
Slika 16. Ispitivanje T3500 vagonskih osovine magnetnim česticama

To prevent similar incidents and to regulate the technical measures for verification and preventive control, a disassembling of all rail axes on the machine is done in order to examine by non-destructive methods, (Fig. 16).

It is necessary to check and control the rail axes using penetrating liquids or magnetic particles, for all multi-functional machines, on their first planned intervention and every subsequent planned major intervention, by totally disassembling the axles.

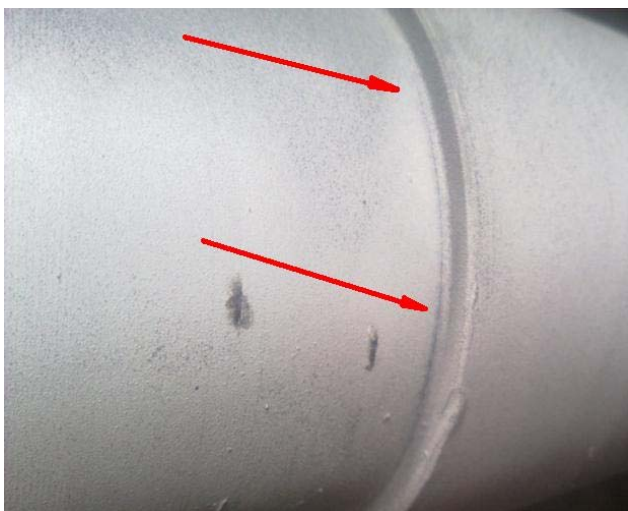
For the analysed case, a magnetic particle inspection is made (Figs. 16-17), considering the simplicity, ease and speed of this test method. It was found that also the other three rail axes showed symptoms (signs) of fracture, under the form of cracks (Fig. 17), in the same area where the fracture occurred. A measure was taken to replace all 4 rail axes with new ones.

Figure 17. Crack in the maximum stress area.  
Slika 17. Prslina u oblasti najvećih napona

The regulation of compulsory verification and non-destructive periodic control of the axles of special rail building machines is necessary, similarly to the technical norms of verification and control of mounted railway axles.
