METHODOLOGY FOR REPAIRING DEFECTS ON INTERNAL SURFACES OF CRANKS OF GUIDE VANE APPARATUS IN HYDROELECTRIC GENERATING SET AT HYDROPOWER PLANT DJERDAP 1

Originalni naučni rad / Original scientific paper
UDK /UDC: 620.179:621.224.35
Rad primljen / Paper received: 25.09.2014

Vertical Kaplan turbines, made in Russia, are installed in 6 hydroelectric generating sets at 'Djerdap 1', with nominal power of 200 MW each. During the refurbishment of the hydroelectric generating set A4 at the hydropower plant Djerdap 1, experimental non-destructive tests on all of its components are performed in order to determine the state of the turbine as a whole.

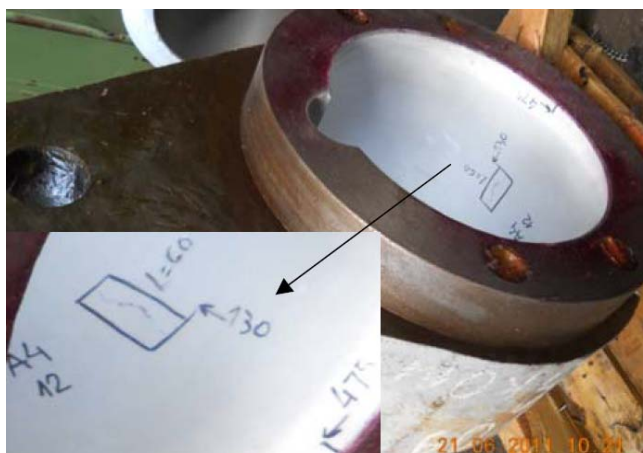
During the tests, the damage and cracks are detected on internal surfaces of guide vane cranks and sleeves, which occurred as a consequence of turbine shaft vibration.

Non-destructive tests are performed in order to determine the current state of the internal surfaces of cranks and sleeves. Defects positioned along the circumference of cranks are measured by micrometer and detected by penetrant testing (PT) or magnetic particle testing (MT), while defects within the material are detected through the use of ultrasonic testing (UT). Defects positioned along the circumference of sleeves are detected visually and measured by micrometer. Characteristic damage on one of the cranks and on the sleeves of guide vane apparatus vanes is shown in Fig. 2.

Figure 2. Appearance of defects at the internal area of a guide vane crank and damage on the sleeve.

Slika 2. Izgled grešaka na unutrašnjoj površini glavčine i oštećenje rukavca sprovednog aparata

This technology refers to the activities performed during the reparation of cranks and sleeves, that required grinding out linear indications and performing welding/surface welding on internal surfaces of crank hubs, as well as on the surfaces of sleeves. Regardless of chemical composition /2/, crank hub thickness ($d = 105$ mm) and damage that had occurred at diameters $\varnothing 240$ mm, $\varnothing 360$ mm and $\varnothing 400$ mm

The first step was to eliminate detected cracks by grinding. Visual testing and magnetic particle testing (or dye-penetrant testing) were performed continuously during crack elimination. Preparation of grooves was performed after grinding, and finally welding/surface welding was carried out. Based on parameters that influence the selection of welding procedure (weldability of base material, energetic characteristics of the welding procedure, geometric complexity of the structure, comparative economic analysis), welding was carried out through the use of the coated electrode E 42 4 B 32 H5 (EVB 50 – Elektrode Jesenice d.o.o.), in accordance with standard, /3/, and through utilization of procedure 111. Preheating to 150°C was performed through the use of induction heaters, as suggested in Russian literature. Preheating temperature inspection was performed by IC thermometers, /4/.

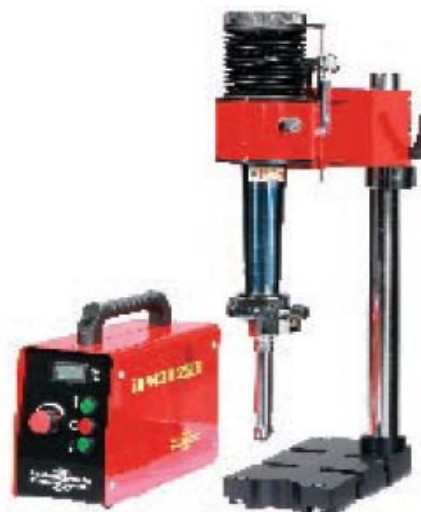
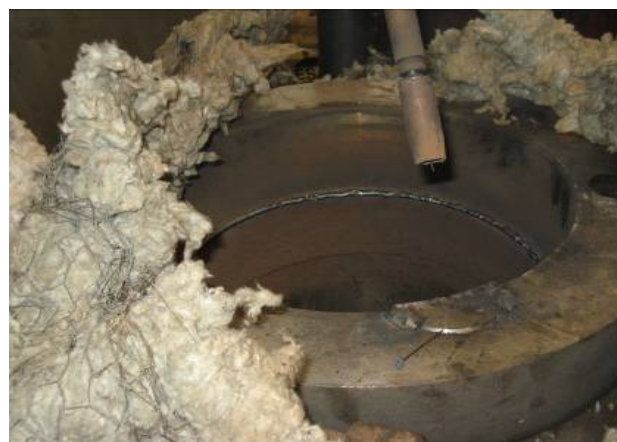
Figure 3. Device ID Weld 2501 for surface welding performed at the openings of guide vane cranks.

Slika 3. Uređaj ID Weld 2501 za navarivanje otvora glavčina sprovednog aparata

Surface welding was performed through the use of ID WELD 2501 device on internal surfaces of crank hubs and utilization of procedure 131, by TIG Mo wire, 1.2 mm in diameter (Elektrode Jesenice d.o.o.) according to standard /5/, and with the use of protection gas M21 according to standard EN 439 /6/, Fig. 3. Optimum surface welding parameters, determined through a series of tests performed on components made of same material and of similar thickness, are as follows /4/: number of revolutions during surface welding: $0.5\text{--}1\text{ min}^{-1}$, surface welding: continuous, $I = 200\text{ A}$, current source: any standard source for MIG/MAG welding process, voltage: $U = 20\text{--}30\text{ V}$, shielding gas flow: $10\text{--}20\text{ l/min}$.

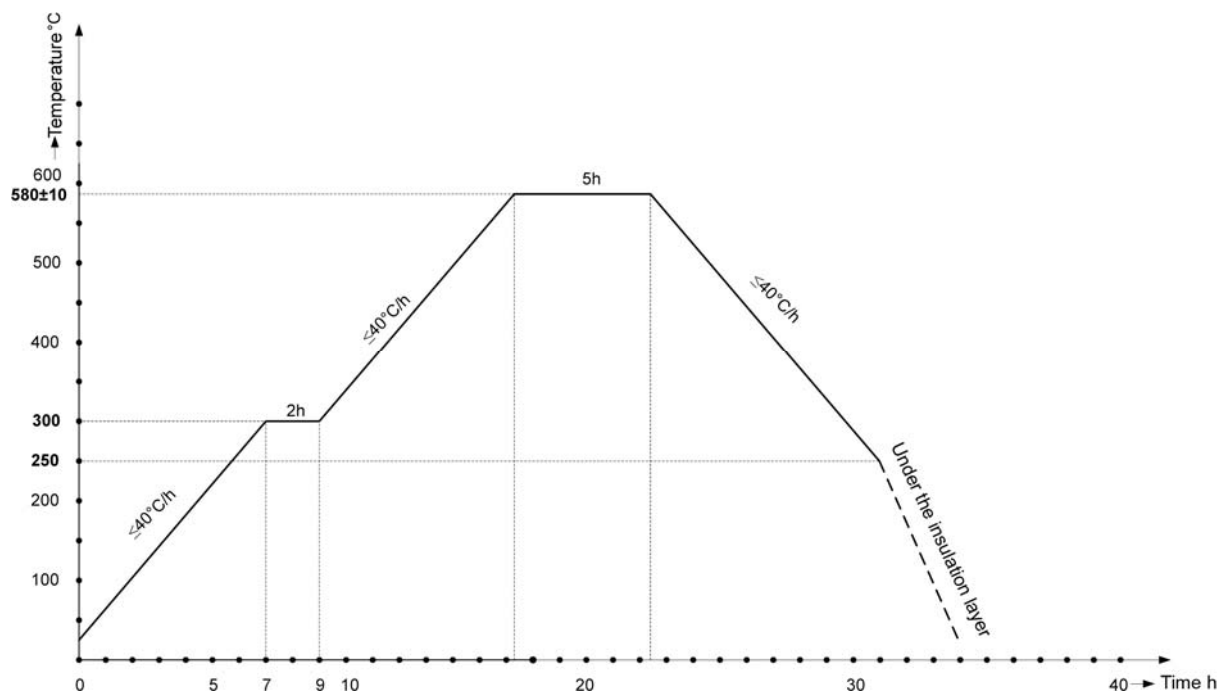
Figure 4. Heat treatment diagram.

Slika 4. Dijagram termičke obrade

In order to reduce the level of residual stresses and eliminate the possibility of occurrence of deformation after welding/repair welding and finish machining, cranks have been heat-treated through the use of technology with the parameters presented in Fig. 4, /4/.

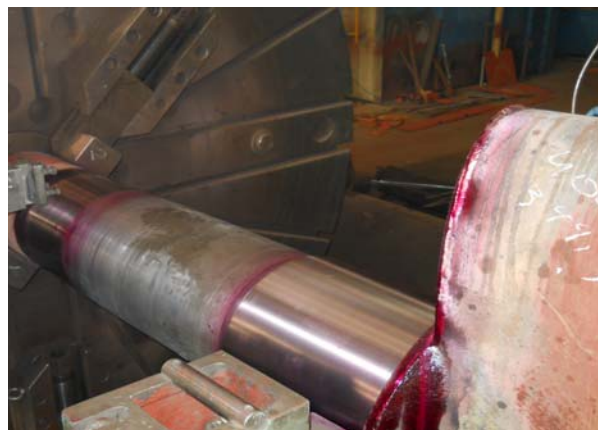
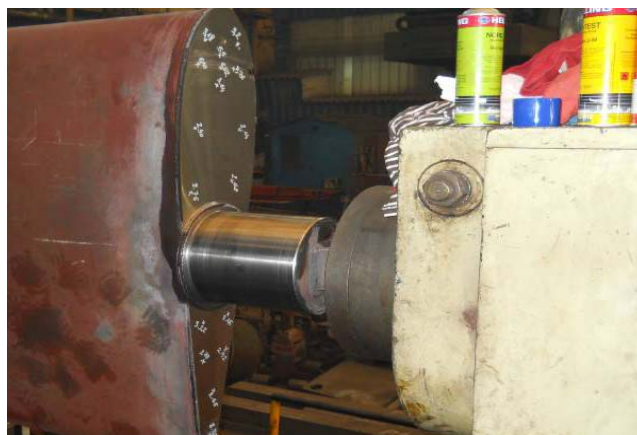
Figure 5. Repaired and machined areas at sleeves.

Slika 5. Reparirane i mašinski obrađene oblasti rukavca

On the basis of parameters on which the procedure for surface welding of sleeves of guide vanes depends, procedure 131 that involves the use of 1.2 mm wire diameter (TIG Mo – Elektrode Jesenice d.o.o.) and shielding gas M21 is selected. Preheating to 150°C is performed by induction heaters, as suggested in Russian literature for cast steel 25L. Preheating temperature inspection is performed by IC thermometers. Surface welding was carried out by MIG-MAG multi-process welding machines with two welders and symmetric and combined directions of weld

bead depositing. The vanes were rotated periodically. The surface welded areas were divided into $150 \times 150\text{ mm}$ sectors, /4/. Optimum surface welding parameters, determined ex-

perimentally through welding procedures performed on components made of the same material and of similar thickness are as follows: surface welding current: direct, $I = 200$ A, current source: any standard MIG/MAG multi-process welding machine, voltage $U = 20\text{--}30$ V, shielding gas flow rate $10\text{--}20$ l/min. The machining and dimensions measurements of repaired areas on sleeves of guide vane apparatus are performed on the lathe, through the use of special centring tools and micrometer screw gauge, Fig. 5.
