## CHARACTERISATION OF UNDERMATCH WELDED JOINT OF X20CRMV121 STEEL AFTER PROLONGED SERVICE

Originalni naučni rad / Original scientific paper

The outlet superheater (SH) tube system of a 600 MW fossil fuel power plant boiler is made of X20CrMoV121 steel (DIN-17175/79). The SH consists of 38 mm tubes with the different wall thicknesses in different sections, Table 1. The inlet part of SH is made of tubes with wall thickness of 4 or 4.5 mm because inlet operating temperatures and pressures ( $t_{steam} = 485^{\circ}\text{C}$ ,  $p = 190.8$  bar,  $t_{gas} = 900^{\circ}\text{C}$ ) are relatively low in that section. However, the outlet tubes have wall thickness of 5 and 5.6 mm, since the operating conditions are more severe in that area ( $t_{gas} = 815^{\circ}\text{C}$ ,  $t_{steam} = 540^{\circ}\text{C}$ ,  $p = 186$  bar). A number of damages are detected on SH tubes during  $\approx 150\,000$  hours of service.

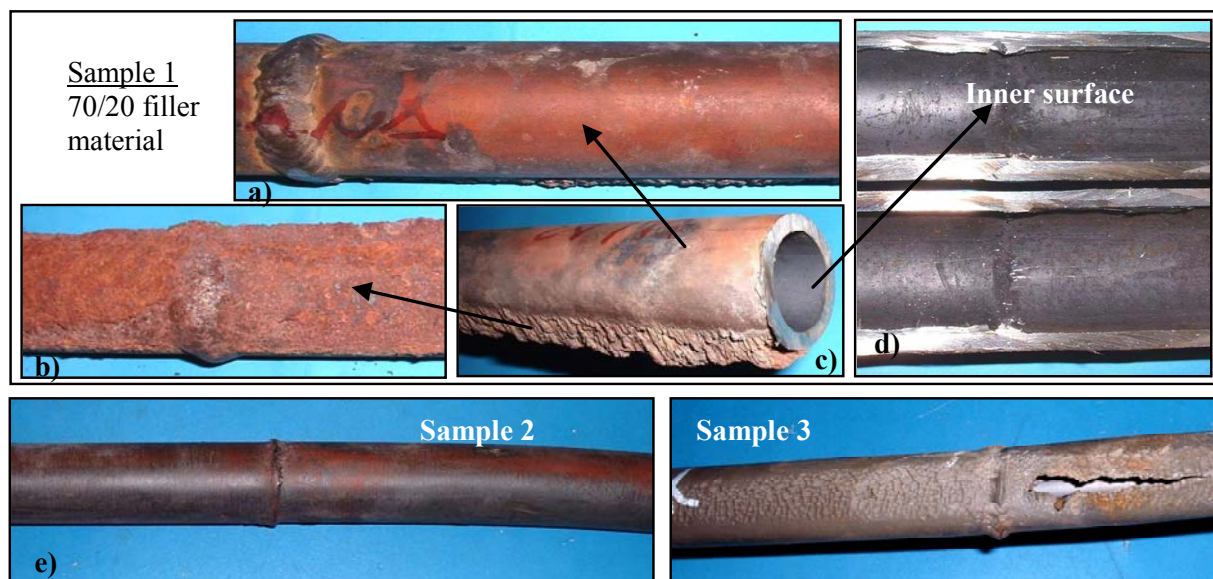
Sample 1 – repair welded joint with 70/20 filler material; Heterogeneous welded joint. Sample 1 is the part of the SH segment with nominal tube dimensions of  $\varnothing 38 \times 4$  and  $\varnothing 38 \times 4.5$  mm. The outer surface of the sample was exposed to combustion products and thus covered with a relatively homogeneous thick scale of rough surface, Fig. 1b. The scale is strongly adhered to the metal surface

Figure 1a-f: Photographs of the examined samples.  
Slika 1a-f: Makro snimci ispitivanih uzoraka

and its thickness varies along the tube. The maximum thickness of the outer scale is measured 12 mm, Fig. 1c. Visual inspection of the welded joints indicates an area with excessive weld reinforcement (overlap 1.5–3.5 mm) or incomplete penetration (1.5 mm), Fig. 1a, d. The magnetite layer can be observed on the inner surface of the tube.

**Sample 2 – homogeneous welded joint.** Sample 2 is cut from the area exposed to intensive erosion. The state of the outer surface suggests that the particular tube was shielded by some other parts in the system and thus not exposed to intensive erosion or scale formation, Fig. 1e. The magnetite layer is also detectable on the inner surface.

**Sample 3 – homogeneous welded joint.** Sample 3 also belongs to the area of intensive erosion. The sample is cut from the failed tube and damages caused by the steam jet are visible on its surface, Fig. 1f. The tube failed due to wall thinning caused by erosion. The lack of scale and intensive surface marks indicate the tube was previously exposed to intensive erosion. The magnetite layer is detected on the inner surface, as on Samples 1 and 2.

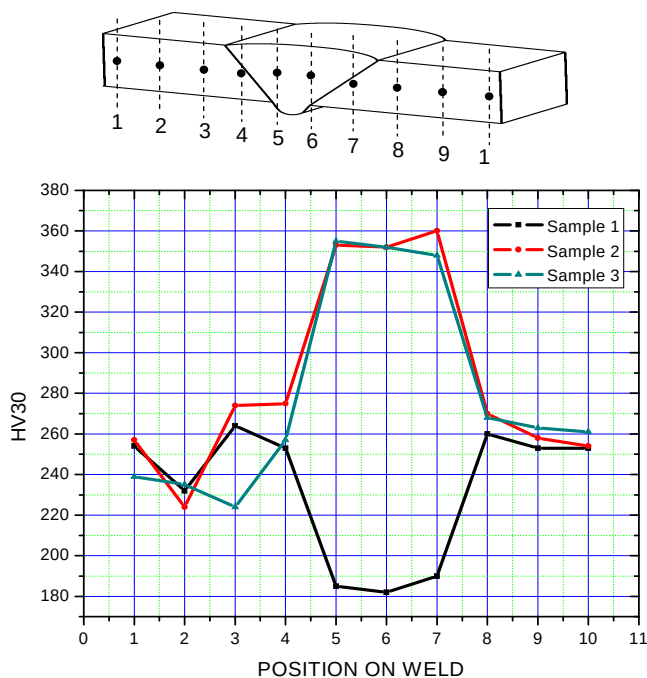
The average hardness of the base metal and welded joints for all examined sample are plotted in Fig. 2. In homogeneous joints, the hardness of the weld and the HAZ are almost equal, /1/. The variation of hardness along the cross-section of welded joints corresponds to the different areas within the welded joint. In the austenitic area the measured hardness is significantly lower due to presence of austenite filler material. However, lower hardness in that area can be also attributed to the prolonged exposition of the material to elevated temperatures.

Figure 2. Results of the hardness measurements.  
Slika 2. Rezultati izmerene tvrdoće

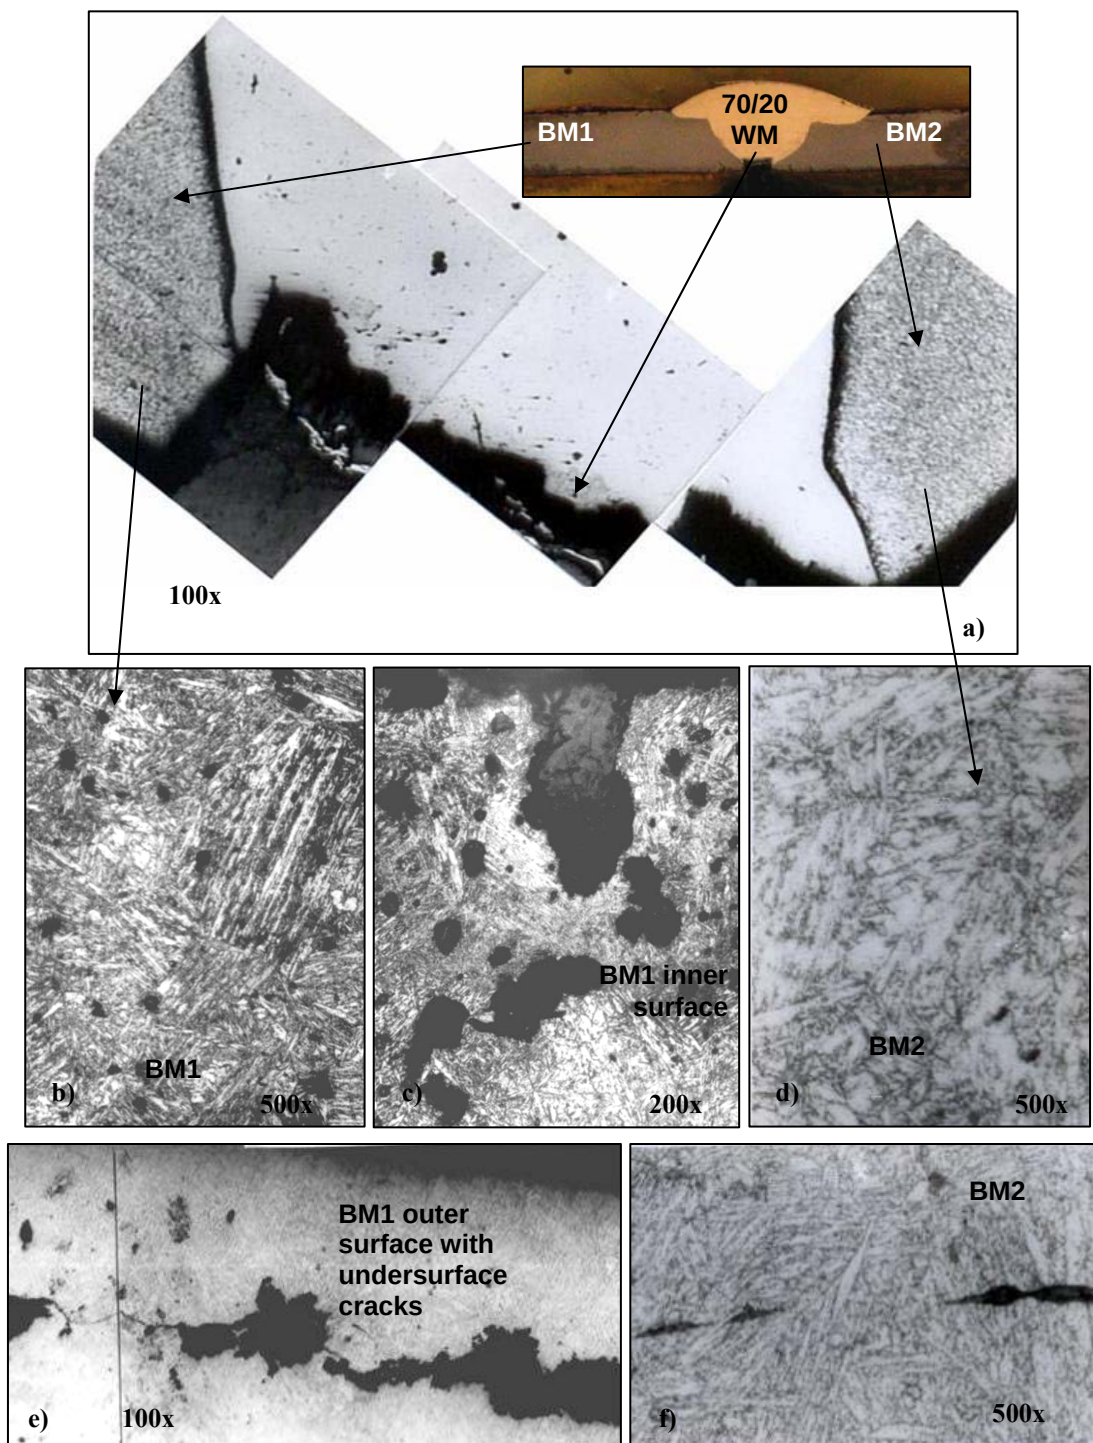
**Sample 1.** Optical micrographs of the different areas of the welded joint with austenitic filler material are shown in Fig. 3. The part of the SH system that had been in service for 150 000 hours is labelled as BM1, while the tube that had been in service for only 60 000 hours (a part that has replaced a failed tube) is labelled as BM2. It is obvious from Figure 3 that the root of the weld is not filled completely with austenitic filler material.

The contact zone between filler and base metal contains a large quantity of carbide phase (the zone width is 0.1–0.3 mm), Fig. 3a. However, carbon depletion is present in the close vicinity of the carbide reach zone. This is more dominant in BM1 because of: (a) the inhomogeneous initial structure of BM1 with areas rich in chromium carbides; and (b) more intensive degradation processes after longer exposure.

The basic structure of BM1 and BM2 is combined from fine-grained and coarse-grained tempered martensite. The structure is not homogeneous across the wall thickness. The microstructural evidence of long term exposure to elevated temperatures, such as the decomposed martensitic phase and the presence of acicular ferrite and bainite can be observed in BM1. In addition, inhomogeneous distribution of the carbide phase is also visible in BM1, along with a huge number of defragmented oxide and MnS inclusions 6–76  $\mu\text{m}$  in length. A great number of inclusions is also visible in the BM2. The manufacturing defects such as subsurface microcracks are visible in Fig. 3e.

In the vicinity of the welded joint, a large quantity of the cavities is present in BM1 indicating creep damage of class 3a or 4 (according to VGB-TW 507 classification), Fig. 3b and 3c. Cavities are visible in the vicinity of both inner and outer surfaces, Fig. 3c and 3e. However, the coalescence of cavities is more pronounced in the vicinity of subsurface microcracks, as shown in Fig. 3e, as well as in the vicinity of corrosion damages, Fig. 3c, and on inclusion surfaces (not shown here). Damages caused by intensive corrosion can be seen in the wide area on the inner surface of the tube. Some are filled with deposits and their depth ranges from 0.15 to 0.20 mm, while the width of the corrosion damages usually does not exceed 0.25 mm.

Macrocracks that were formed during exploitation can be seen in the austenitic filler material, Fig. 3a.

Figure 3a-f. Optical micrographs of Sample 1 with 70/20 filler material.

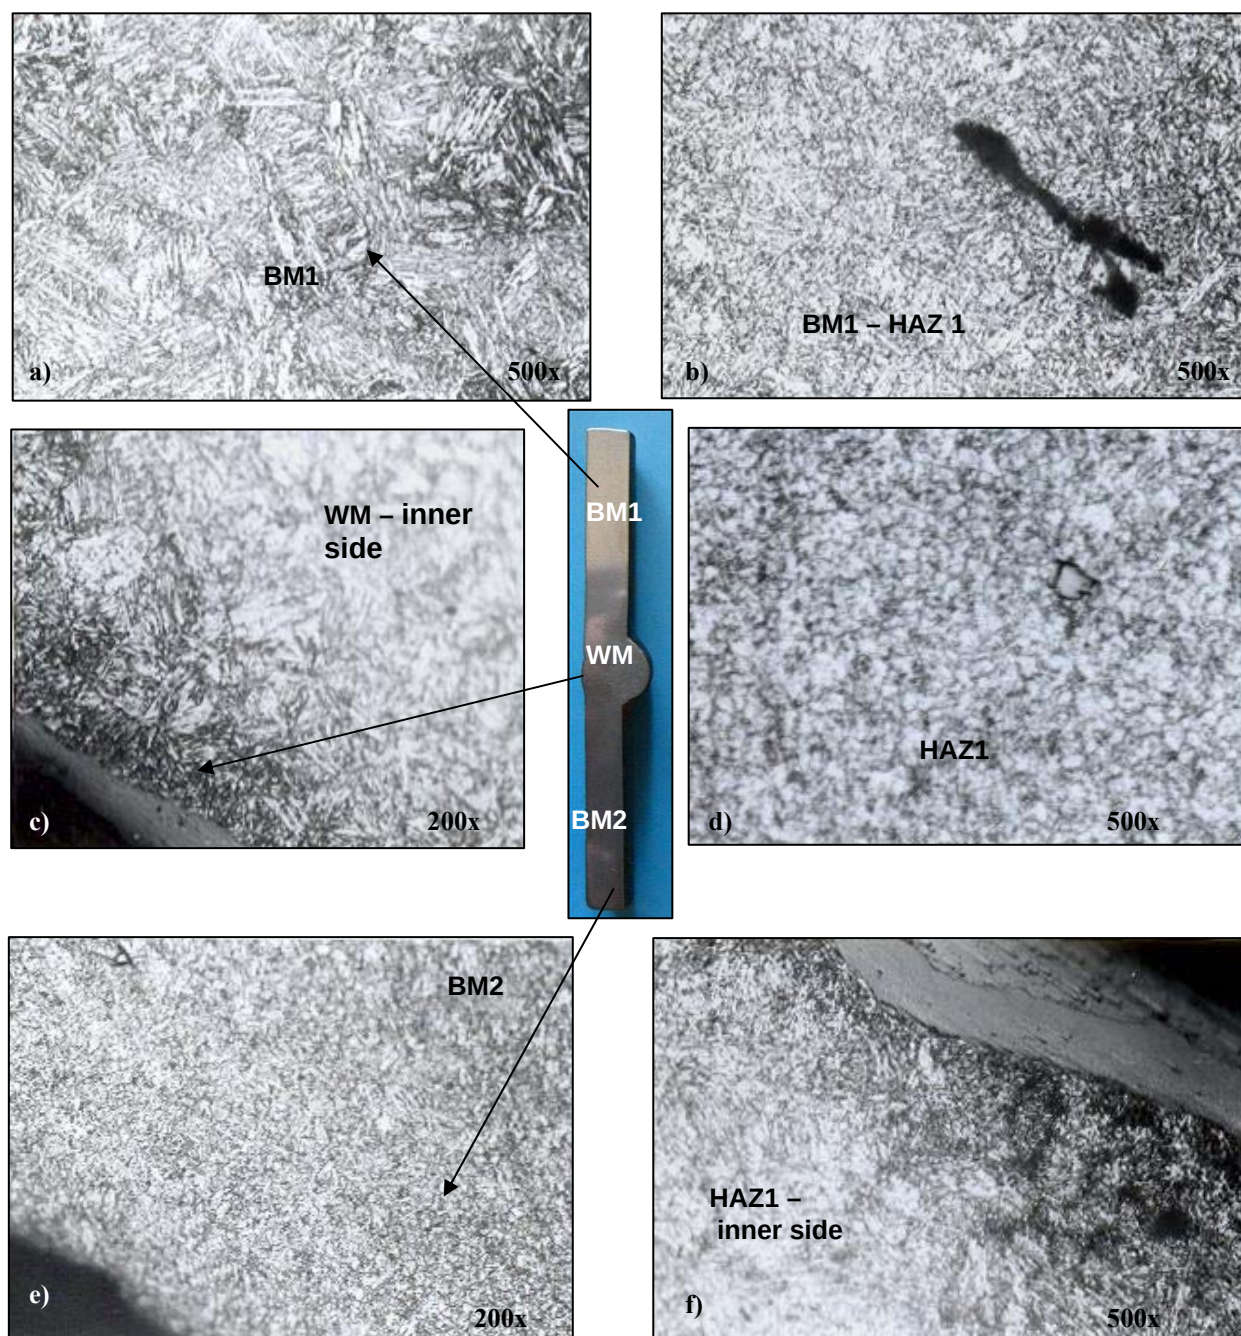
**Samples 2 and 3.** The basic structure of examined welds 2 and 3 with martensitic filling material is the tempered martensite. The morphology of tempered martensite depends on the maximum temperature to which it was exposed to during welding, Figs. 4 and 5.

The compact layered deposits of oxides that are formed during long term service at elevated temperatures can be seen on the inner surface of the tube, Figs. 4f and 5e. In addition, the microstructure in the vicinity of the inner surface is an area rich in Cr-carbide phase, [5]. This area rich in carbide is formed due to diffusion processes that took place during prolonged service at elevated tempera-

tures. The diffusion of Cr resulted not only in the formation of carbides but also in the formation of the Cr-rich oxide layer on the inner surface of the tubes. In both samples, the time-dependant microstructural damages such as individual cavities are present, Figs. 4e, 5a, 5b, 5f and 5g. The low level of martensitic decomposition can be observed in the base material and welded joint, Figs. 4 and 5.

Figure 4a-f. Optical micrographs of Sample 2.  
Slika 4a-f. Mikrostruktura uzorka 2

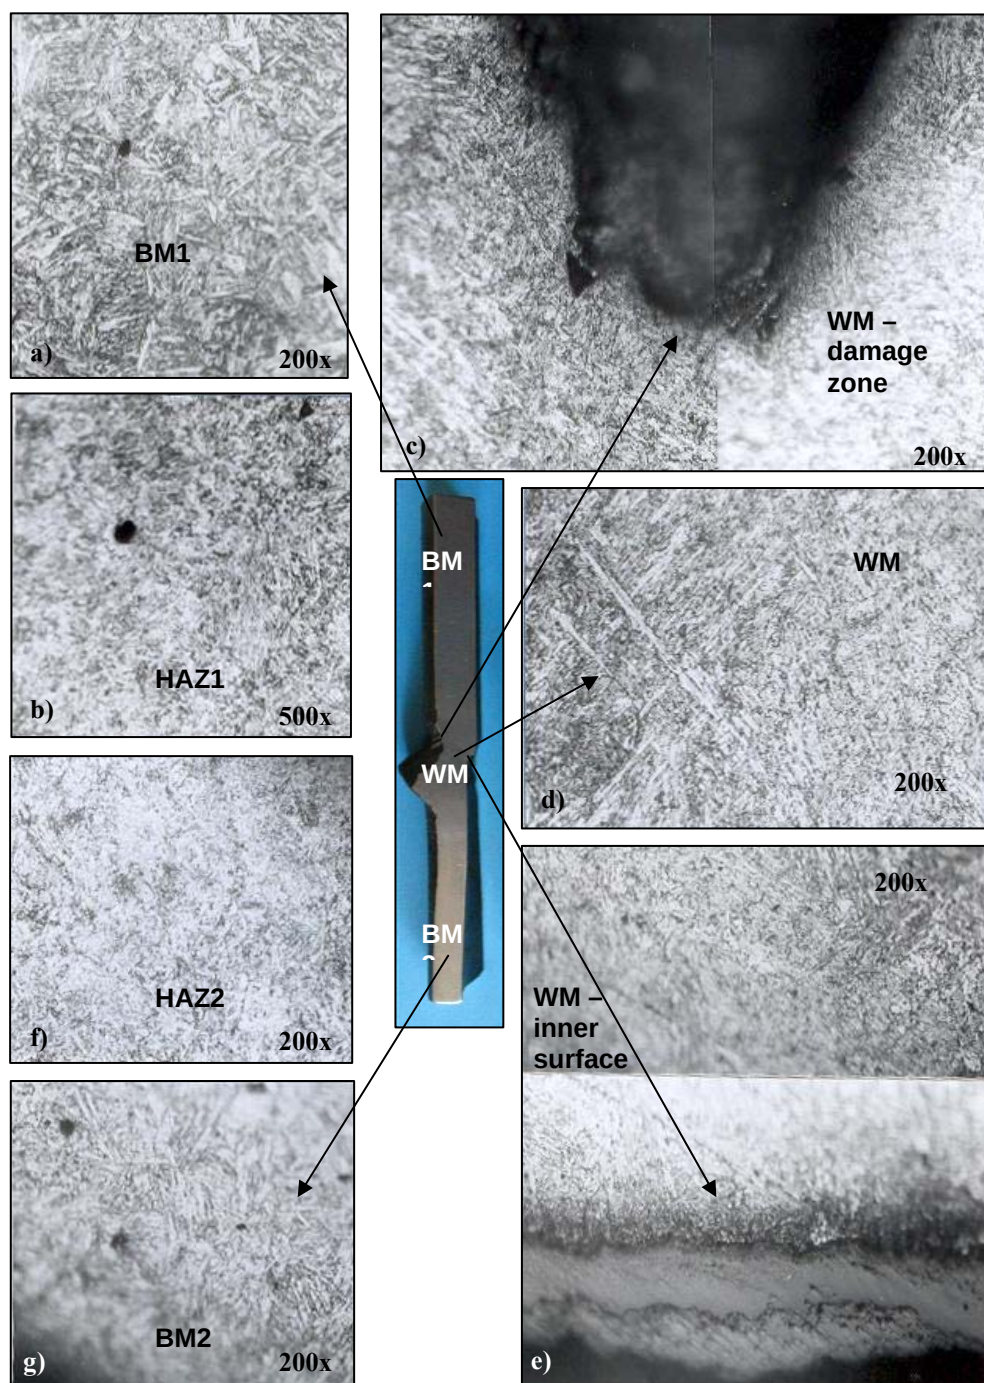
Figure 5a-g. Optical micrographs of Sample 3.  
Slika 5a-g. Mikrostruktura uzorka 3
