THEORETICAL-EXPERIMENTAL FRACTURE ANALYSIS OF A RESPONSIBLE MACHINE PART TEORIJSKO-EKSPERIMENTALNA ANALIZA LOMA ODGOVORNOG MAŠINSKOG DELA

Originalni naučni rad / Original scientific paper

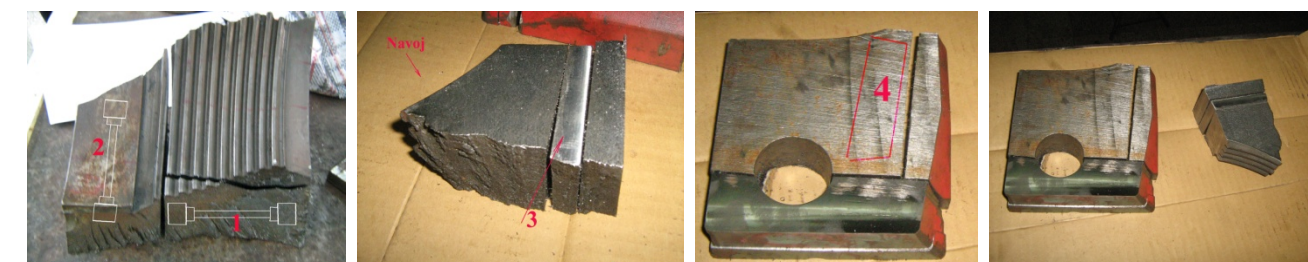
a) Tensile testing

b) Impact toughness testing and microstructure

Figure 3. Sampling locations on the broken part.
Slika 3. Mesta uzimanja uzoraka sa havariisanog dela

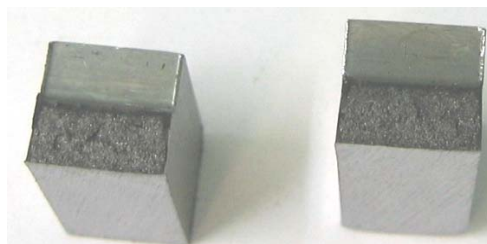
Figure 4. Location for microstructural test KU 5 on specimen (4).
Slika 4. Mesto kontrole mikrostrukture KU 5 na uzorku (4)

- Metallographic analysis of the fracture zone on samples and with impact energy of 6 J at -40°C are with segregations of phosphorus on 1/3 of the fracture surface (Fig. 4);

during the forging phase create micro and macro-cracks which expand during further heat treatment and during exploitation. This conclusion is drawn from the sample with the impact energy of only 6 J.
