FAILURES OF BRASS CONDENSER TUBES LOMOVI KONDENZATORSKIH CEVI OD MESINGA

Originalni naučni rad / Original scientific paper
UDK /UDC: 620.194:669.35`5
620.194:621.643.2-034.35
Rad primljen / Paper received: 21.01.2016.

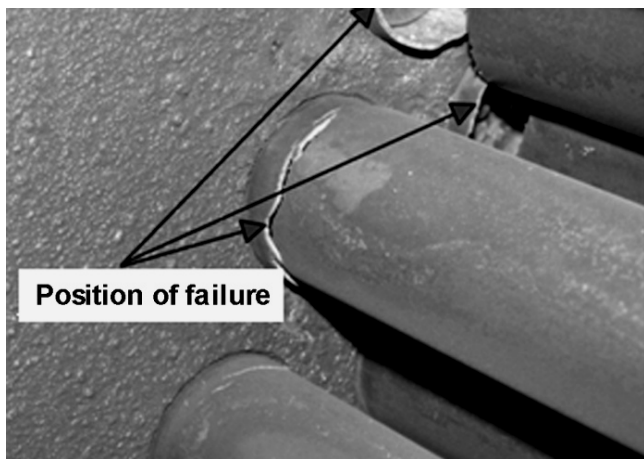
Brass condenser tubes are mechanically joined to the backing plate of carbon steel. The cooling water (roughly filtered river water) flows through the tubes, while the hot steam flows around the tubes. It was noted that the failure of the brass condenser tubes occurred in the region of ~ 4-5 mm from the joining place with the backing plate (Fig. 1).

Figure 1. Failure of brass condenser tubes near joining location with backing plate.

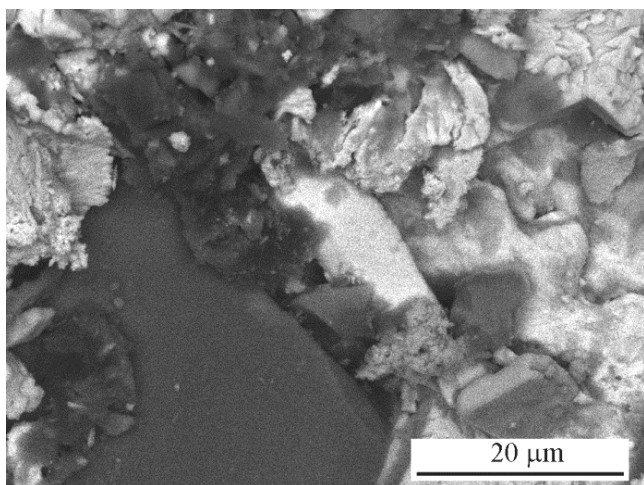
Figure 2. SEM micrograph of deposits on fractured surface.

Organic and inorganic deposits are present on the inner side of brass condenser tubes, in the vicinity of fracture, as well as on fractured surfaces. Figure 2 shows the SEM micrograph of the deposit on the fractured surface. FTIR analysis of the deposits on the tube inner side in the vicinity of fracture shows that deposits contain ammonia and nitrate

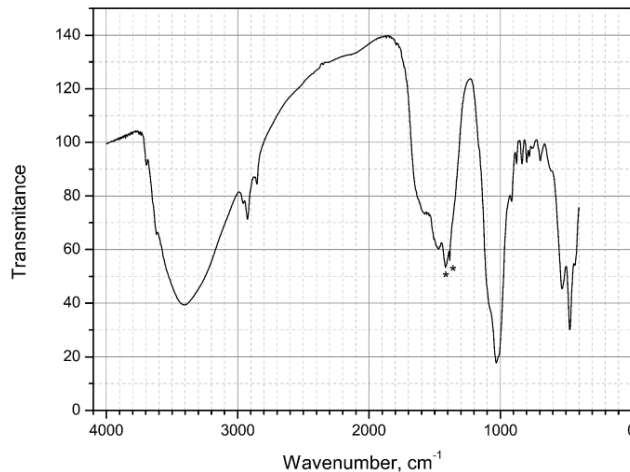
compounds (Fig. 3). Ammonia and nitrate compounds are the specific agents that cause stress corrosion cracking (SCC) of brass. The results of FTIR analysis are direct evidence of the presence of compounds in condenser tubes. A SEM micrograph of the condenser tube fractured surface is shown in Fig. 4.

Figure 3. Results of FTIR analysis of deposits on inner side of condenser tube near fracture site. Wave-number peak at 1417 cm^{-1} corresponds to ammonia compounds, while wave-number peak of 1385 cm^{-1} corresponds to nitrate compounds.

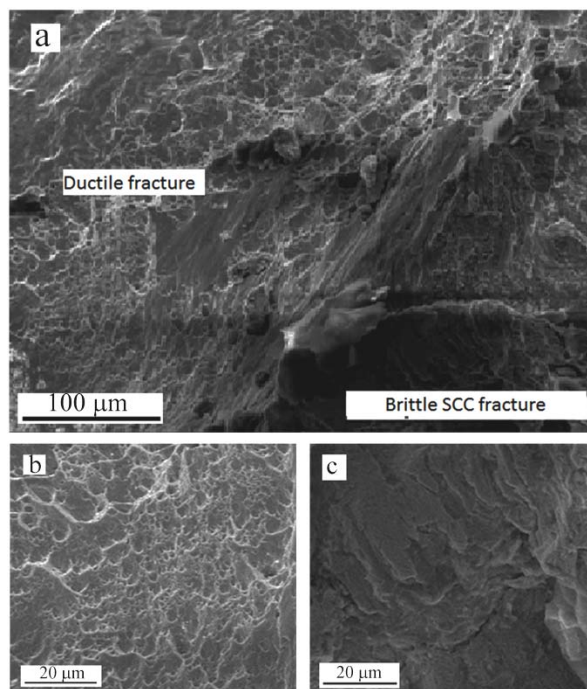
Figure 4. a) Fractured surface of brass condenser tube, b) ductile fracture is a result of mechanical action, c) brittle transgranular fracture is a result of SCC.

During the operating delay of the power plant, there are suitable conditions for SCC occurrence in the unclean brass condenser tubes, in the region of residual tensile stresses (the region of mechanical joining of condenser tubes to the backing plate). Initial cracks are formed in the inner wall of the tubes. The cracks started to grow at low rate through the tube wall, so that a relatively long time is needed for the cracks to reach critical size, when fast mechanical fracture has occurred. This phenomenon has been observed in a large number (several hundred) of brass condenser tubes. The fractured surface of the brass condenser tube is presented in Fig. 4. It can be seen that brittle transgranular fracture is a result of SCC. SCC fracture is always brittle (intergranular or transgranular) regardless of the level of alloy plasticity (brass), /3/. The final mechanical fracture is ductile type fracture in alloys with a higher degree of plasticity, such as brass.

Failure of brass condenser tubes occurred due to SCC, because the necessary conditions for the SCC occurrence were fulfilled. Fractographic (SEM) analysis shows that the fracture of brass condenser tubes is a brittle transgranular fracture caused by SCC, while the final mechanical fracture is ductile fracture. It is possible that SCC cracks exist in a certain number of brass condenser tubes, although the failure of these tubes has not occurred in the previous period. It can be expected that some of these condenser tubes will fracture during further operation of the thermal power plant.

The risk of SCC in brass condenser tubes can be reduced if specific substances responsible for SCC occurrence are removed, as much as possible. This can be achieved by cleaning and drying the tubes immediately after the operation delay of the power plant. After such treatment, the condenser tubes should be free of organic and inorganic impurities, and dry. This will extend the lifetime of existing and new condenser tubes made of brass CuZn28Sn1.

Another way to reduce the risk of SCC occurrence in condenser tubes is the replacement of existing tubes (made of brass CuZn28Sn1, very susceptible to SCC) with tubes made of alloys of greater resistance to SCC, such as copper nickel alloys. These alloys are much more resistant to general and erosion corrosion than the brass CuZn28Sn1. Copper nickel alloys are also resistant to selective corrosion. Service life of condenser tubes of these alloys will be significantly extended.

Residual tensile stresses exist near the joining location of condenser tubes to the backing plates. In practice, the risk of SCC occurrence is usually reduced by eliminating or lowering residual tensile stresses. If residual stresses in brass condenser tubes are removed, the risk of SCC occurrence in the tubes will be significantly reduced.
