FAILURE OF A COMBINE HARVESTER FRONT AXLE ANALIZA LOMA POLUOSOVINE KOMBajNA

Originalni naučni rad / Original scientific paper

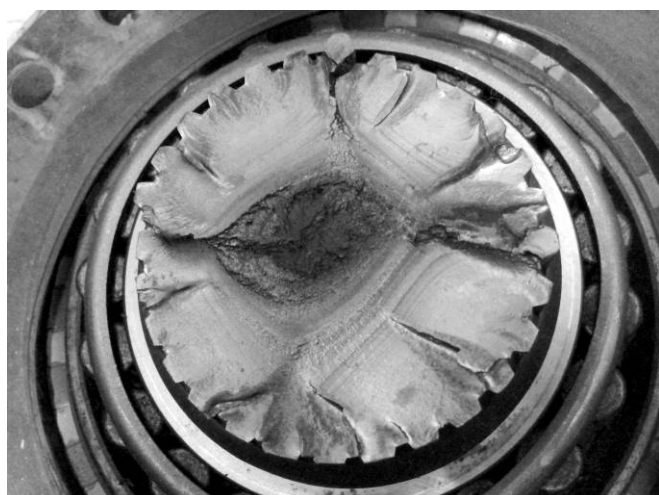
The fractured surface is shown in Fig. 1. Fracture morphology reveals a torsion-bending fatigue as a result of crack development that started at four initiation regions, with multiple sites at specimen surface, with corresponding beach marks. The cracks initiated at tooth flank. Initiated cracks propagated and consecutively met, which is followed by the area of overload (final) fracture towards specimen centre. Visual examination reveals an adequate heat treatment with a relatively small overload section.

Figure 1. Macrograph of an axle shaft fractured surface with indicated fracture origins-initiation sites.

The obtained results indicate that the fracture was caused by fatigue, that started at the initiation site at the tooth flank or top. Microstructural and lower hardness results indicate that the surface was decarburised or partially decarburized before case hardening. After the case hardening process, a lower amount of carbon in the surface and sub-surface layers affected the hardness and therefore influenced a decreased stress required for fatigue crack initiation. The definite reason for premature fracture is found to be a defective heat treatment of the axle shaft.

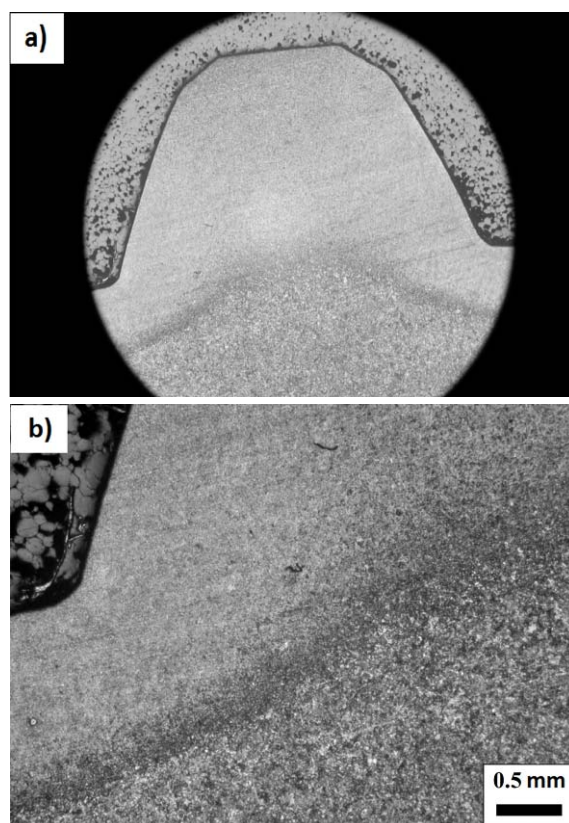
Macro testing is done at the surface and sub-surface regions of the specimen, Fig. 2. A macro image of the gear

tooth reveals that two regions are apparent: surface layer that appears to be case hardened (most probably induction hardened) and the inner section that probably corresponds to the microstructure obtained by tempering.

Figure 2. Sample microstructure: a) low magnification showing gear tooth geometry, b) intermediate layer microstructure.

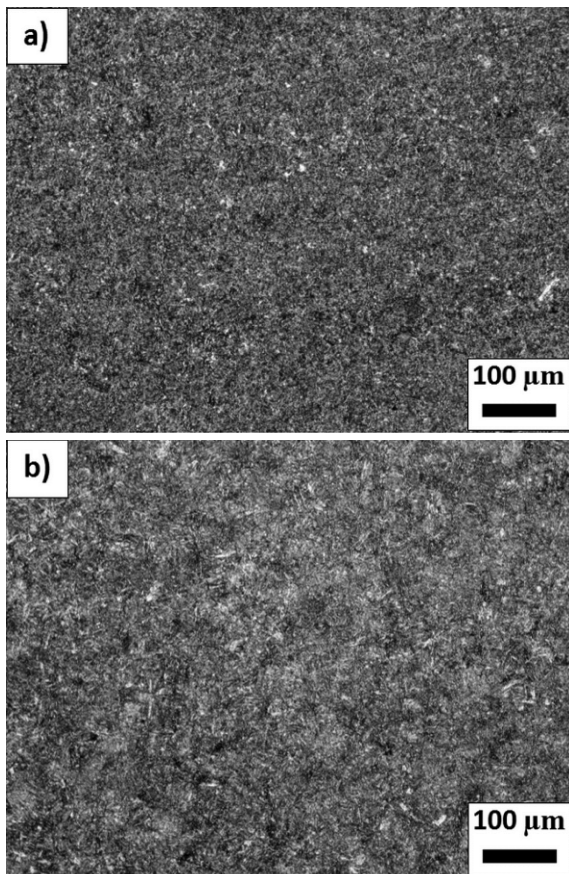
Sub-surface microstructure at 0.5 mm depth and inner section microstructure are shown in Fig. 3. In Figure 3a, a tempered martensite, typical for low temperature tempering heat treatment, is shown. In the inner section, a tempered martensite may be observed as well, however, the morphology is typical for through tempering process. This indicates that a through tempering process was conducted first, with a higher tempering temperature, thus increasing ductility. It was followed by case hardening and low temperature tempering to increase surface hardness and fatigue resistance by the prevention of crack initiation.

Figure 3. Failed axle shaft microstructure: a) surface; b) core.

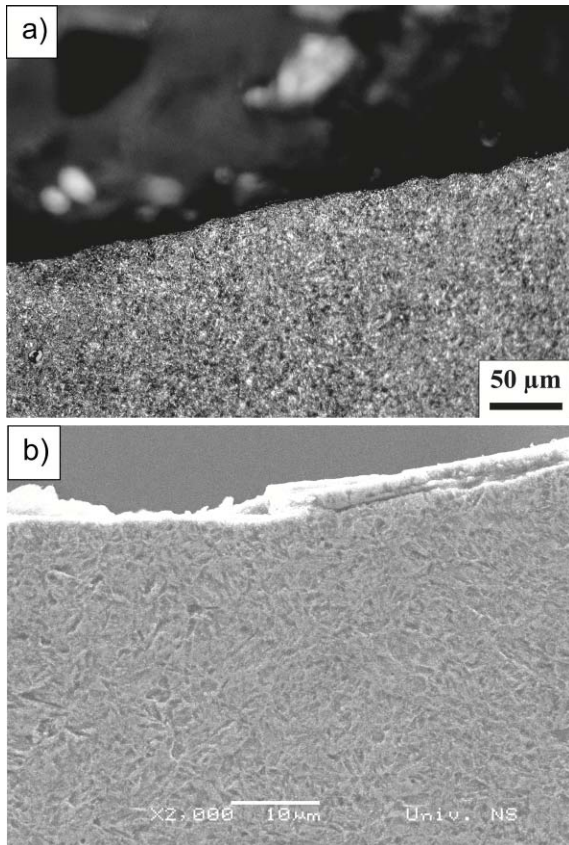
The microstructure of gears bottom land is shown in Fig. 4. Its morphology corresponds to case hardening and low temperature tempering. No differences between surface and sub-surface layers are visible.

Figure 4. Gears bottom land: a) LM; b) SEM. No morphological differences between surface and sub-surface layer are observed.

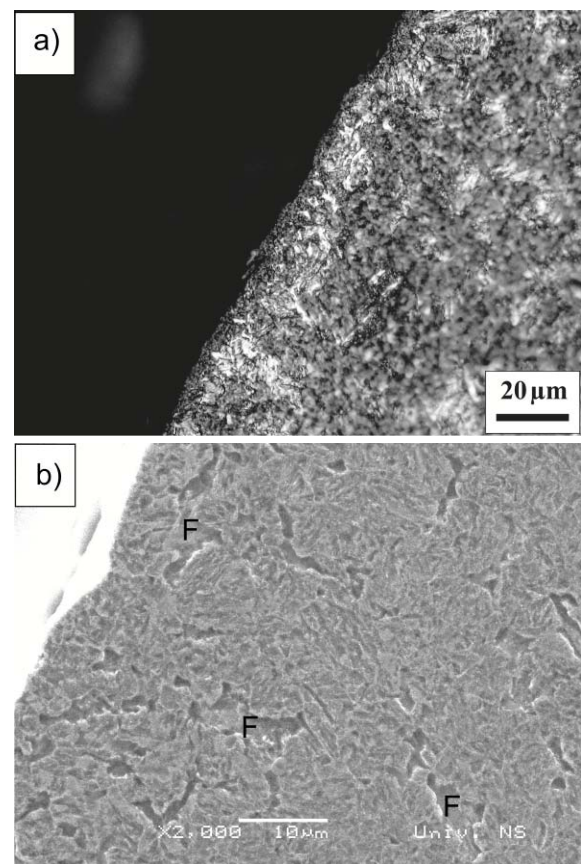
Tooth surface (flank) microstructure is shown in Fig. 5. On the flank surface, a case hardening microstructure is visible. The surface layer is clearly brighter and with a different morphology than the sub-surface layer. Light microscopy- (LM) and SEM micrographs reveal the presence of ferrite isles in the tempered martensite matrix.

Figure 5. Tooth flank surface: a) LM; b) SEM. Ferrite isles may be observed in tempered martensite matrix.

Microstructure testing revealed the existence of two layers, a thin surface case hardened (probably induction hardened) and the inner tempered core. However, the microstructure of the surface layer varies with the tooth or gear section. The predominant tempered lathe martensite with ferrite isles is found in the tooth top and flank, while tempered lathe martensite is observed in the gears bottom land. This finding is supported by a decreased hardness in tooth top and flank regions where ferrite isles are observed. Ferrite isles may have appeared before heat treatment (quenching and tempering), most probably as the result of decarburisation. Furthermore, the decarburisation is more severe as the distance from the gears bottom land is greater. Obviously, based on microstructure and hardness measurements, the highest decarburisation occurred in external or exposed gear sections, such as the tooth. It is possible that the extent of the decarburization on the tooth flank is higher than evaluated in this expertize, since the surface might be worn out during operation. A decreased hardness on some tooth sections influenced the decrease in the stress required for fatigue crack initiation. However, the main reason for crack initiation is the presence of ferrite in the microstructure. This means the crack might initiate at the ferrite isle, even in a lower decarburized region if this region is more severely loaded as the tooth lower flank.

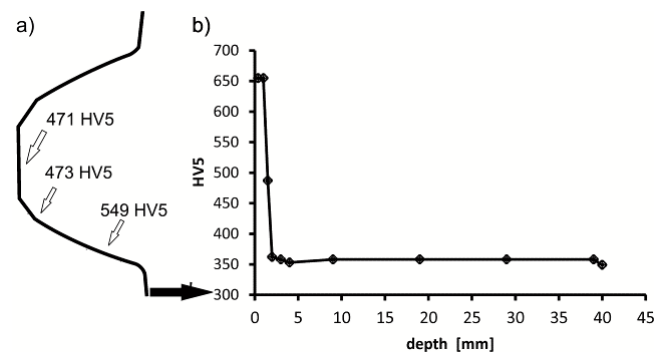
Vickers hardness results, measured on the tooth top, flank and from the gears bottom to the interior of the cross-section, are shown in Fig. 6. It can be seen that hardness of the tooth top and upper tooth flank are similar (471-473 HV5), followed by the mid- and lower section of the tooth flank (549 HV5), Fig. 6a. The highest hardness is obtained in the gears bottom (655 HV5), Fig. 8b. In Figure 8b, a hardness profile, measured from the gears bottom to the interior of the cross-section, up to the axle shaft centre is shown. It can be seen that in the surface layer, reaching 1 mm, a relatively high hardness is obtained, followed by a steep drop with nearly constant hardness values of 349-362 HV5, that reach up to the centre of the cross-section.

Figure 6. Hardness values at axle shaft cross-section: a) tooth top and flank; b) hardness profile at tooth bottom to the axle shaft centre.
