LOW-TEMPERATURE CORROSION DAMAGE AND REPAIR OF BOILER BOTTOM PANEL TUBES

Originalni naučni rad / Original scientific paper

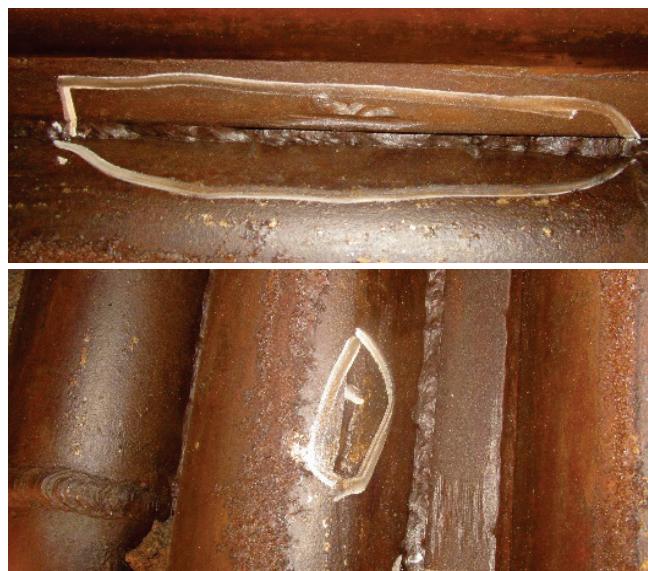
During the visual inspection of the firebox, damages mostly present in the bottom panel are observed. In addition, large edge notches and damages in the connection between membrane strips and tubes are detected (Fig. 1, top), along with occasional damage in the tubes themselves (Fig. 1, bottom).

Figure 1. Edge notches in the connection between membrane strips and tubes (top); tube damage (bottom).

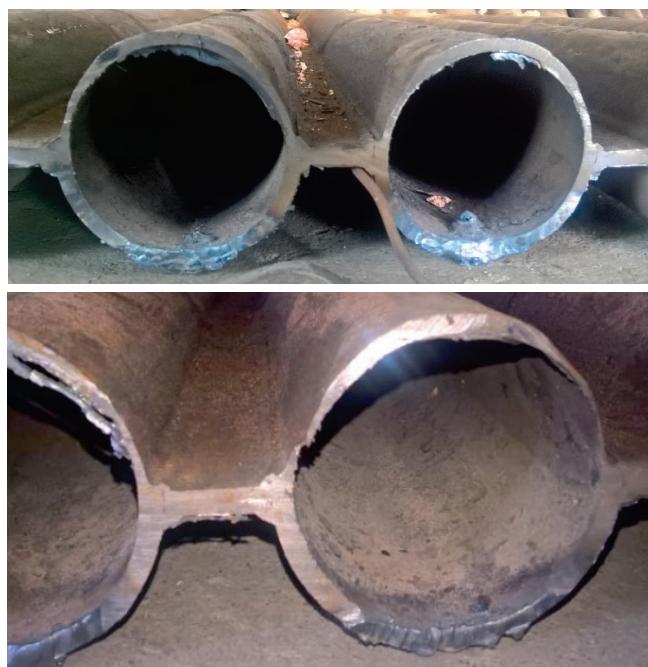
For the purpose of determining the extent of damage to the lower floor screen, NDT testing of membrane tube wall thickness is performed by the Welding Institute in Belgrade. Wall thinning due to the effects of sulphuric acid is observed on the screen tube walls (Fig. 2).

the front firebox wall, whereas cross-section III-III is at a distance of 2400 mm from the front firebox wall. Measuring is performed in a single point, i.e. on the upper side of the tube. After measuring, it is determined that the most damaged zone includes tubes 7-29 at a distance of approximately 1000 mm from the front screen. Once this part of the floor screen is cut and dismantled, it has been revealed that the damages are more prominent in the connection between the tubes and the membrane sheet, as can be seen in Fig. 2, and that thickness measurements provided unfavourable results. Repeated measuring determined that floor screen damages are greater than initially assumed. The cutting line was moved to almost 3000 mm from the front screen.

Figure 2. Zones of the largest damage and wall thinning.

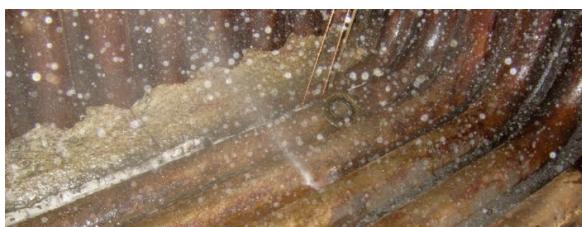
After the tube wall thickness tests, cutting, i.e. dismantling of the bottom panel is performed according to the new cutting line. Welding preparations were undertaken, and new tubes have been welded. After the original welding, radiography of these new joints is performed. No significant defects were detected. After completing all procedures, the joints are tested using cold water pressure, in the presence of the appointed body. A new problem arose during the tests. One of the tubes that has not been the subject of previous repair has leaked (Fig. 3), which resulted in the need for additional tests and an increased extent of repairs.

Figure 3. Leakage during the pressure test.

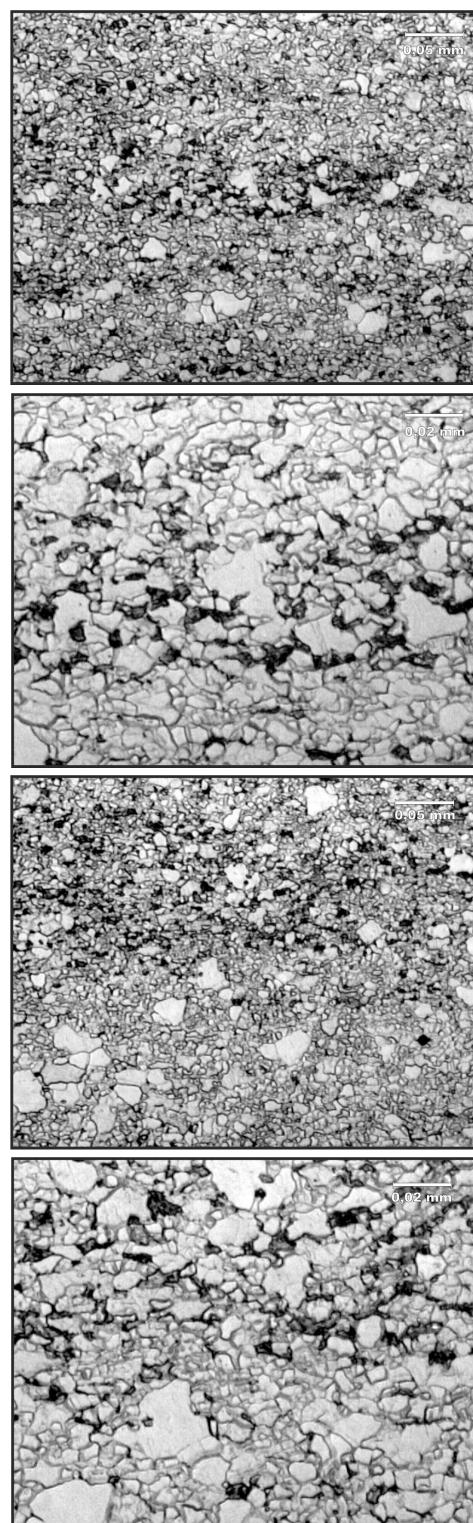
Metallographic analysis has determined a ferrite-pearlite type microstructure on the tested location at the surface (Fig. 5a-d) with a significantly reduced share of pearlite micro-constituent. It has also been observed that initial ferrite-pearlite strip structures are present, along with coarse ferrite grains, which is not related to the exploitation period of the tested tube, but rather a consequence of the manufacturing technology used on the tube.

The presence of unallowed microstructural defects that could have resulted from exploiting conditions and previous service life, such as degradation of the pearlite micro-constituent, surface decarbonisation, existence of surface corrosion remnants or intergranular corrosion, etc., have not been detected during the testing of the surface microstructural state of the tube.

Figure 5. Microstructure of selected tube taken from the Remming hot-water boiler panel.
