MICROSTRUCTURE EVOLUTION AND MECHANICAL PROPERTIES DEGRADATION OF HPNB ALLOY AFTER AN ELEVEN-YEAR SERVICE

Originalni naučni rad / Original scientific paper
UDK /UDC:

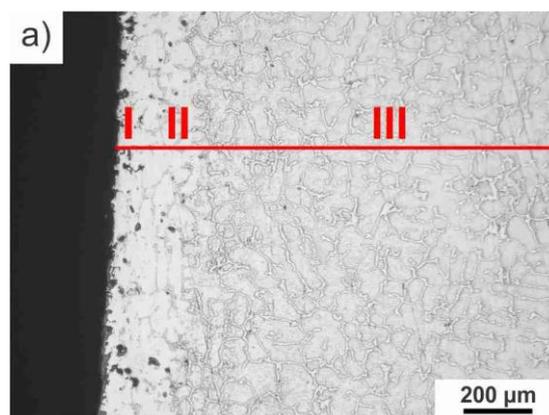
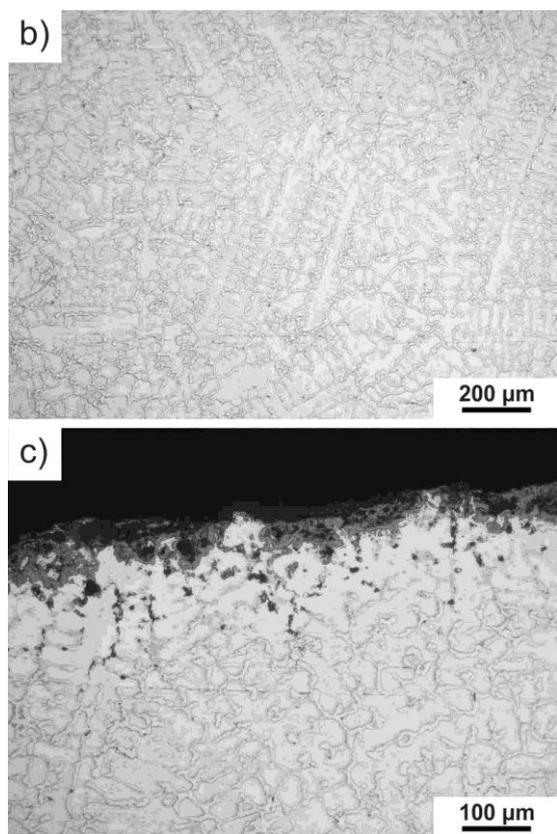
Microstructures of the ex-service material are shown in Fig. 1a-c. It can be seen that there are different microstructures in the exposed areas (the inner, outer surfaces, and central regions). A black phase (I in the micrograph Fig. 1a) is an oxide layer with thickness of about 30 µm. Closer to the inner surface (II in Fig. 1a), is a second zone prolonged for about 150 µm, showing the precipitate - free layer. According to Fig. 1a, the farthest from the inner wall side is the III zone. This zone has skeletal-shaped carbides and some secondary carbides within the austenitic matrix. According to Fig. 1b the material in the middle section consists of an austenitic dendritic matrix and a complex network of coarsened intergranular precipitates. Figure 1c shows typical damage to the outer surface of the radiant tubes. Unlike the tube's inner wall, the material degradation on the outer surface is different. Creep damage seems to be the main cause of material degradation in the tube outer wall as indicated by the formation of cavities which nucleate along grain boundaries, as seen in Fig. 1c. Some cavities which appear along dendritic boundaries, had already coalesced with each other, forming intergranular cracks at grain boundaries, thus indicating creep damage accumulation in the failed tube during long term service at high temperature, /23/.

Figure 1. LM micrographs of sample cross sections from the tube close to the: a) inner surface; b) middle thickness; c) outer surface.

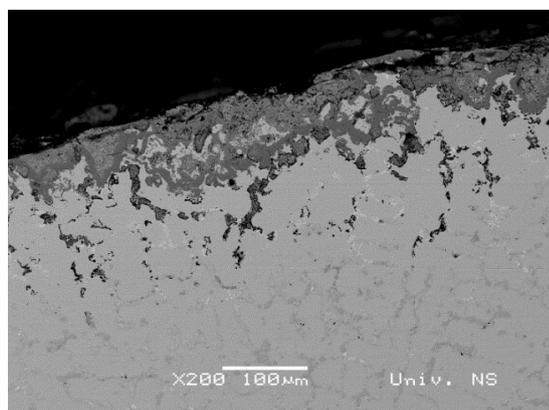
SEM micrograph of a carburized tube shows the outer scale, a precipitate free zone with micro-cracking, and carbide formation at the inside of the tube (Fig. 2).

Figure 2. SEM micrograph at the inner section part of tube using backscattered electrons.

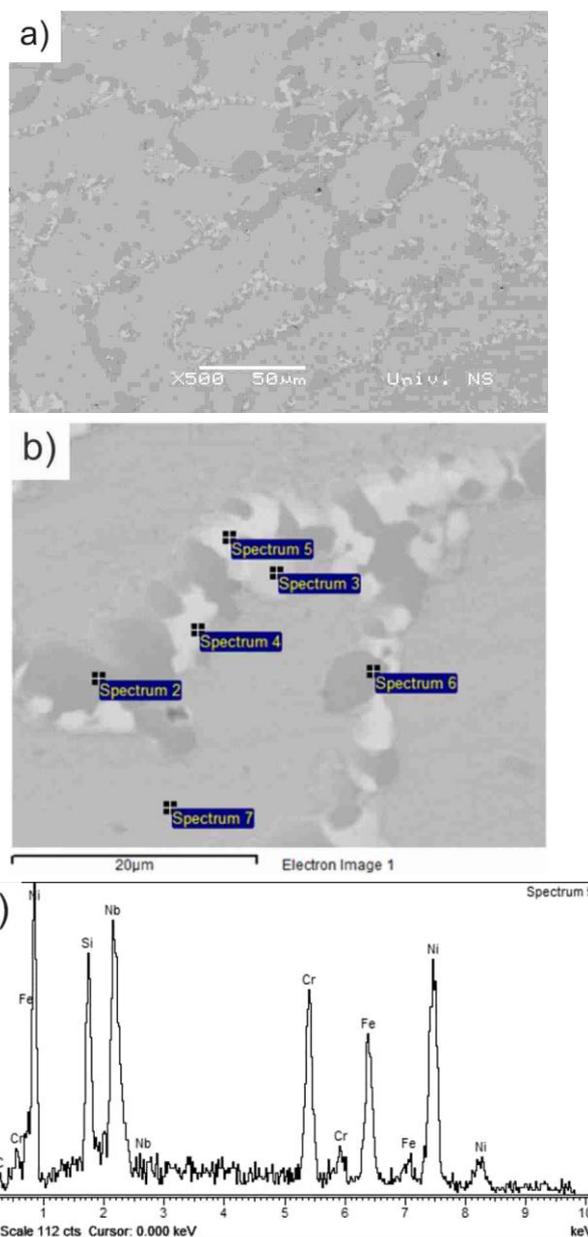
The precipitation of carbides can be identified to be of the two types as revealed in the SEM micrographs (Fig. 3a). Light grey ones are more continuous and plate-like, while the dark grey are present mostly at intra-dendritic locations, as confirmed by SEM-EDX studies (Table 1). The microstructure consists of an austenitic matrix (Spec 7) and a continuous network of primary eutectic carbides of two types: one rich in Nb (bright particles in Fig. 3b, Spec 3, 4, 5), and one rich in Cr (dark particles in Fig. 3b, Spec 2, 6). These carbides are NbC and complex M_7C_3 ($M = Cr, Ni, Fe$) type.

Carbides in the intra-dendritic boundaries appear as lamellar, or skeleton form, /23/. The niobium-rich carbides are more stable at high temperature compared to the secondary chromium carbides, /24/.

Figure 3. SEM and EDS analysis: a) SEM micrograph from cross section of the failed tube (11.4 years service) close to the inner surface; b) positions of EDS analysis (dark and light phases); c) corresponding EDS spectrum 5.

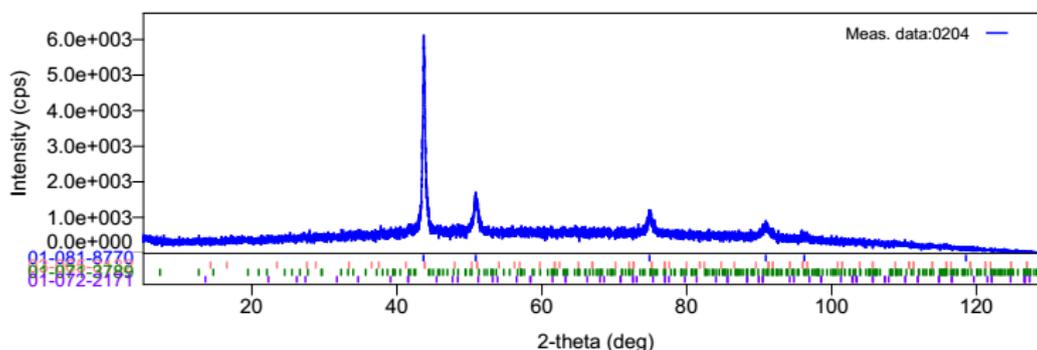
In the failed tube sample the following crystal phases are identified: γ -Fe whose diffraction pattern corresponds to the standard PDF # 01-081-8770; Cr_{23}C_6 whose diffraction pattern corresponds to the standard PDF # 03-065-3132; Cr_7C_3 whose diffraction pattern corresponds to the standard PDF # 01-071-3789; $\text{Nb}_3\text{Ni}_2\text{Si}$ whose diffraction pattern corre-

sponds to standard PDF # 01-072-2171 (PDF-2 Release 2016 RDB), Fig. 4. Results of the submitted chemical analysis indicate the possibility of multiple atomic replacements in the mentioned crystal structures. The stated formulas of crystal phases should be considered as approximate chemical formulas.

Figure 4. XRD patterns of the used tube are shown in blue.

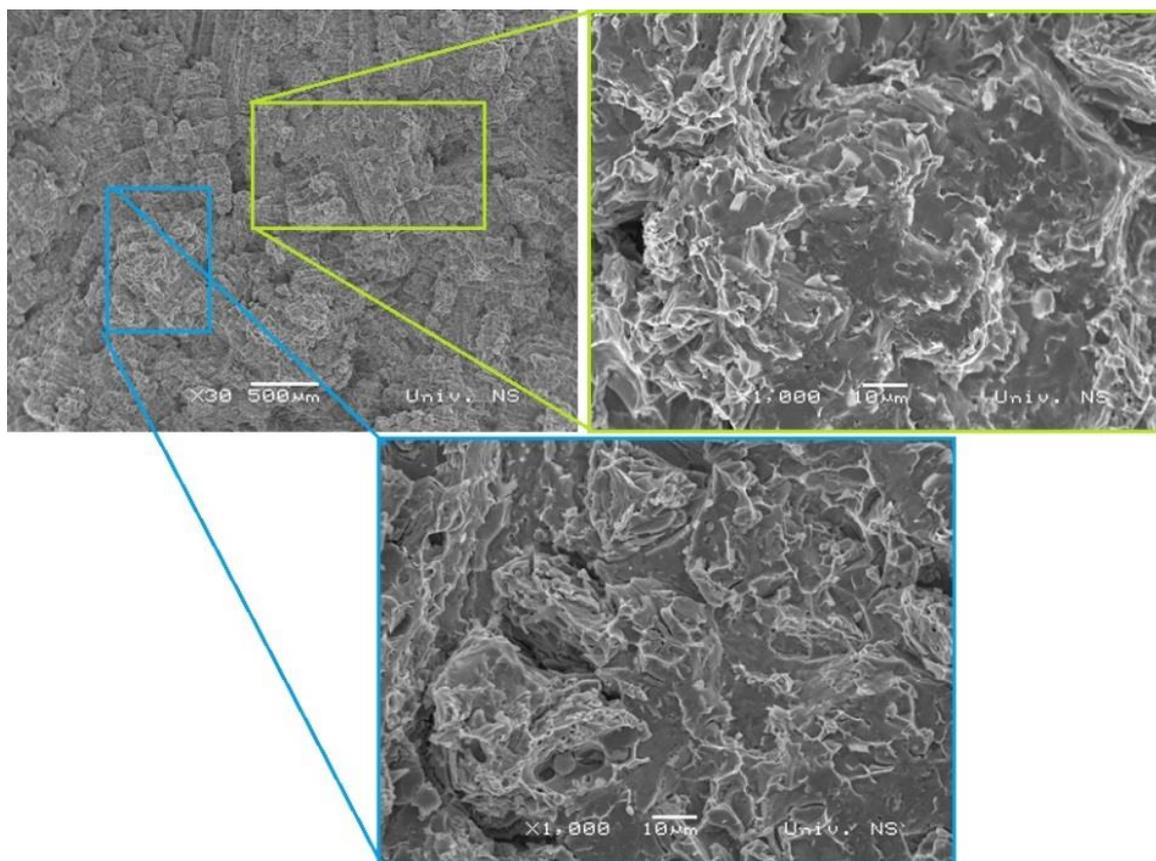
To verify the observed differences in fracture behaviour, the fractured surfaces of tensile and impact test specimens are examined using SEM. This investigation reveals that both types of microstructures show very similar fracture morphology (Figs. 5 and 6). The brittle mechanism of fracture predominates on fractured surfaces, although some other

modes are also present. The brittle intergranular fracture mode is explained by the presence of massive precipitation and coarsening of intergranular carbides at grain boundaries (Fig. 5). These precipitates have been brittle and have produced secondary cracks, which significantly decrease grain-boundary strength and toughness of tube material, /22, 26, 27/.

Figure 5. Fractography of the HP40Nb alloy specimen at different magnifications after the tensile test.

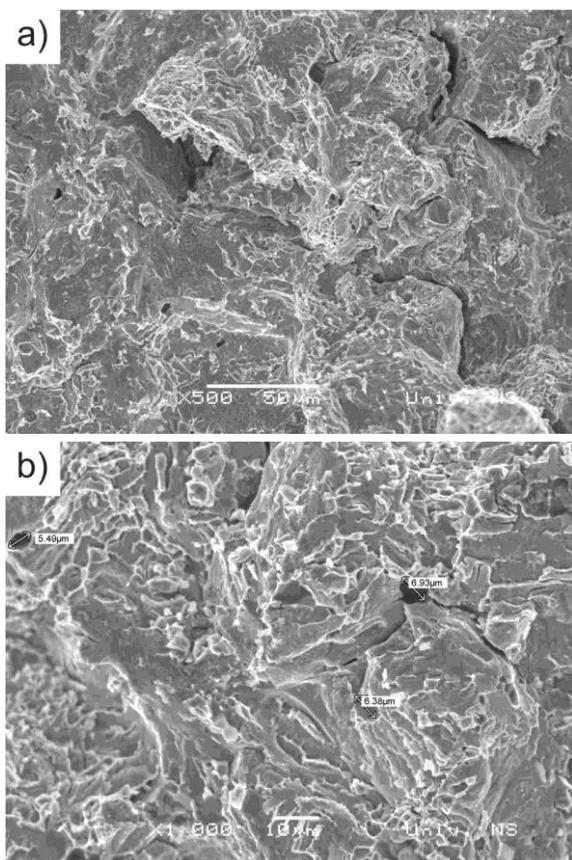
Morphological features that appeared in the failed specimen after Charpy impact test illustrate a signature of the brittle mode of fracture. The presence of microcracks and microvoids act as initiation sites and provide an easy way for the crack to propagate during the Charpy impact test and ultimately lowering the fracture toughness of this material. Low-magnification observation (Fig. 6a) of the fractured surface of the specimen tested at room temperature reveals quasi-cleavage features. The figure shows a number of large voids like features on the fractured surface. As can be seen in Fig. 6b, the high magnification reveals intergranular cleavage features and microcracks on the fractured surface, indicating the dominant failure mechanism as brittle fracture.

Figure 6. Fracture surfaces of Charpy impact specimens of HP40Nb alloys after service.
