ANALYSIS OF REMEDIATION OF MANIFOLD LINE DAMAGED BY LONGITUDINAL CRACK IN THE PIPING ELBOW OF OIL AND GAS WELL COLLECTOR

Originalni naučni rad / Original scientific paper
UDK /UDC:

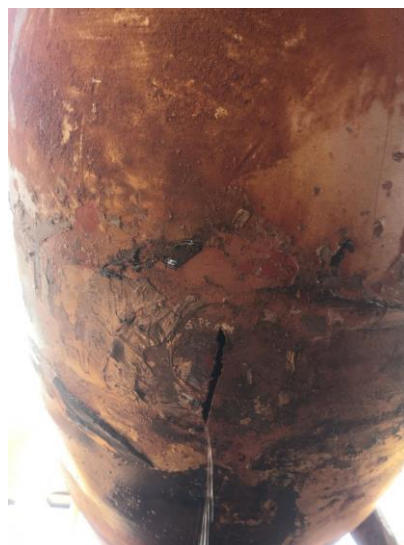
During long-time service (18 years) of the manifold line, used for transporting the mixture of oil and gas to upstream plant has a leak that has occurred on the vertical elbow due to appearance of a longitudinal crack (Fig. 6).

The longitudinal crack appeared on a 20" piping elbow, belonging to a welding type. Also, it is highlighted that the elbow is such a pipe element type of non-uniform stress distribution and by rule, and the exterior part of the elbow is usually the most critical part. Taking into account the fact

that piping elbows are pipe elements, used for changing the pipe direction, the external side of elbow is usually the area strongly affected by erosion, /6-8/.

Figure 6. Longitudinal crack in a vertical 20" elbow.

This is particularly expressed when flow velocity is high and when the flow carries some solid particles as stones and sand. Considering that one of the causes of this leakage is erosion and that in a situation such as this, when leakage on the main manifold appears, it requires quick analysis of the problem and making decisions because the temporary shut-down of the well collector will decrease the production capacity of the upstream plant. In this case a plan of examination is adopted in the sense of making the decision whether this elbow can be repaired by cutting the area around the crack and inserting a new piece of material of the same shape and radius, or the elbow should be cut at positions where it is connected to the horizontal and vertical segment of the manifold line, /9, 10/.

So, a final decision for solving this problem is adopted, taking into account also the location and type of crack (Fig. 7), cutting the damaged elbow and welding a new elbow onto the existing pipes.

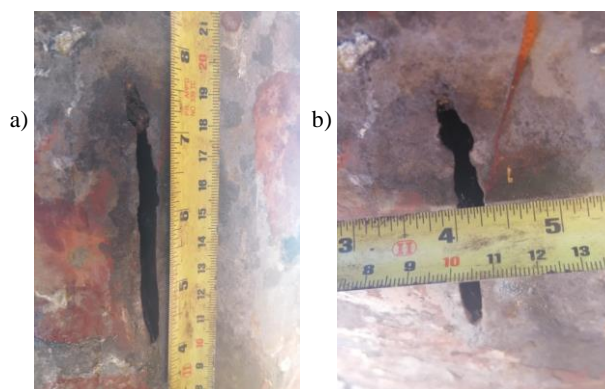
This examination includes visual examination and ultrasonic thickness measurements of the area around the crack in the sense of establishing dimensions of a possible patch which should be butt-welded. On that occasion, detailed size measurements (length and width) of the longitudinal crack are performed also from the outer side of the elbow. The mentioned NDE examination is performed in detail, and a conclusion has been reached that the crack has propagated substantially and the thickness around crack has decreased.

Figure 7. Dimensions of crack: a) length; b) width.

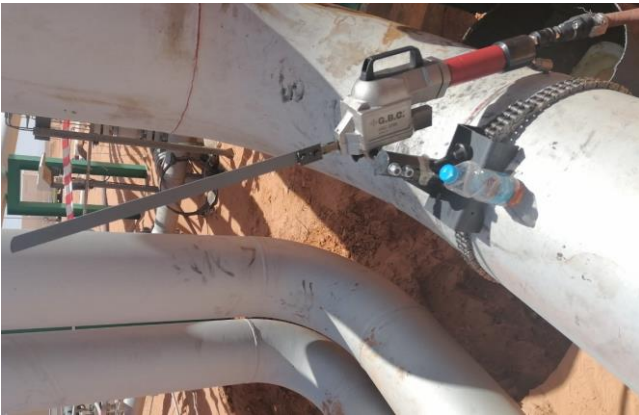
Figure 8. Cutting of a damaged elbow in a safety manner.

After the cleaning and removal activities for needs of providing safety aspects, machine cutting has started without sparking in contact with the metal (Fig. 8).

In sense of providing the appropriate position for the new elbow, the existing elbow was cut at the middle of welded joint. After the cutting process, the damaged elbow was removed by crane, and bevels are prepared on surrounding pipes for welding the new elbow.

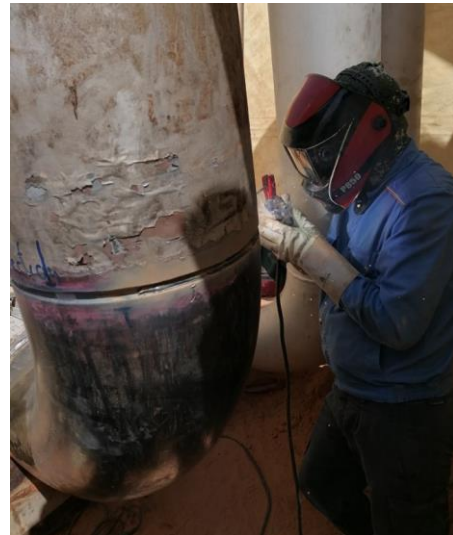
Figure 9. Welding of the new elbow to the manifold line.

An appropriate WPS (welding procedure specification) was applied for welding the new elbow to manifold pipes. It included applying the GTAW procedure for the first two layers and the SMAW procedure for other weld layers of the carbon steel material. ER70S-6 wire was used as a GTAW filling material, and electrode E7016G for SMAW (Fig. 9).

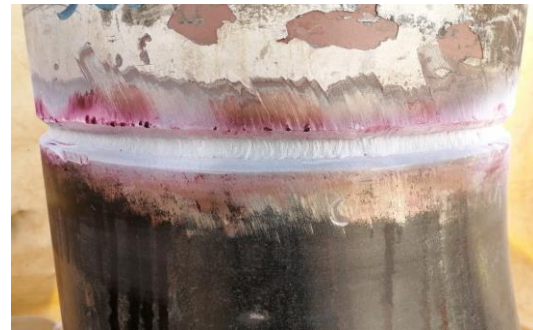
Figure 10. Penetrant tests of welded joints: root pass.

Necessary NDE examinations of the new welded joints followed after the completed welding of the new elbow to manifold pipes. NDE examinations included penetrant tests and radiographic testing for checking the quality of the fabricated joints. Penetrant tests were performed also on root pass of the welded joint (Fig. 10), and on the final layer of welded joint (Fig. 11).

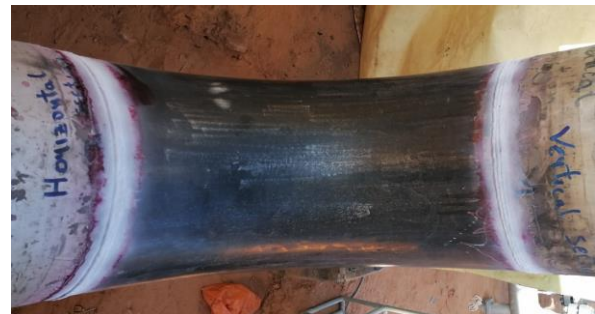
Figure 11. Penetrant test of welded joints: final layers.

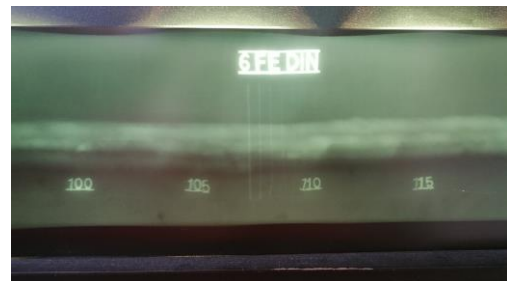
Radiography testing was used as a volumetric NDE method and interpretation of radiographs was conducted in a detailed way (Fig. 12). Radiography analysis has shown that the new welded joints were fabricated without defects /11/.

Figure 12. Interpretation of radiographs after welding.
