## DAMAGE ANALYSIS AND RESTORING OF STRUCTURAL INTEGRITY OF PELTON RUNNER AFTER REPAIR WELDING: CASE STUDY

*This paper presents the repair welding technology of a Pelton runner blade, including an analysis of damage caused by cavitation. Extreme exploitation conditions resulted in crack initiation followed by its propagation, with a length 200 mm, detected during regular annual maintenance, compromising Pelton turbine's structural integrity. The base material of the Pelton turbine was steel X3CrNiMo13-4, and as well as the blade geometry itself, required special attention during the process of defining repair welding technology. An austenitic electrode was used for this purpose along with a welding technology defined in a way to counter the initiation of new cracks at the same location. Following the NDT, the Pelton runner was put back into exploitation, along with recommendations for its further monitoring.*

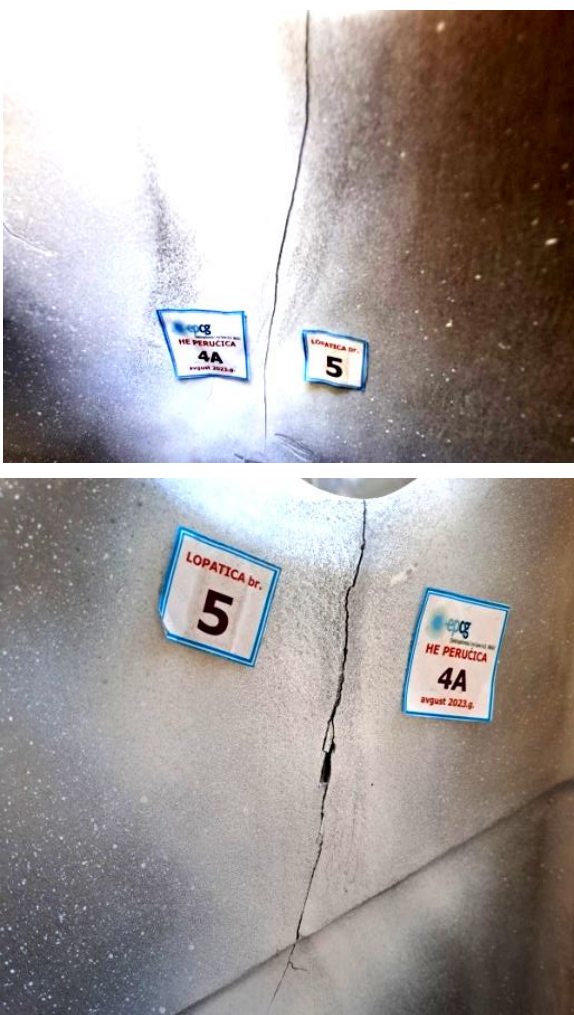
During regular annual maintenance of Pelton turbines, a large crack was detected in blade no. 5, using NDT methods, namely magnetic particles. Figure 3 shows the appearance of the detected crack, with a length of 200 mm, from both front and back sides. It was confirmed that this crack was caused by cavitation, leading to the decreasing blade's thickness and crack initiation, where even at lower load level the rapid crack growth can occur. It must be noted that this case represents a considerable crack growth during a single year.

Figure 3. Detected crack on Pelton runner's blade length of 200 mm: top) front side; bottom) back side

All of the above imposed the question of what should be done about this damaged runner. Taking into account sophisticated feature of it, this part with such damage should not be allowed to operate, where its failure could cause downtime and severe financial losses. Since it was impossible to determine with certainty if this was a defect that occurred during design, and there was no evidence of casting defects (taking into account how Pelton runner was made) that could cause crack initiation (which was confirmed by NDT), it was concluded that the best course of action would be to repair weld the turbine blade using an electrode of higher toughness compared to the base material. One of the main reasons for this electrode's type selection is better absorption of impact forces. In this way, future damage of this zone could be prevented. For this purpose, austenitic electrode was the choice for filler material.

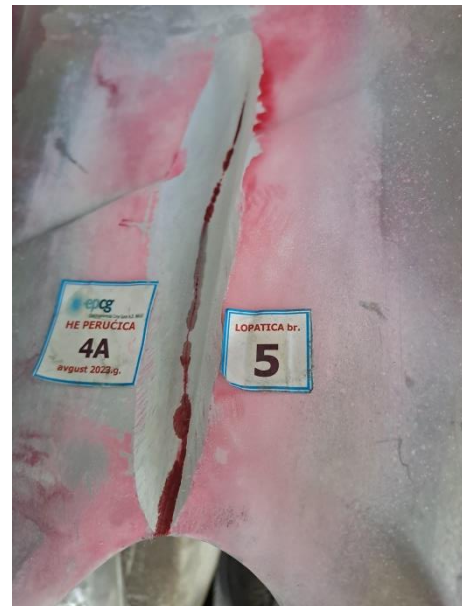
Figure 4. Groove on the Pelton runner's blade, made on the back side

Prior to repair welding, it was necessary to machine the U groove by grinding of the crack on the blade back side, up to approximately one half of its thickness, in the direction of the crack, Figure 4. So-called 'removal' of the crack

was then performed, and penetrant testing was also done in order to examine the state of the damaged area of the blade.

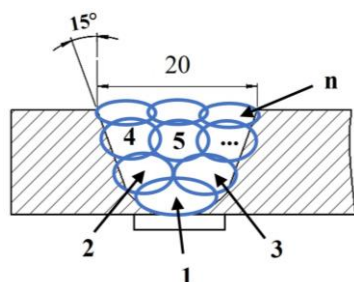
Figure 5. Filling plan for U groove of runner's blade

Immediately before welding, the electrodes were dried at a temperature of 300°C for 2 hours. Due to small blade thickness, there was no need for preheating. Welding parameters are given in table 5, whereas the welding plan is shown in figure 6. Interpass temperature was not greater than 200°C. Required level of welded joint quality was B (according to EN ISO 5817 standards).

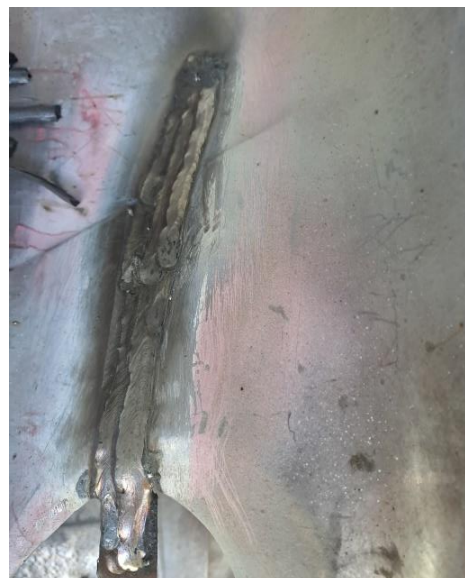
Figure 6. Blade groove after filling on the back side

After filling the groove, a 3 mm surface layer was welded above the cap weld. This was done for two reasons: (i) to avoid undercuts after grinding and (ii) to anneal the cap pass. The appearance of the groove after repair welding is shown in figure 6.

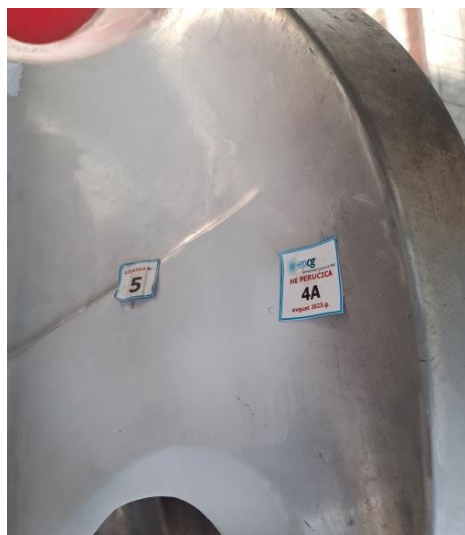
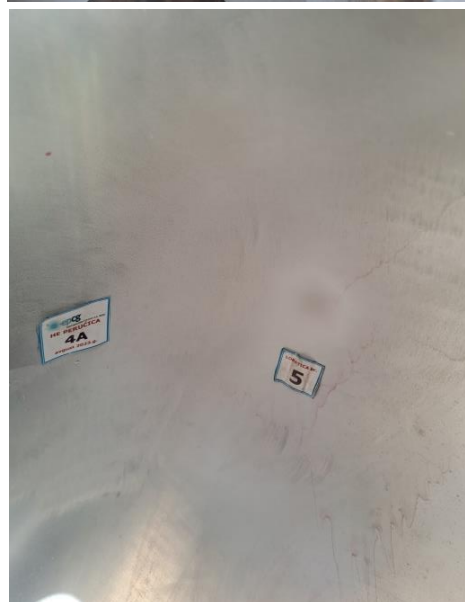
Figure 7. Repaired section of blade no. 5 where the crack was located: top - back side, bottom - front side

This was followed by making a small U groove on the blade front side, while also monitoring the damage of the surface. Welding on the front side of blade no. 5 was performed in the same way as the back side. After cooling of the welded joint to ambient temperature level, the start plate was removed, and the blade was ground and polished to its design geometry, from both sides. Grinding was performed to minimum surface quality of  $R_a = 1.6 \mu\text{m}$ . The front and the back sides of repaired blade are shown in figure 7.

After grinding and machining of blade geometry to its predefined dimensions, NDT was performed using visual and penetrant methods, with a scope of 100%. These tests did not reveal crack-like defects, pores, undercuts nor any other indications, which confirmed that the Pelton turbine in question fulfils the requirements for further exploitation.
