## REPAIR AND STRUCTURAL INTEGRITY ASSESSMENT OF A LARGE SPHERICAL TANK POPRAVKA I PROCENA INTEGRITETA VELIKOG SFERNOG REZERVOARA

Tests aimed at assessing the integrity of a pressure vessel are performed on a spherical tank for liquid petroleum gas (LPG marked R-113), Fig. 1. The R-113 spherical tank has been in operation since 1974, which is a sufficient reason to carry out an integrity assessment, bearing in mind that the NDT tests performed during periodical inspection revealed crack-type flaws that were detected by magnetic particle testing and ultrasound. The crack front length ranged from 5 to 150 mm. Unacceptable flaws of the crack type need to be repaired at locations where crack type flaws are detected.

Technical data: volume 600 m<sup>3</sup>, LPG medium, working pressure 1.67 MPa, waterproof pressure 2.5 MPa, diameter 10.5 m, and thickness 26 mm.

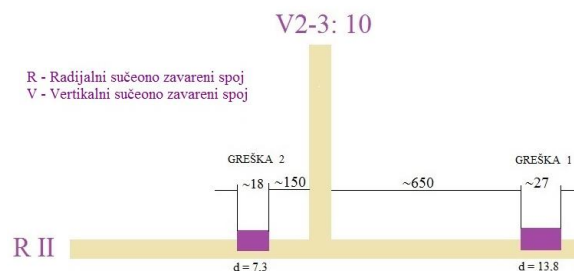
Figure 3. Disposition of DEFECTS 1 and 2

Repair of welded joints is defined according to the type and size of defects. Figure 3 shows the location and size of the crack-type defects located on the second (II) radial butt-welded joint, labelled "DEFECT 1" and "DEFECT 2". Both cracks-like defects and their geometry (length and depth) were detected by UT examination. The length of "DEFECT 1" was 28 mm and its depth 13.8 mm, whereas "DEFECT 2" was 18 mm long and 7.3 mm deep. In both cases, the measurement was made from the outside of the spherical tank.

Based on the defect types and depths, repair was carried out in 3 different ways:

If defect depth is less than 1.9 mm, it was removed by grinding, followed by VT and MT examination. In the case that the defect has not been removed completely, the repair was continued by grinding and carried out by welding only after complete removal of defect.

The same procedure was applied for defects up to  $\frac{1}{2}$  of wall thickness, except when they were not completely removed after grinding, when the third option was used.

Repair in the case of defects with depth more than  $\frac{1}{2}$  thickness (13 mm) was carried out in the following way: First, the defect was grooved up inside to  $\frac{2}{3}$  of the thickness and then the test was performed with liquid penetrants. This was followed by welding on the inside. With the completion of the welding work on the inside of the tank, "V" groove was made outside by grinding, assembling an asymmetric "X" joint.

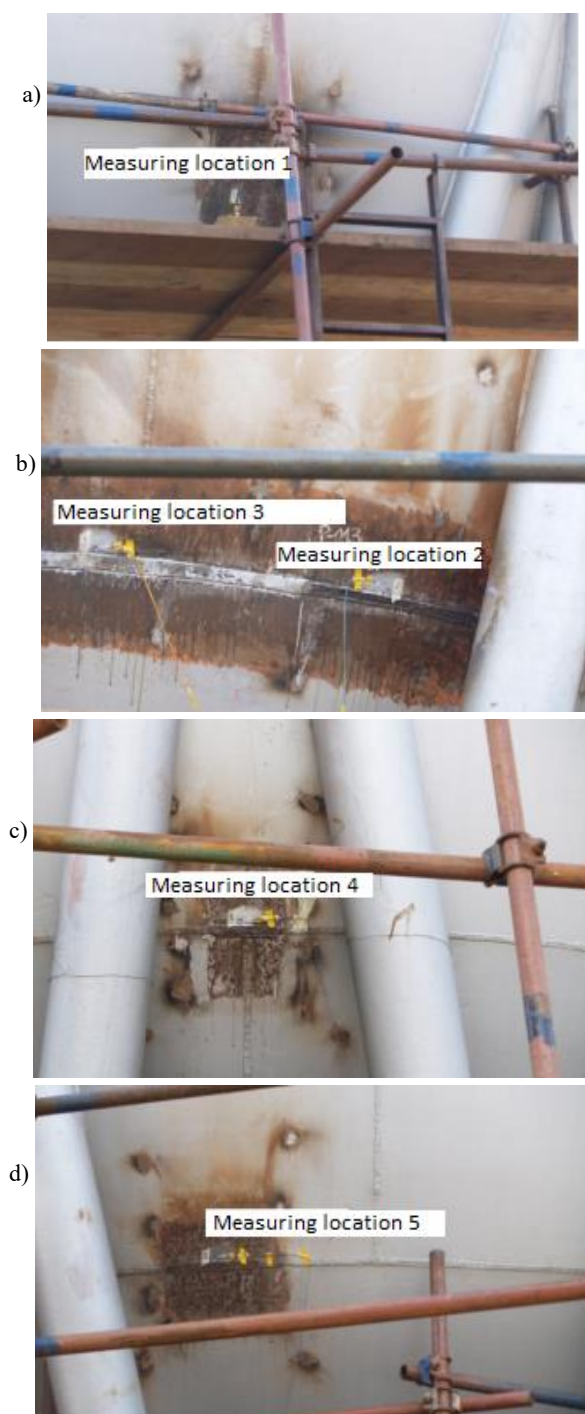
Figure 5. Measuring locations and strain gauges.

In order to determine the stress state in the zones where the repair was carried out (measuring points 2, 3 and 4), and

regions without defects (measuring points 1 and 5), strain gauges 10/120 LY 11 were used, as defined in tab. 3. The layout of the strain gauges is shown in Fig. 5. Diagrams pressure vs. strains are shown in Fig. 6.

| MP 1 | Defect free zone close to vertical welded joint V2-3: 5. |
| MP 2 | Repair zone – radial welded joint II - DEFECT 1. |
| MP 3 | Repair zone – radial welded joint II - DEFECT 2. |
| MP 4 | Repair zone – radial welded joint II - DEFECT 3, above vertical welded joint V2-3: 6 |
| MP 5 | Defect free zone close to radial welded joint II, 350 mm left from the vertical welded joints B2-3: 4 |

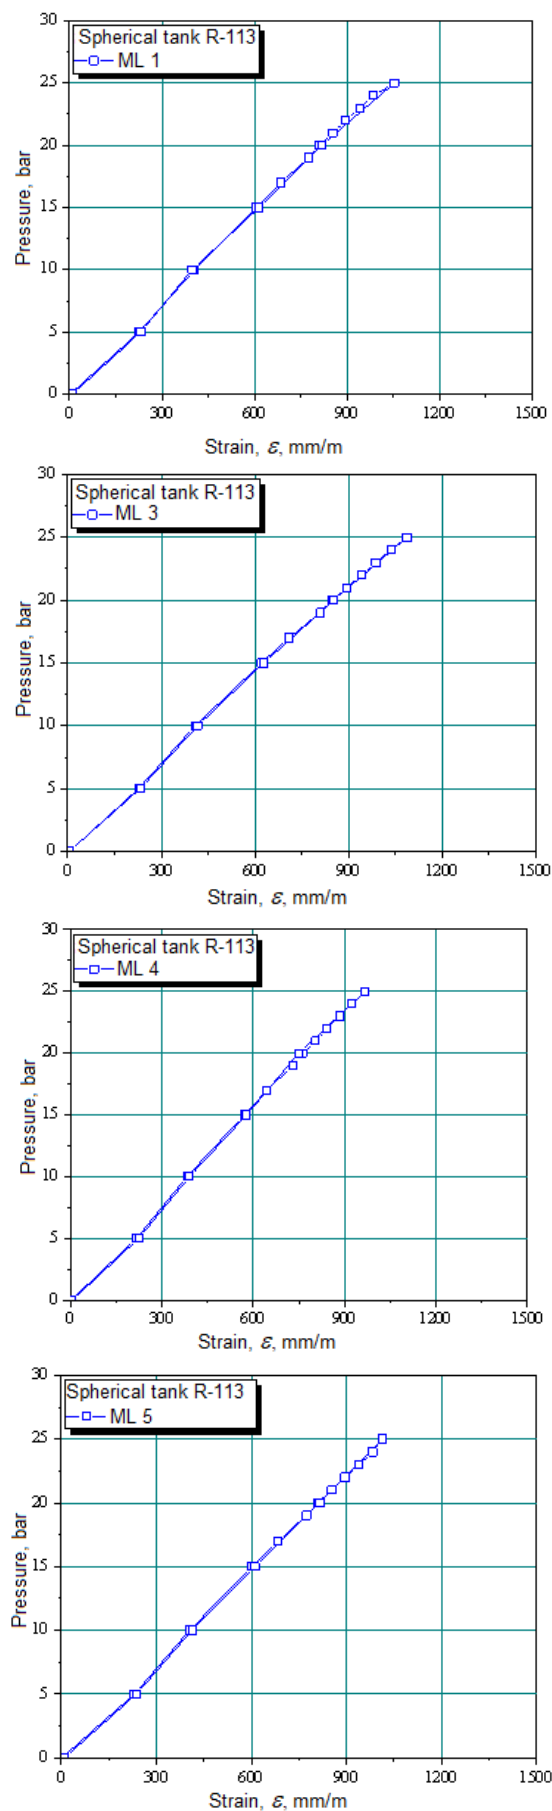
Figure 6. Pressure-strain diagrams for spherical tank R-113.

In addition to strain measurements that indicated elastic behaviour, acoustic emission is performed at the same time during waterproof testing, /7-9/. Processing acoustic emission signals is based on ring down counting. Scheme of this testing is shown in Fig. 7.

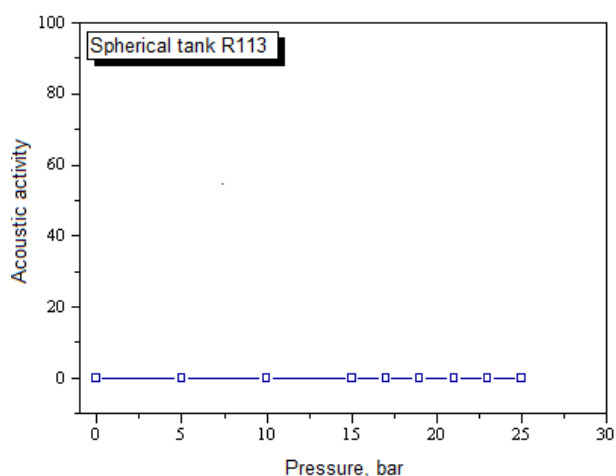
Figure 8. Acoustic activity for various pressure levels.

As one can see from Fig. 8, there is no signal in AE indicating that the repair is performed successfully and proving that the structural integrity of the tank is not compromised.
