## EVALUATION AND SEISMIC RISK OF CONFINED MASONRY BUILDINGS IN THE CITY OF ETEN - CHICLAYO - PERU, 2023

*The results of soil tests, visual inspections and mathematical models of 14 masonry houses belonging to a state programme called 'Techo Propio' (Own Roof), located in the city of Eten, Chiclayo province, Peru, are presented. In order to evaluate the damage to the houses, the probable causes of their predominant pathologies are determined.*

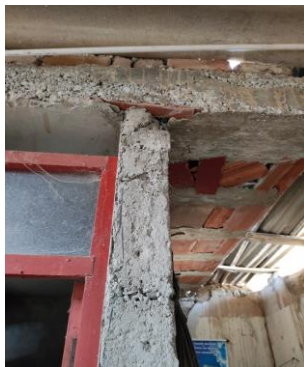
According to the American Concrete Institute (ACI), it defines a crawl space as an empty space that is present in the concrete, either due to the construction process, inadequate mix design or poor gradation of materials /2/ (Fig. 2).

Figure 2. Concrete spalling - house N°12.

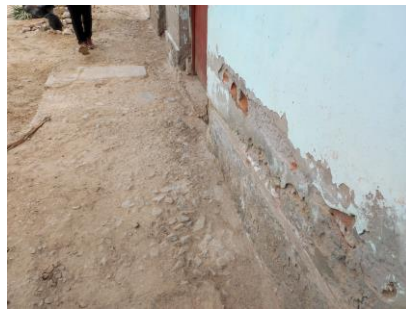
This pathology is one of most common in dwellings, due to the area where it is located, or the humidity concentrated within. The ACI explains it as an accumulation of whitish salts originating in the superficial part of the structural element (Fig. 3), either in walls or concrete structures, and precipitate by the action of evaporation, /2/.

Figure 3. Efflorescence in walls - house N° 06.

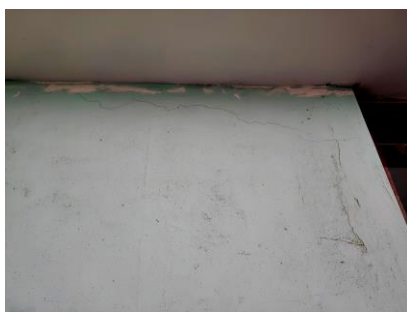
They are elongated openings, with a separation of up to 1 mm which only affect the superficial part of the structural element (Fig. 4). Their presence is caused by temperature changes, inefficient load distribution, soil movement and tension between its reinforcements, /3/.

Figure 4. Fissures in walls - house N°10.

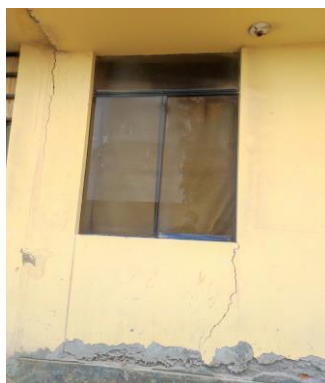
its entire width and can affect the seismic response capacity of any structural element, /3/.

These are openings with a separation greater than 1 mm (Fig. 5). Compared to the crack, this affects the structure in

Figure 5. Cracks in walls - house N° 06.
