RECONSTRUCTION OF A DAMAGED ROTOR SPOKE RIB - PART 1: STRESS ANALYSIS REKONSTRUKCIJA OŠTEĆENE NOSEĆE GREDE ROTORA - DEO 1: NAPONSKA ANALIZA

Originalni naučni rad / Original scientific paper

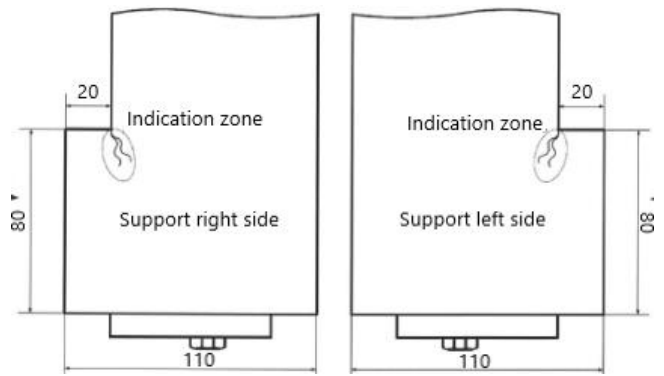
Figure 3. Schematic presentation of cracking.

Recently, during the rehabilitation of RHPP in 2025, cracks were discovered on rotor spoke ribs, as shown schematically in Fig. 3, and detected by penetrants, Fig. 4.

Through an analysis of the rotor spoke it was determined that cracking was caused by an unexpected overloading due to the weight of rotor rim and poles, i.e., its whole weight. It was also concluded cracks cannot be grooved and surface welded due to very limited space, even though the material is simple to handle - common carbon structural steel S275. Thus, a different approach had to be taken, leading to a reconstruction of the rotor spoke, as shown in this paper. To do so, the pre-condition was to stress release the rotor ribs and then strengthen them with new additional rib elements. This solution is based on a detailed stress analysis performed by finite element method (FEM) using software KOMIPS, /1/. Loading was taken as 10 % more than the total weight

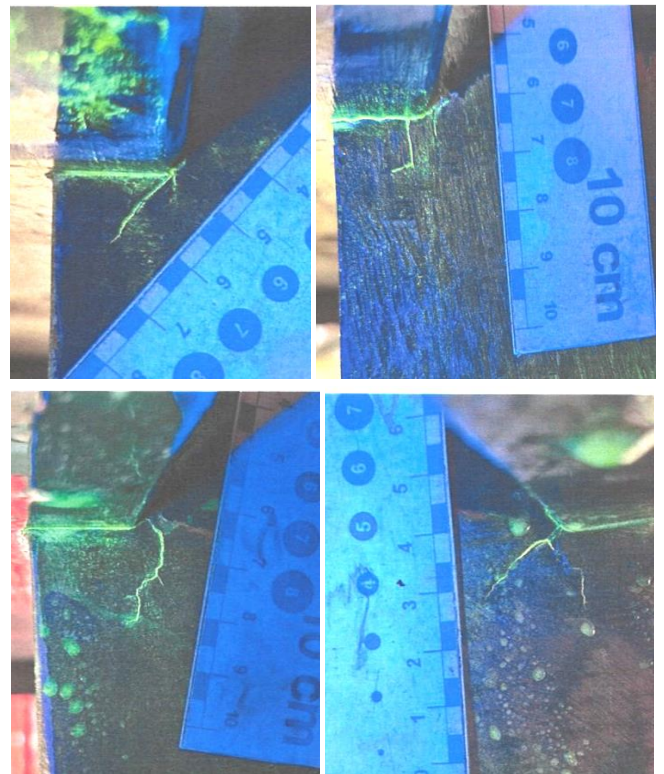
Figure 4. Cracks detected by penetrants.

The role of vibrations is yet to be investigated. A reasonable assumption is that vibrations unlock coupled wedges (at least to some extent) that otherwise support the loading due to weight. It is yet to be proved, but a current thought is that this phenomenon had caused the cracking in rotor ribs which was not uniform. Namely, only two rotor ribs cracked all over their circumference, while others cracked only up to a few millimetres, or not at all.

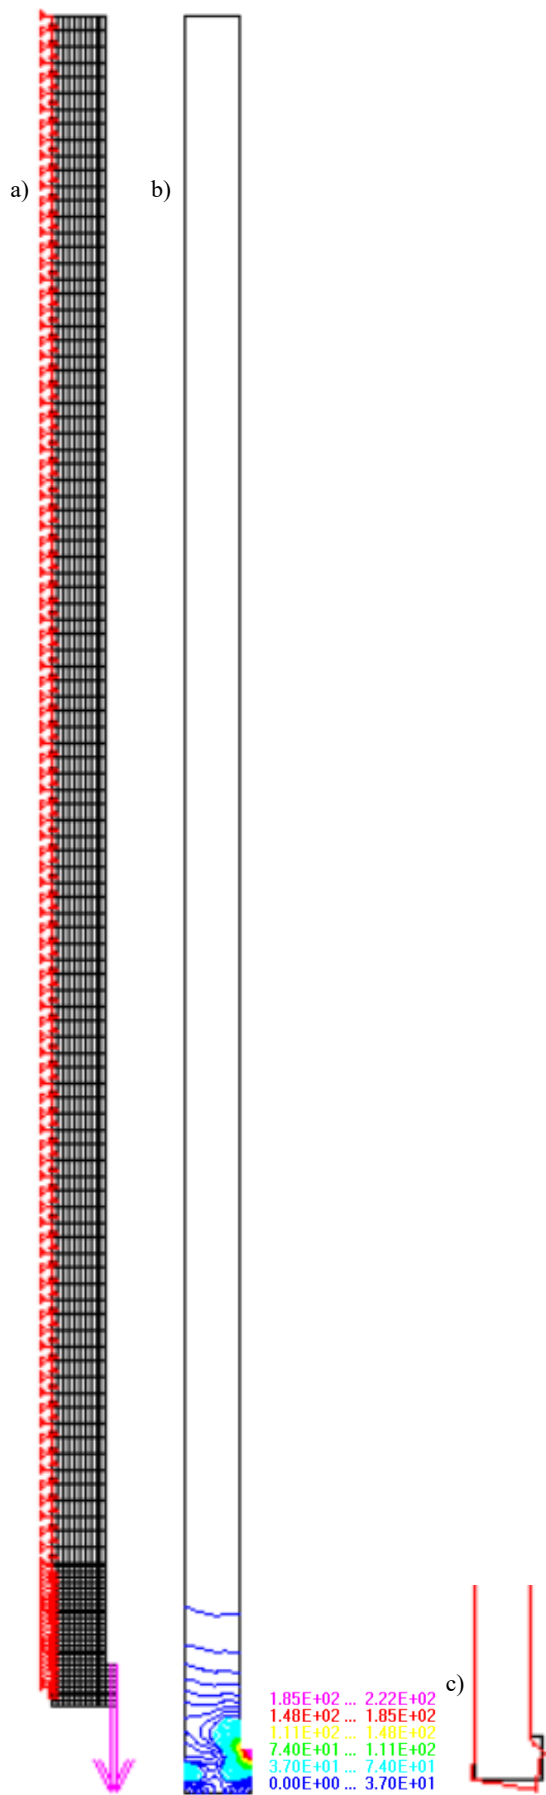
Figure 5. a) FE mesh; b) von Mises stress; c) deformation of a rib.

Stress analysis was performed first by 2D finite element (FE) model, Figs. 5-6, with different element sizes (10×10, 5×5 and 2.5×2.5 mm) to check the convergence, and then by 3D analysis to get a more precise stress distribution, as well as the deformation state. Results have indicated high maximum von Mises stress values (from 222 to 237 MPa, Figs. 5-6) and very small maximal displacements (less than 0.1 mm). Results also proved good convergence, and as the most important practical fact that stresses are significant only at the bottom 300 mm of the rotor rib, Fig. 5, leading to the conclusion that the new ribs can be as short.

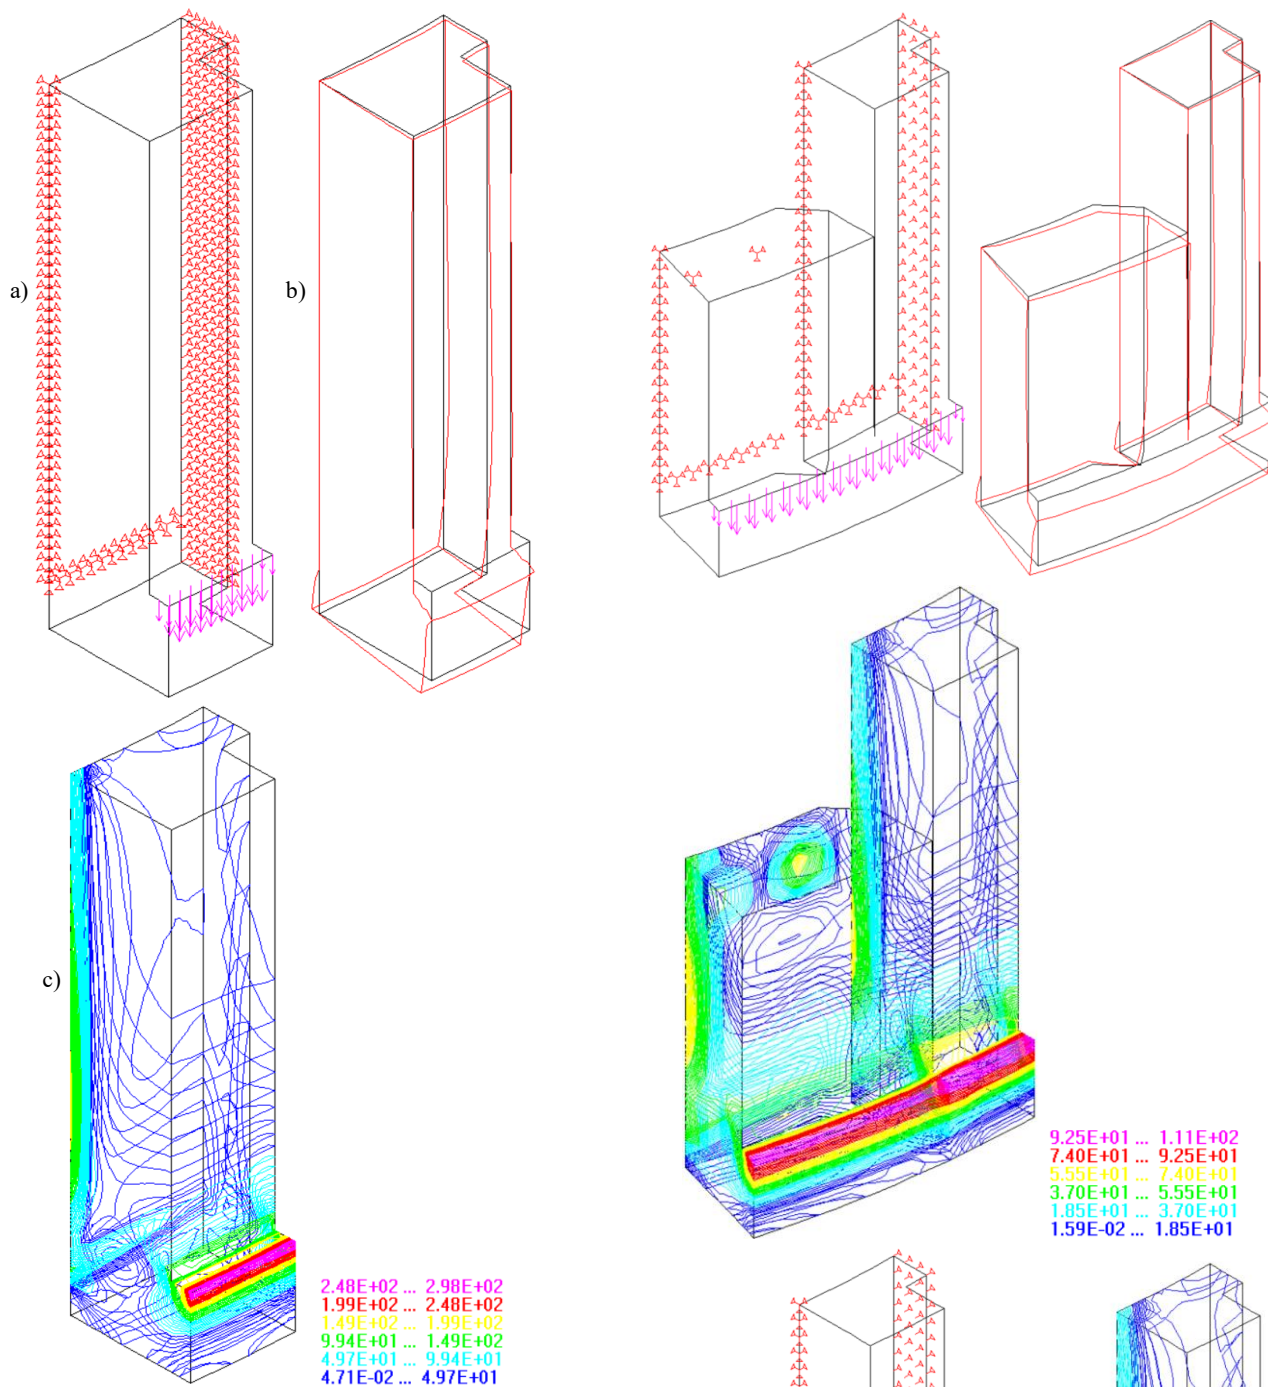
Figure 7. a) 3D mesh; b) deformation; c) von Mises stresses.

The 3D FE model with 9176 points indicated maximal displacement $f_{max} = 0.138$ mm and maximum von Mises stress 298 MPa, Fig. 7. This clearly points out the fact that the existing rotor rib cannot sustain the overload caused by total weight.

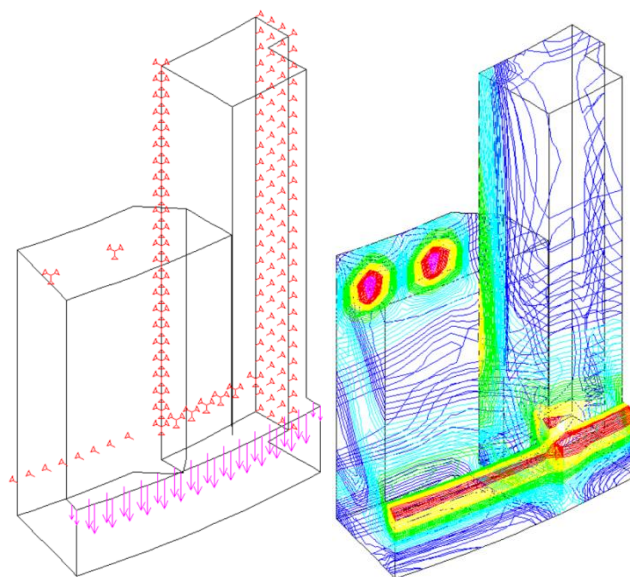
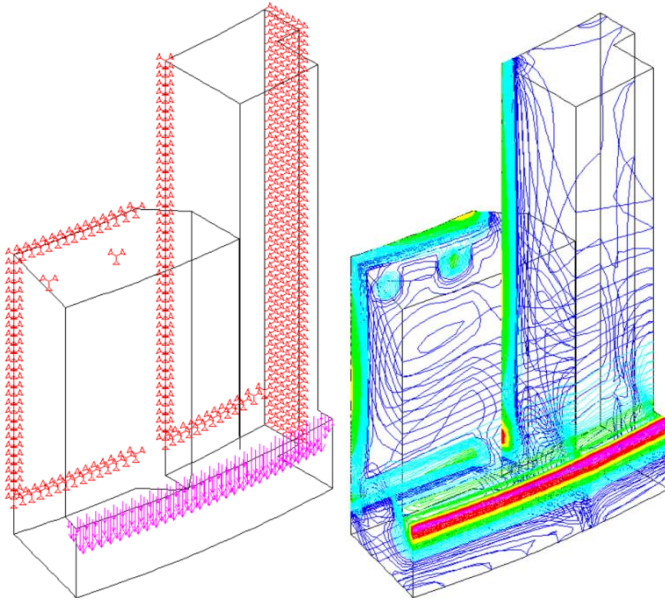
Figure 8. The FEM 3D stresses.

Figure 8 shows 3 different stress distributions according to 3 different boundary conditions. The maximal stress is 111 MPa, almost 3 times less than the existing, making this new geometry significantly more resistant to loading.

Further stress analysis is performed using 3D FE models created for the redefined rotor rib geometry, i.e., for the strengthened rotor rib made with two additional short ribs welded from both sides onto the existing rib. In addition these 2x8 ribs (315 mm length) are fastened to the rotor spoke by 2 large screws M33, close to their top surface and welded vertically to the rotor spoke. In this way the existing and new ribs became an integral supporting element with approximately 3 times the capacity of the existing one.

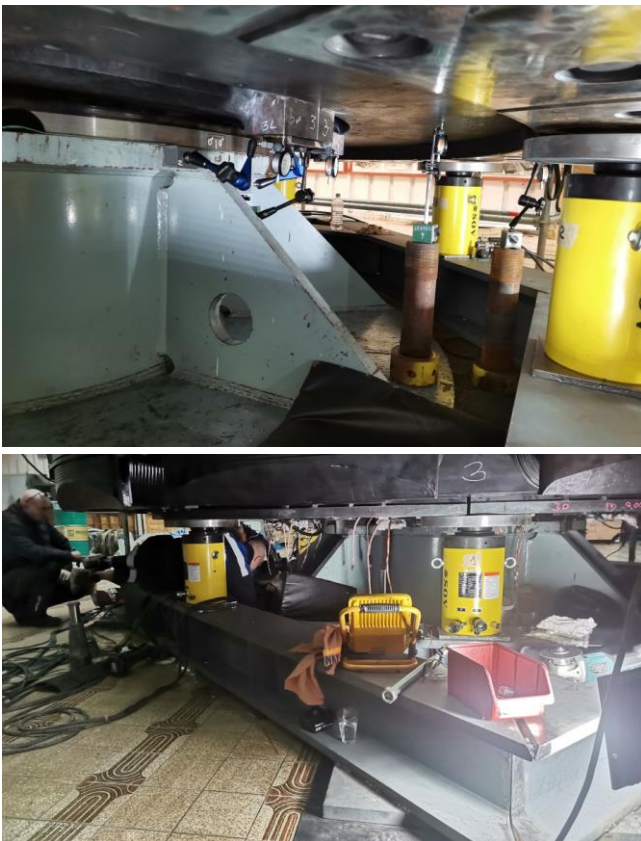
Figure 9. Hydraulic lifting and testing.

After the welding, machining and mounting of the rotor spoke, it was necessary to test the stress state to verify both the FEM results and rotor spoke behaviour. This was done by careful lifting and lowering using hydraulic jacks, Figs. 9 and 10. Displacements are recorded while moving the rotor up and down, indicating uneven position of rotor spoke lower platform, not related to the reconstruction, as well as the reasonable agreement with the numerical stress analysis.
