## REPAIR PROCEDURE OF BOILER FLUE PIPES PROCEDURA SANACIJE DIMNIH CEVI KOTLA

This specific case involves the replacement of flue pipes for the second and third draft (a total of 8 pipes, one for each draft group) on a block steam boiler. Damage is caused by combustion product depositing and results in leakage during a cold water pressure test. Figure 1 shows the position of flue pipes that are replaced.

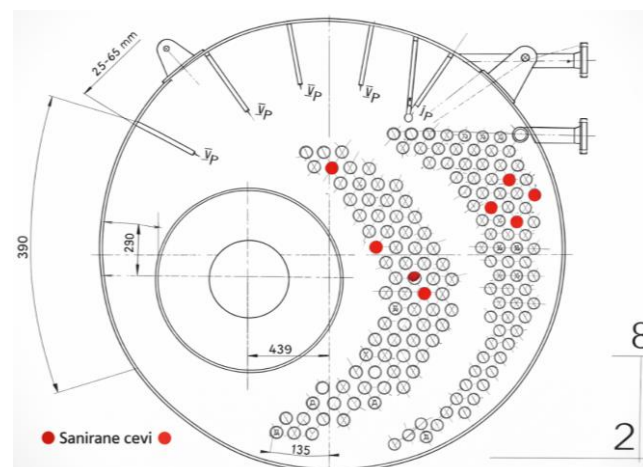
Figure 1. Position of repaired pipes of the second and third draft of a steam boiler.

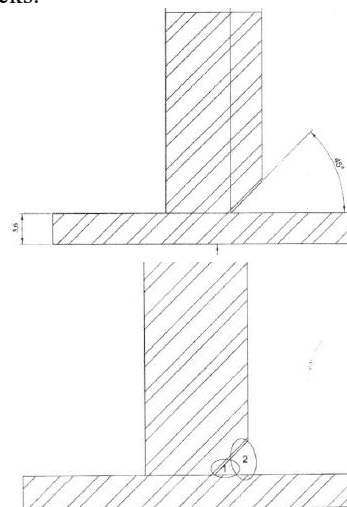
Figure 2. Weld groove geometry and welding sequence.

Manual arc welding with coated electrode is used. The geometry and dimensions of the weld groove are shown in Fig. 2. Grooves are made in accordance with relevant standards, while ensuring that they are clean and that no defects are present and that welding is performed by certified welders (according to standard EN 9606-1).

Welding is performed in two passes, Fig. 2. Weld root is performed in the way that fulfils all acceptance criteria according to standard SRPS 12953, including the use of adequate NDT methods, e.g., penetrant testing in the case

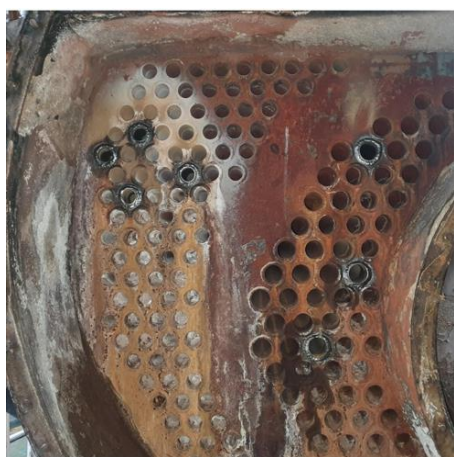
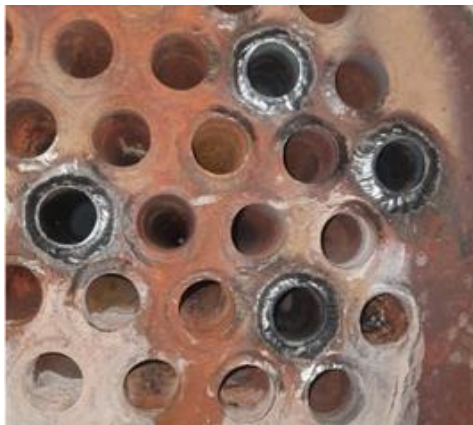
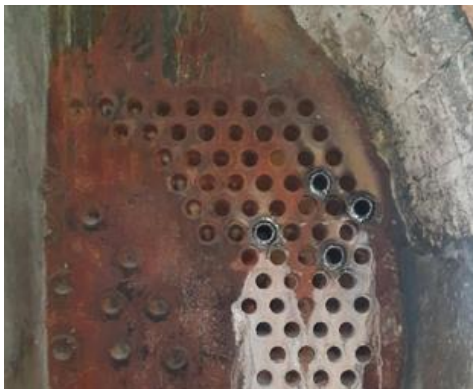
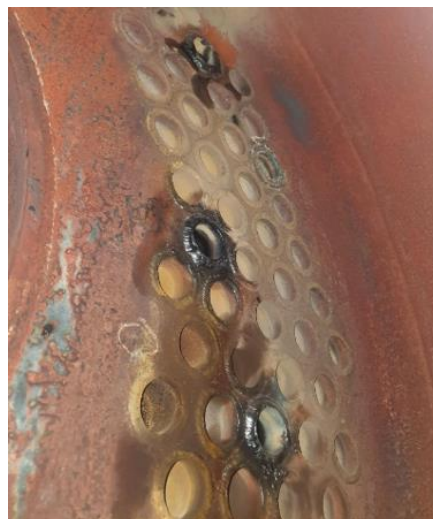
Figure 3 shows the welded joints after successful repair welding, and Fig. 4 shows the same after penetrant testing is performed, indicating no defects in the welded joints.

Figure 3. Front and back side of the boiler after repairs.

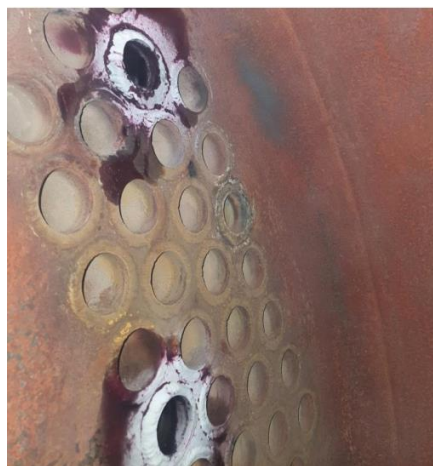
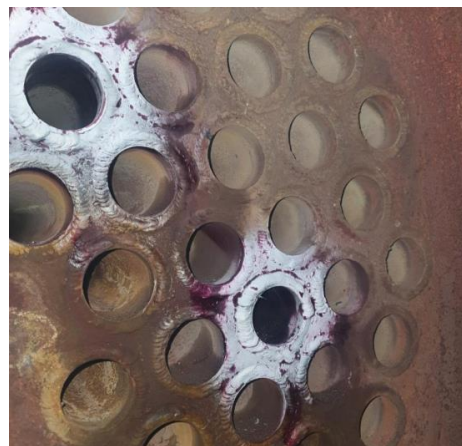
Figure 4. Welded joints of flue pipes after PT techno-economical analysis of repair of flue pipes in steam boiler Oro 65.
