# REMAINING LIFE ASSESSMENT OF LONG-TERM EXPLOITED St.35.8/II BOILER SCREEN TUBES VIA AN INTEGRATED MICROSTRUCTURAL DEGRADATION AND CREEP MODEL

Originalni naučni rad / Original scientific paper

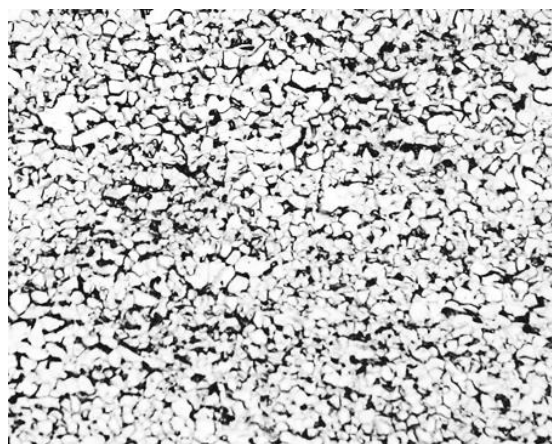
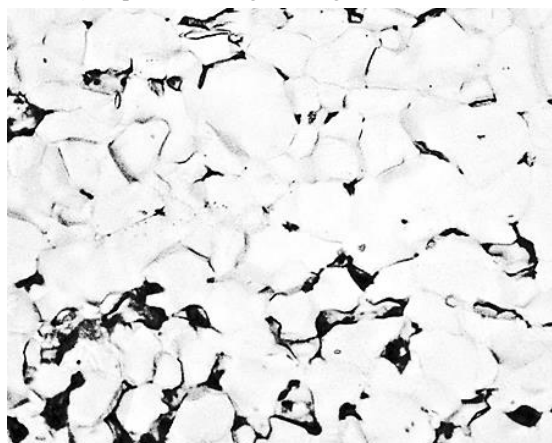
a) Replica R1. Original magnification 100×

| Replica ID | Location/elevation | In-situ hardness (HB) | Wedel-Neubauer creep class | Proposed structural assessment & actions |
|---|---|---|---|---|
| R1 | Tube 1 / 7 m (furnace side) | 159 | Class 0 (Undamaged) | Stable matrix, initial pearlite spheroidisation. No immediate action required. |

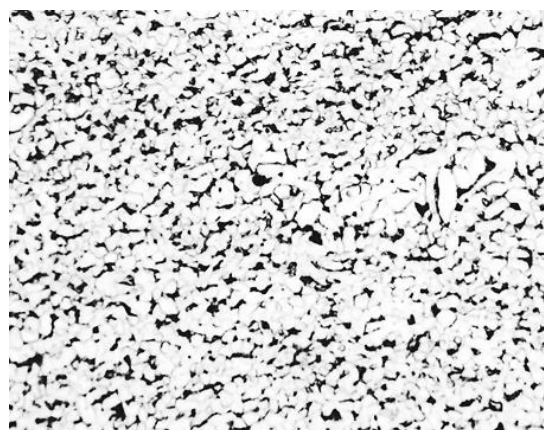
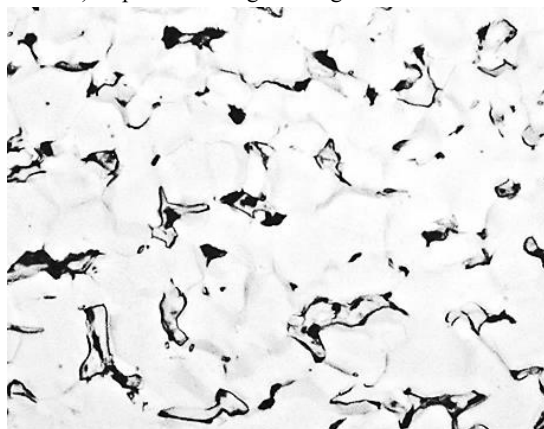
c) Replica R2. Original magnification 100×

| Replica ID | Location/elevation | In-situ hardness (HB) | Wedel-Neubauer creep class | Proposed structural assessment & actions |
|---|---|---|---|---|
| R2 | Tube 1 / 7 m (support side) | 161 | Class 0 (Undamaged) | Heat-affected zone (HAZ) exposure. Structure structurally acceptable. |

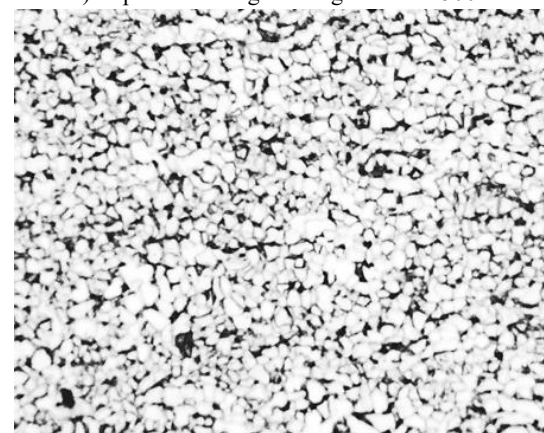
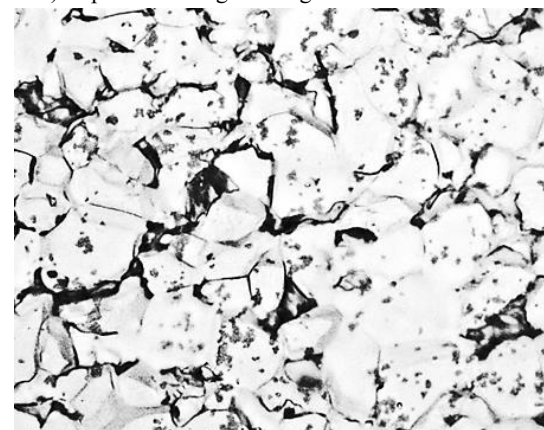
e) Replica R3. Original magnification 100×

| Replica ID | Location/elevation | In-situ hardness (HB) | Wedel-Neubauer creep class | Proposed structural assessment & actions |
|---|---|---|---|---|
| R3 | Tube 2 / 10 m (support side) | 166 | Class 0 (Undamaged) | Advanced spheroidisation. Monitor during scheduled overhaul. |

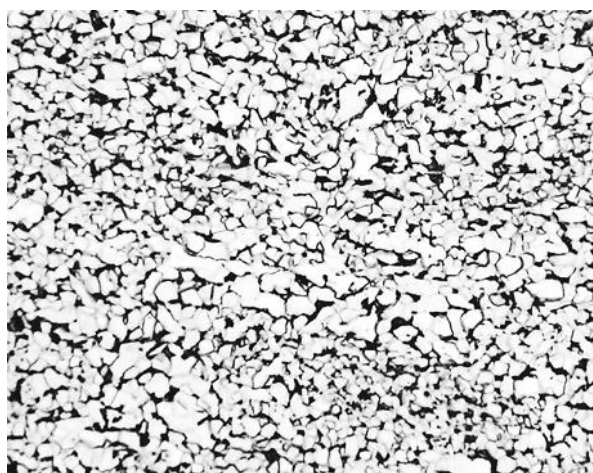
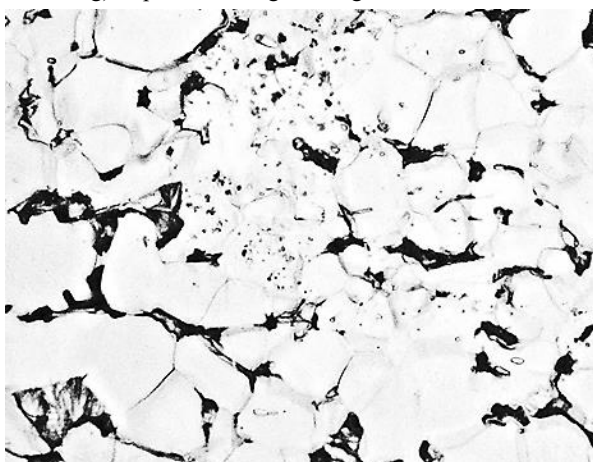
g) Replica R4. Original magnification 100×

| Replica ID | Location/elevation | In-situ hardness (HB) | Wedel-Neubauer creep class | Proposed structural assessment & actions |
|---|---|---|---|---|
| R4 | Tube 2 / 10 m (furnace side) | 174 | Class 0 (Undamaged) | CRITICAL! Continuous intergranular carbide network. Immediate tube replacement required. |

In the metallurgy of boiler steels, the localised hardness peak of 174 HB at location R4 represents a structural response linked to advanced phase degradation and severe secondary carbide distribution along the grain boundaries which directly alters the local indentation resistance. Furthermore, such elevated *in-situ* hardness numbers in heavily aged low-carbon steels can be influenced by the shallow surface work-hardening layer introduced during portable mechanical grinding preparation. Consequently, these elevated hardness measurements must not be misinterpreted as a macroscopic strengthening of the component, as the grain matrix interior itself has become depleted of carbon and significantly softened.

The actual degradation mechanism is characterised by pearlite spheroidisation and the continuous precipitation of a brittle intergranular carbide network at the 10 m elevation furnace zone (R4), which severely embrittles the structure.

Immediate replacement of the tube sections corresponding to location R4 is strongly recommended, and a modified metallurgical assessment framework incorporating carbide network continuity must be implemented to ensure structural integrity.

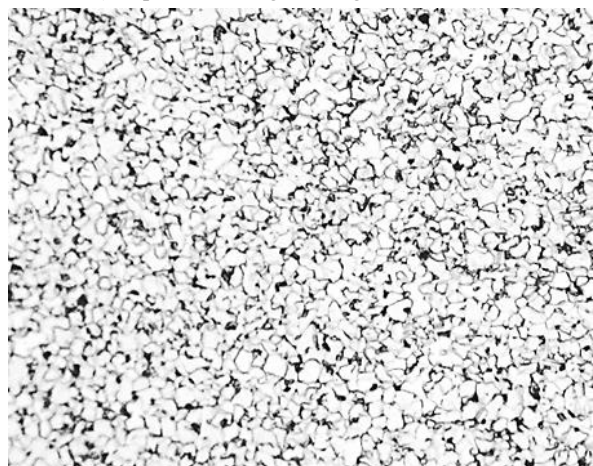
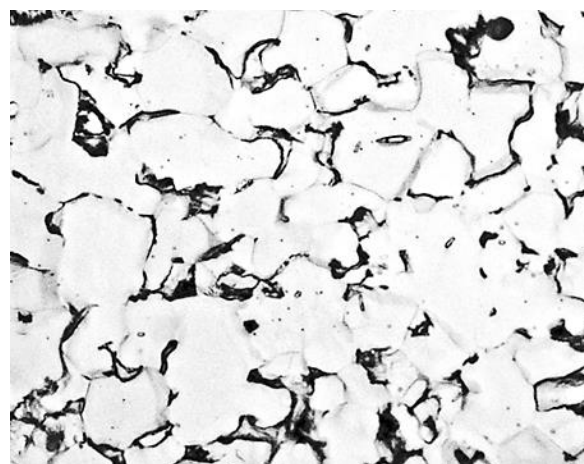
j) Replica R5. Original magnification 100×

| Replica ID | Location/elevation | In-situ hardness (HB) | Wedel-Neubauer creep class | Proposed structural assessment & actions |
|---|---|---|---|---|
| R5 | Tube 3 / 10 m (furnace side) | 164 | Class 0 (Undamaged) | High risk; semi-continuous carbide boundary decoration. Enhanced inspection interval. |
