## STRUCTURAL INTEGRITY ASSESSMENT OF A STEAM SUPERHEATER OUTLET HEADER PROCENA INTEGRITETA IZLAZNOG KOLEKTORA KONVEKTIVNOG PREGREJAČA PARE

*In this paper, the structural integrity assessment of the exit convective superheater steam collector at Unit 1 of the 'REK Bitola' thermal power plant is presented. The collector is newly fabricated as part of a reconstruction project intended to replace equipment that had exceeded forty years of service. Material verification is performed through mechanical, microstructural, destructive and non-destructive testing, while hydrostatic testing confirmed the pressure-tightness of the fabricated component. Integrity assessment is subsequently carried out using the Fracture Assessment Diagram (FAD) methodology in accordance with BS 7910 procedures. Influence of fully circumferential internal flaws and weld misalignment on structural integrity is analysed under operating loading conditions. Results demonstrate that the investigated collector possesses sufficient resistance to both fracture and plastic collapse, with acceptable flaw tolerance margins for the considered defect sizes. The study confirms that the fabricated collector satisfies the str

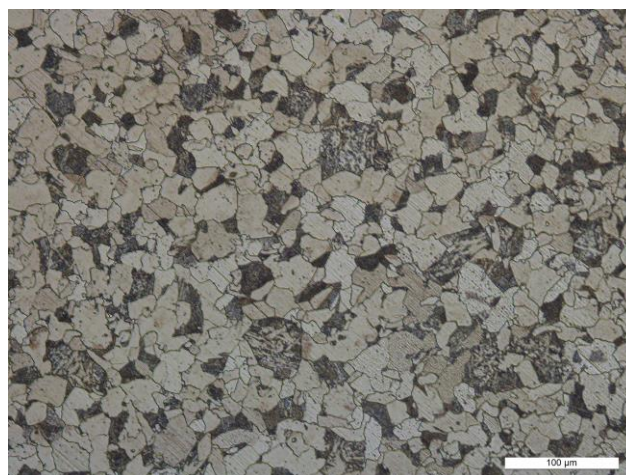
Figure 1 presents the microstructure of a Ø32×6 mm 12H1MF steel tube at a magnification of ×200, with a

measured bainite content of 26.5 % (Grade 2). These tubes are used for the fabrication of pipe bends and branch connections attached to the header body. Figure 2 shows the microstructure of a Ø133×25 mm 12H1MF steel tube at a magnification of ×200, with a bainite content of 20.3 % (Grade 3). This semi-finished product is utilised for the fabrication of the drain connection located between the two

Figure 1. Microstructure of pipes Ø32x6 mm 12H1MF magnification 200x, proportion of bainite 26.5%.

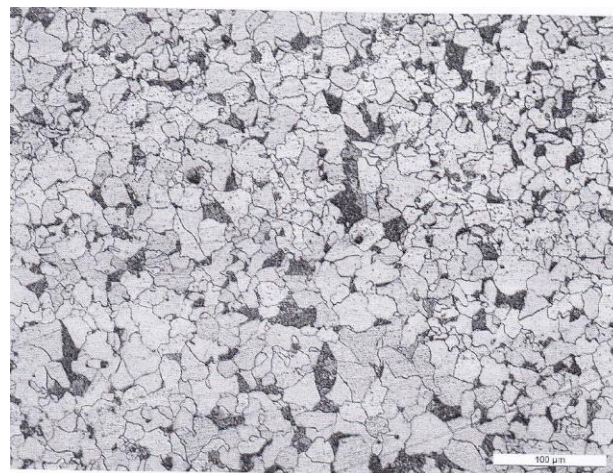
Figure 2. Microstructure of pipes Ø133x25 mm 12H1MF magnification 200x, proportion of bainite 20.3%.

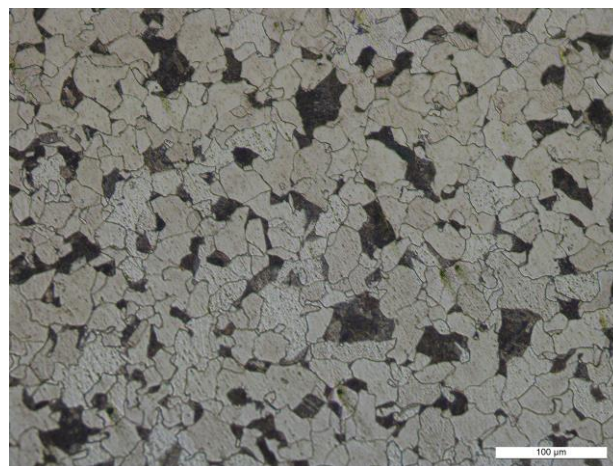
Figure 3. Microstructure of pipes Ø273x40 mm 12X1MF magnification 200x, proportion of bainite 17.4%.

end caps of the header. Figure 3 illustrates the microstructure of a  $\varnothing 273 \times 40$  mm 12H1MF steel tube at magnification of  $\times 200$ , with a bainite content of 17.6 % (Grade 4). This pipe section is employed for the fabrication of the main header body containing all branch and piping connections.

The obtained results confirm that the bainite content of all semi-finished products investigated satisfies requirements prescribed by the applicable specification, thereby verifying the suitability of the selected material for long-term operation under elevated pressure and temperature conditions.

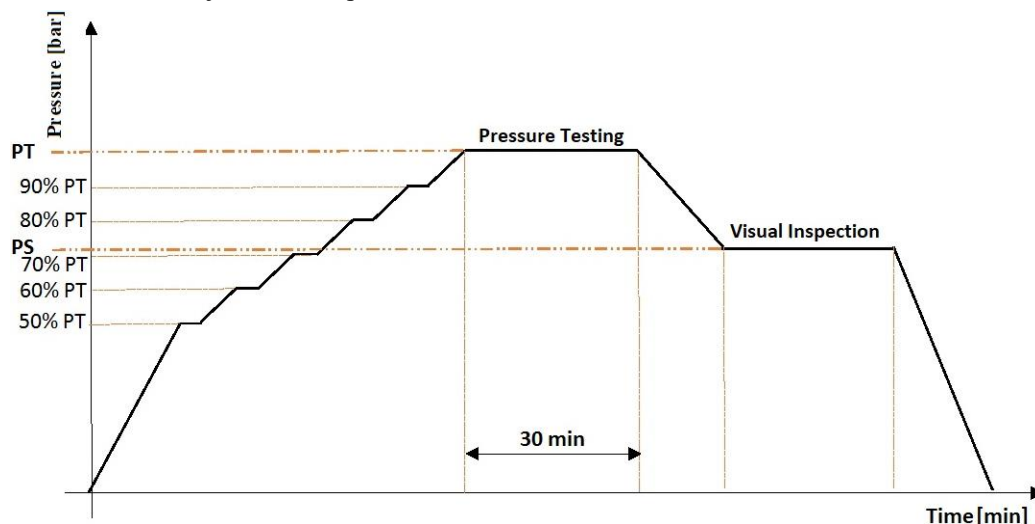
Figure 6. Pressure-Time Diagram of the Cold Hydrostatic Pressure Test.

Following the completion of the tests on the first-stage convective steam superheater, no signs of failure are observed during examination. No permanent deformation, leakage, local constriction, sweating, or other indications of loss of pressure boundary integrity are detected in either welded joints or base metal. Furthermore, no pressure drop is recorded on the calibrated pressure gauge during the test period.

Based on the obtained results, the reconstructed component successfully satisfied the acceptance criteria for the hydrostatic pressure test, confirming its pressure tightness and structural integrity under prescribed testing conditions.

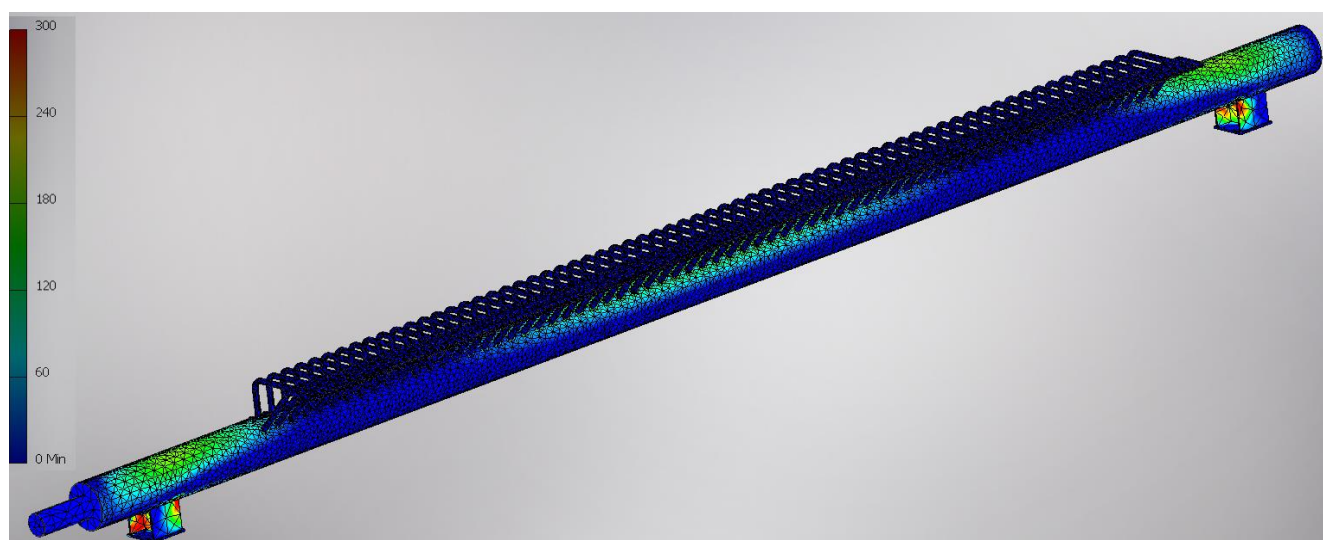
Figure 7. Finite element model (FEM): stress distribution in the superheater.

Following the numerical stress analysis, no regions with unacceptable stress levels are identified within either the welded joints or the base material. Furthermore, no indication of plastic deformation, associated with exceeding the material yield strength, are observed. The maximal equivalent stress, evaluated according to the von Mises criterion, is approximately 180 MPa. This value remains below the yield strength of 12H1MF steel at operating temperature, indicating that the component operates within the elastic range under prescribed loading conditions. The obtained stress distribution reveals no critical stress concentrations that could adversely affect the structural integrity of the outlet header. Therefore, the numerical simulation confirms the adequacy of the adopted design and provides additional verification of the safe operation of the reconstructed convective steam superheater header under service conditions, /7/.

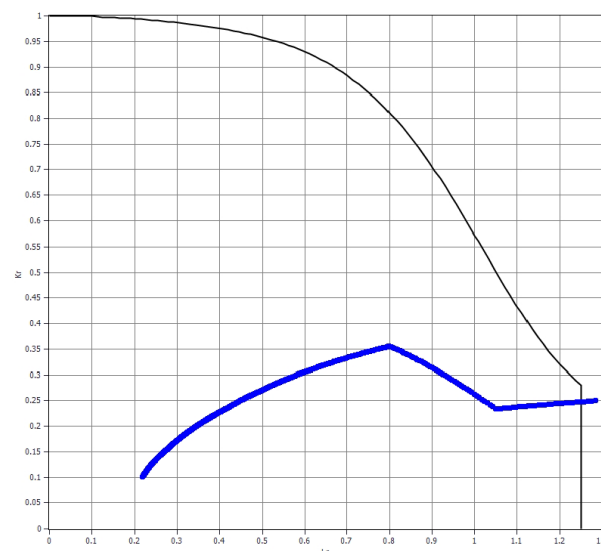
Two axial weld root misalignments, namely 1.5 mm and 2.0 mm, are investigated to evaluate their effect on flaw tolerance and structural integrity margins. Selected values are used to represent realistic fabrication deviations that may occur during manufacture and assembly of steam piping systems. Relevant material properties at working temperature are: yield stress 225 MPa; tensile strength 450 MPa, Young modulus  $E = 183$  GPa, fracture toughness  $K_{Ic} = 124$  MPa $\sqrt{m}$ . Loading is set as membrane stress 27.1 MPa. Results obtained by using Crackwise 5.0 [15], are presented in Figs. 9 and 10 for weld root misalignment of 1.5 mm and 2 mm, indicating critical defect sizes 3.48 and 3.74 mm, in respect.

Figure 9. FAD for a weld root misalignment of 1.5 mm.

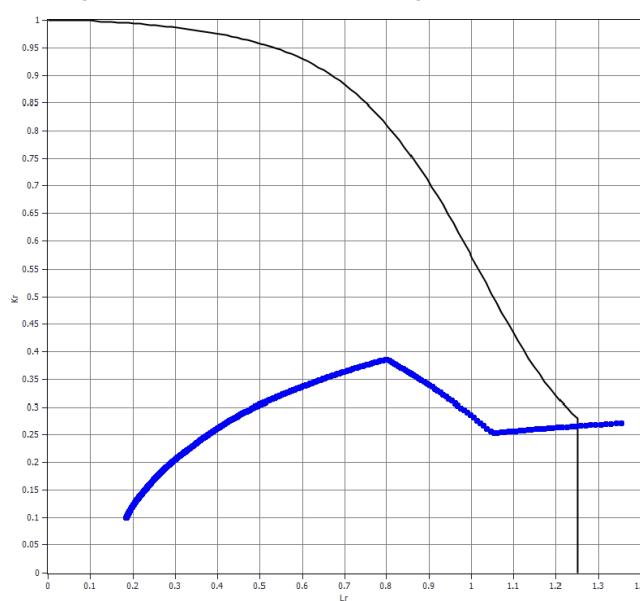
Figure 10. FAD for a weld root misalignment of 2.0 mm.
