POČETNO STANJE NAPONA CEVI KOTLA ZA OCENU INTEGRITETA KONSTRUKCIJE INITIAL STRESS STATE OF BOILER TUBES FOR STRUCTURAL INTEGRITY ASSESSMENT

Stručni članak / Professional paper
UDK /UDC: 620.179: 621.18
Rad primljen / Paper received: 27.11.2006.

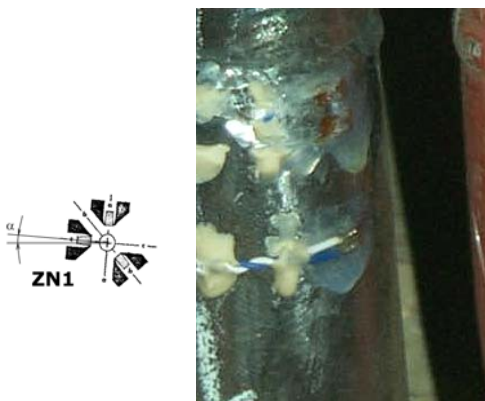
Slika 1. Merno mesto 1 (pri montaži plastično deformisana cev 52)
Figure 1. Measuring location 1 (plastically deformed tube 52 during assembly).

The measured residual stress is at 44% yield strength level on tube 52. The measured residual stress was 39% of yield strength in welded joint HAZ and BM of tube 13. Due to residual stress relaxation by plastic deformation in the stress concentration region, the residual stress has reduced to 32% of yield strength, after the proof pressure test.

and $\sigma_2 = 135$ MPa) at measuring location 1 (tube 52, Table 2), indicating that tube plastic deformation affects residual stress level. Calculated residual stresses in tube 13 (measuring locations 1 and 2, i.e. 3 and 4, Table 3), are relatively high, but they are quite close. It is interesting that after the pressure proof test, residual stresses were reduced, thus confirming that the applied pressure had caused the redistribution of residual stresses.

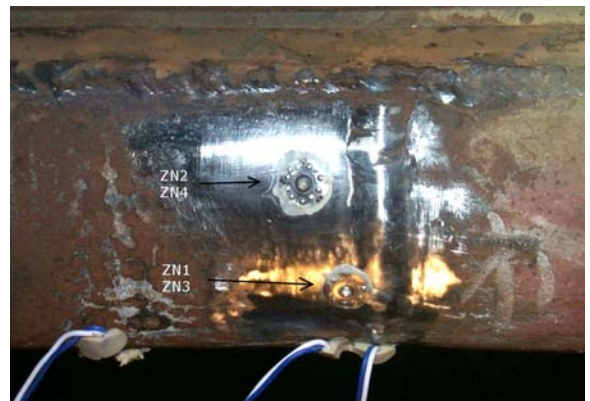
Slika 2. Merno mesto 2 (cev 13 kod koje je pri zavarivanju u procesu montaže došlo do greške nesaosnosti)
Figure 2. Measuring location 2 (tube 13, misalignment defect involved during welding in the assembly process).

Tube 13 is dispositioned during welding, since it was not properly centred in the assembly. The boiler owner agreed to measure residual stresses in the region of welded joint before and after pressure proof test, in order to check the assumption that in this case residual stress redistribution had taken place in the tested volume of material due from short length of tube 13.

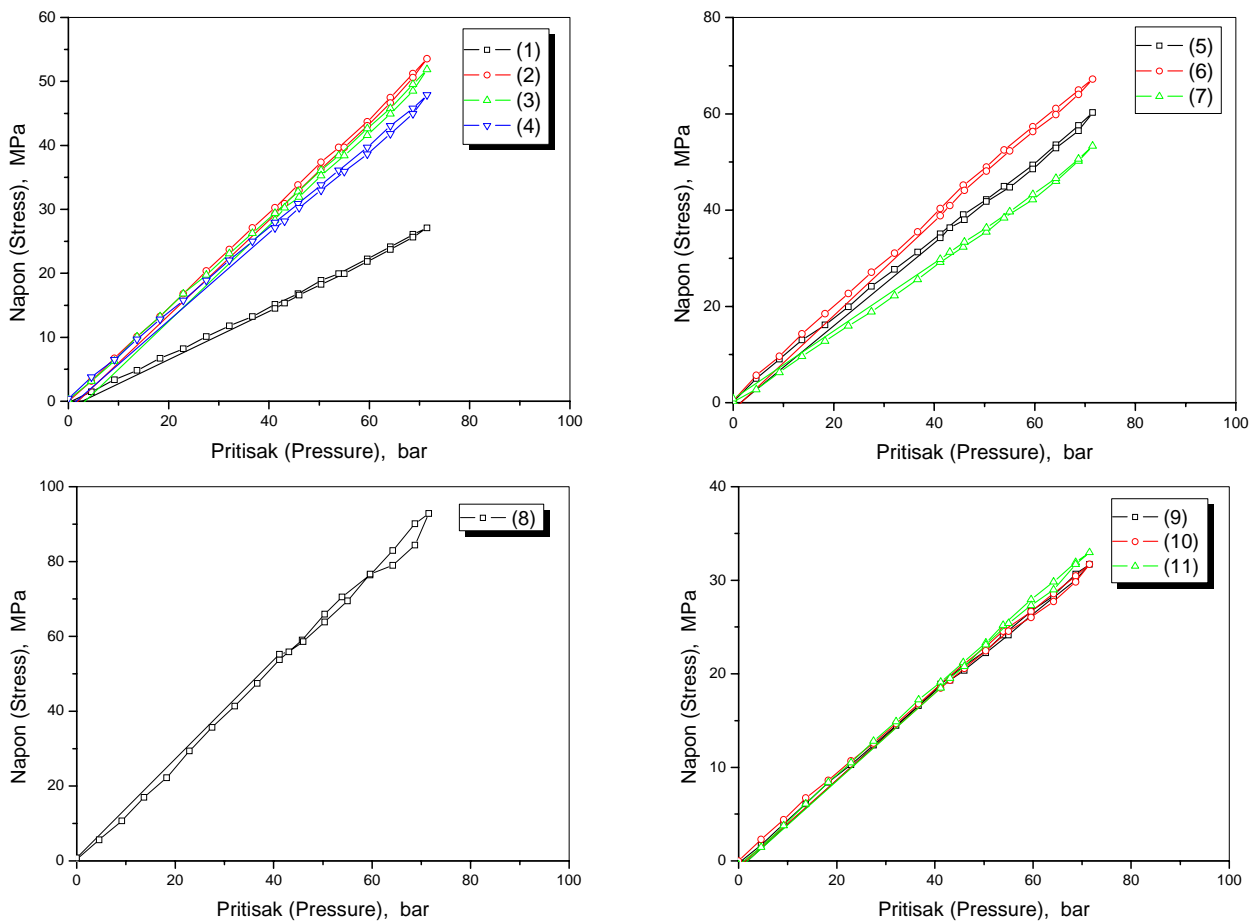
Slika 5. Zavisnost napon–pritisak
Figure 5. Dependence stress–pressure.

Stress calculations from microstrains measured by strain gauges during the pressure proof test showed elastic behaviour of material (Fig. 5) in all zones of tubes and boiler drum, with maximal value of 99.3 MPa in boiler drum and 66 MPa in tube 52.

Strains measured by strain gauges during pressure proof testing and the calculated principal stresses show that in none of the measuring locations has the yield strength been exceeded, meaning that material behaviour is linear elastic up to the maximal test pressure of 71.5 bar. Principal stresses are low in all zones and ranged from 26 MPa at measuring location 1 (tube 13) to about 53 MPa at measuring location 3 in zone I, Fig. 5a, from 52 MPa in measuring location 7 to 66 MPa in measuring location 6 in zone II (tube 12), Fig. 5b. Higher stresses in undamaged tube 12 compared to stresses on tube 13 shown that the induced defect of the misaligned tube 13 did not affect structural integrity, so it can be disregarded at boiler acceptance. In zone IV, the principal stresses are very low and uniform as a result of plastic deformation in tube 52, Fig. 5d. The maximal principal stress is found at measuring location 8, zone III, Fig. 5c, as expected, since the strain gauge is placed in the hoop direction of maximal strains on the boiler base metal. Principal stress values in regions of detected defects in the assembly, as well as in regions with no defect are within the limits of relative measurement error, and are lower than the minimal yield strength of the built-in material.

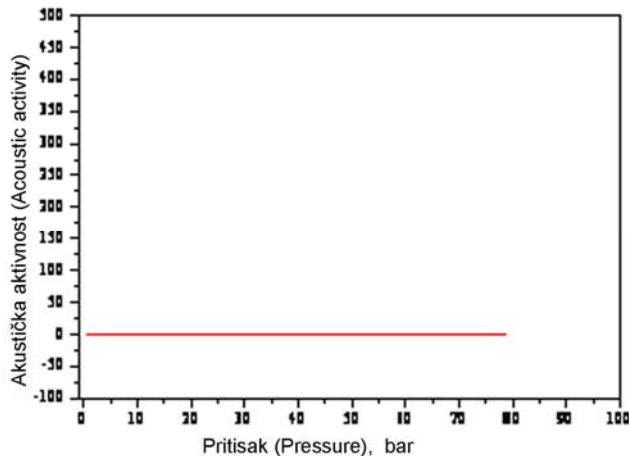
Slika 7. Zavisnost akustična aktivnost–pritisak
Figure 7. Dependence acoustic activity–pressure.

As seen from Fig. 7, acoustic activity during pressure proof test was not recorded, meaning that plastic deformation did not occur and crack initiation or propagation did not take place.

Based on performed tests and analyses it is recommended to accept the boiler as “fit for purpose.”
