KLASIFIKACIJA EKSPLOATACIJSKIH OŠTEĆENJA ČELIČNIH UŽADI CLASSIFICATION OF IN-SERVICE DAMAGES OF STEEL WIRE ROPES

Stručni članak / Professional paper
UDK /UDC: 620.169.1: [679.74: 669.14
Rad primljen / Paper received: 26.11.2007.

Adresa autora / Author's address:
Institut za ispitivanje materijala IMS, Bulevar vojvode Mišića 43, 11000 Beograd, dejan.momcilovic@institutims.co.yu

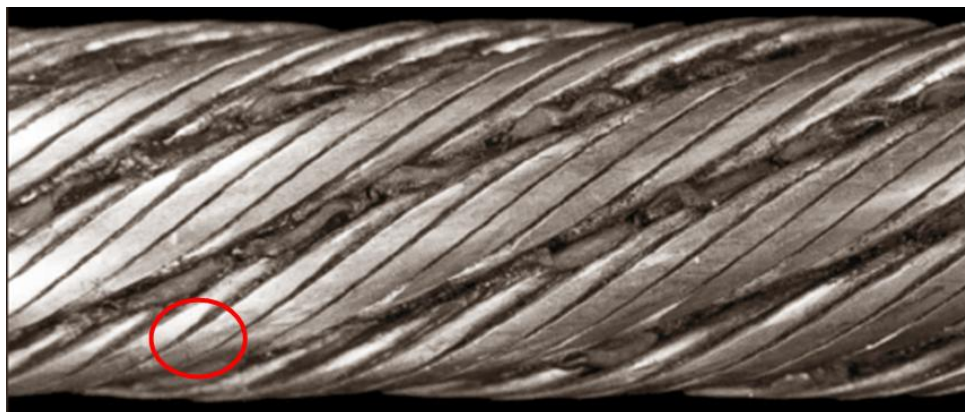
Sve dok je brzina smanjivanja početnog poprečnog preseka usled habanja veća od brzine rasta zamorne prsline, u žicama užeta neće doći do zamornog loma (sl. 2).

Slika 2. Ravnomerno jako mehaničko habanje spoljnjih strukova užeta bez pojave zamornih prsline na žicama
Figure 2. Uniform intensive mechanical wear of outer strands of steel rope without fatigue fracture of wire.

As long as the rate of initial cross section reduction due to wear is higher than the fatigue crack propagation rate, fatigue fracture of rope wires will not develop (Fig. 2).

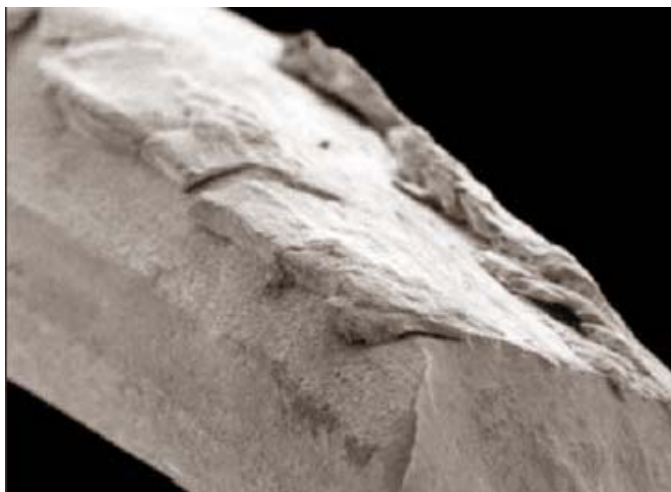
Mehaničko habanje ne treba mešati sa plastičnim habanjem. Plastično habanje je intenzivna površinska deformacija materijala, bez ili sa malo gubitka materijala. Slike 3 i 4 pokazuju primere plastičnog habanja.

Mechanical wear must not be confused with plastic wear. Plastic wear is the intensive plastic deformation of material, without or with only little material loss. Figures 3 and 4 present examples of plastic wear.

Slika 3. Plastično habanje na površini žica spoljnjih strukova
Figure 3. Plastic wear on the surface of an outer wire of a strand.

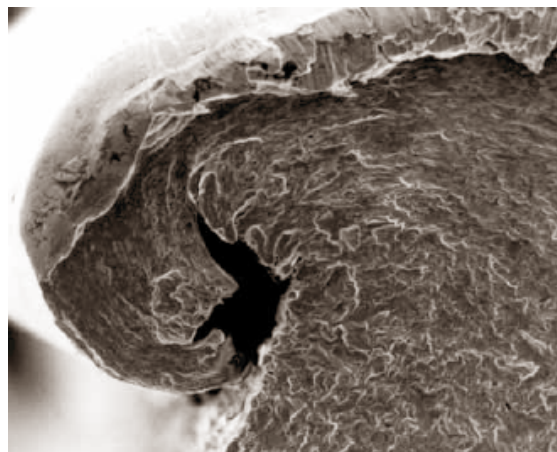
Slika 4. Smicanje materijala pri intenzivnom plastičnom habanju spoljnjih strukova
Figure 4. Material shearing at intensive plastic wear of outer strands

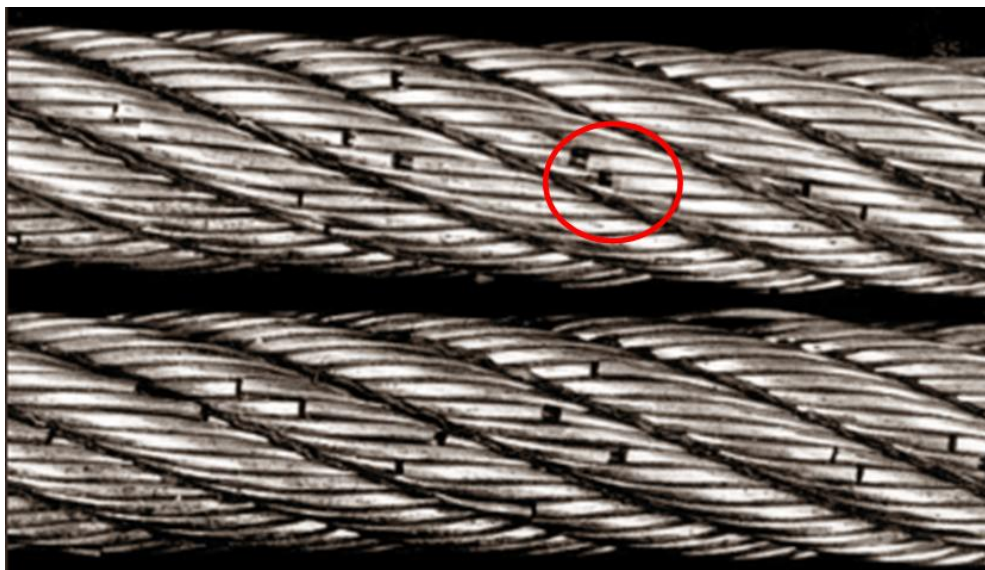
Zamorne prsline se javljaju zbog savijanja užeta oko vodećih točkova, na mestu kontakta spoljnjih strukova užeta i doboša, odnosno koturače, ili na mestu kontakta između žica unutar pojedinačnog struka. Zamorna prsline, koja je poprečna na uzdužnu osu žice, nastaje tokom rada zbog višestrukog savijanja (sl. 5 do 8).

Fatigue cracks are caused by rope flexion around guiding pulleys, in contact points between the outer rope strands and drum, or sheave in respect, or at contact points between wires inside an individual strand. A fatigue crack that is perpendicular to the wire longitudinal axis, initiates during operation with repeated flexion (Figs. 5 to 8).

Slika 5. Savojni zamorni lom užeta u spoljnjim strukovima. Raspodela prekinutih žica je slučajna
Figure 5. Flexion fatigue fracture of ropes in outer strands. The distribution of fractured wires is random.

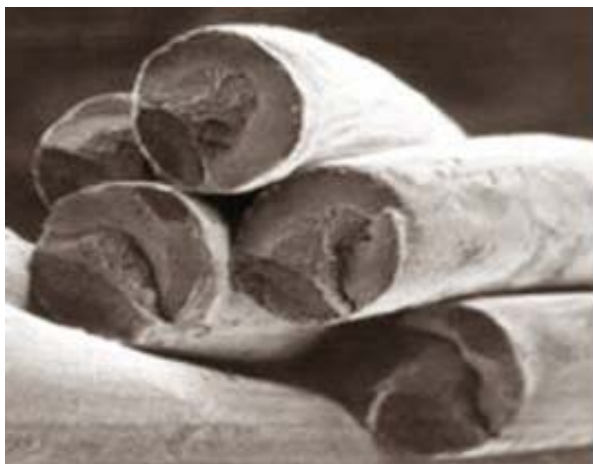
Slika 6. Zamorne prsline na mestu kontakta pojedinačnih žica.
Inicirane prsline se vide nakon kidanja struka zatezanjem.
Figure 6. Fatigue cracks at contact points of individual wires.
Initiated cracks are visible after fracture of strand in tensile test.

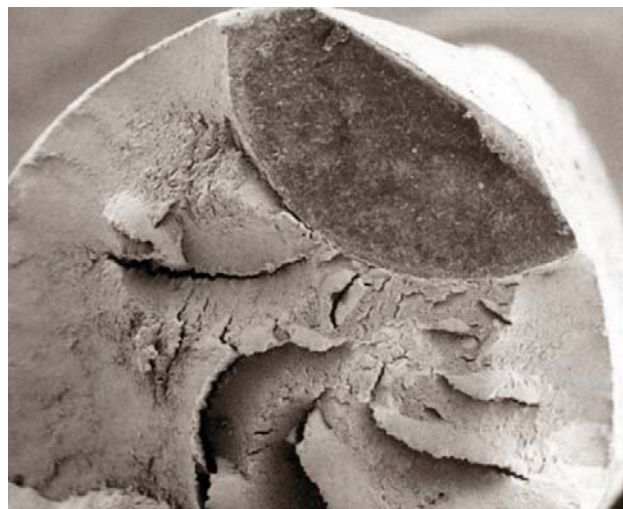
Slika 7. Zamorna prsline nastala na mestu dodira žice sa koturačom
Figure 7. Fatigue crack initiated at the contact point with a sheave.

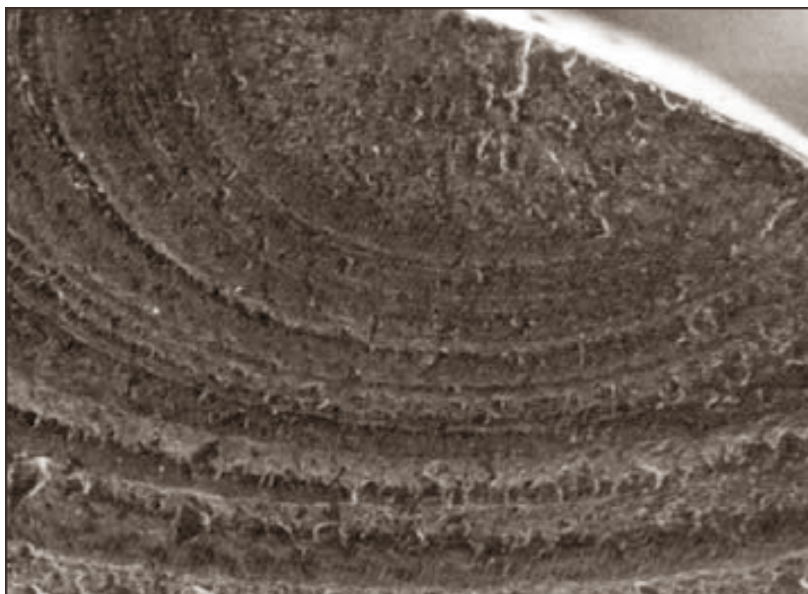
Slika 8. Linije zamora i odmora (strije) oko mesta iniciranja prslina, uvećani detalj sa slike 7
 Figure 8. Fatigue and rest lines (striations) around location of crack initiation, magnified detail from Figure 7.

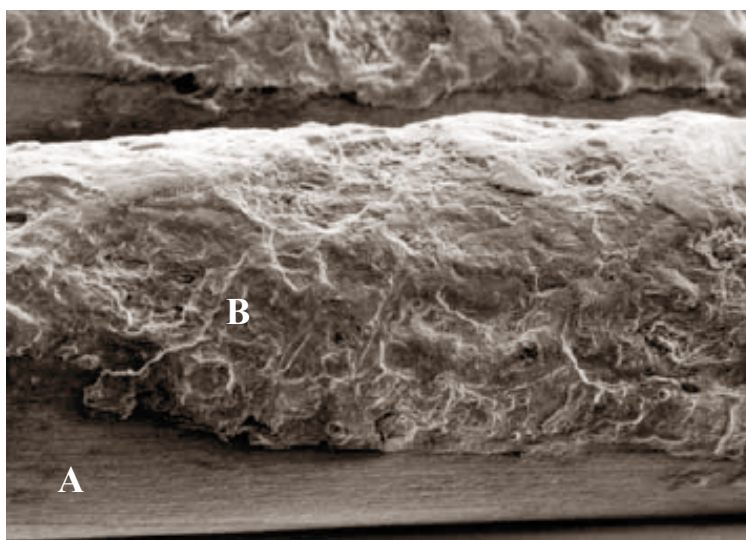
Korozija je obično reakcija metala sa kiseonikom. Kod čeličnih užadi se razlikuje atmosferska korozija, koja proizvodi ravnomerni sloj rđe, sl. 9, od lokalizovanih oblika korozije, kao što je piting, koji stvara duboke jamice u oblastima gde je zaštitni sloj oštećen ili nedostaje.

Corrosion in the usual sense is the reaction of metal with oxygen. In steel wire ropes one can distinguish atmospheric corrosion that produces a uniform rust layer, Fig. 9, and localised corrosion such as pitting, creating deep pits in the region where the protective coating is damaged or is missing.

Slika 9. Atmosferska površinska korozija „B“ na jednoj žici i deo žice neoštećen korozijom „A“, $\times 100$
Figure 9. Atmospheric surface corrosion “B” on a single wire and an undamaged part of the same wire “A”, $\times 100$.

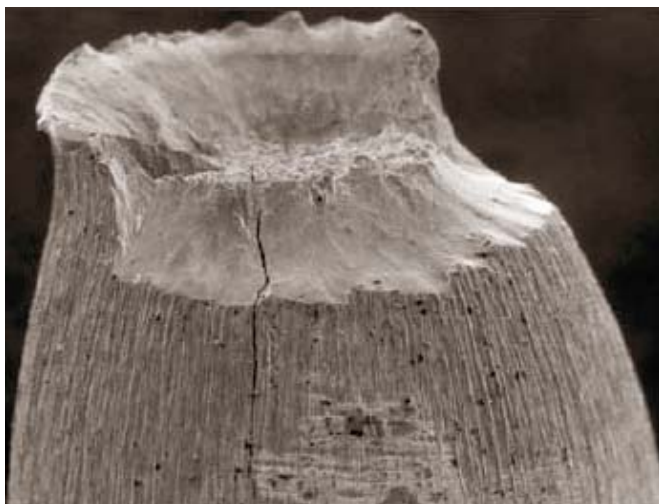
Do otkaza užeta dolazi i kada pri zatezanju zbog preopterećenja dođe do prekoračenja zatezne čvrstoće materijala žice. Lom je tada duktilan, sa izraženim suženjem i karakterističnim konusom klizanja završnog loma (sl. 10).

Rope failure will be experienced when the wire ultimate tensile strength is exceeded by tensile overload. Fracture is then ductile, with expressed necking and typical “cup and cone” ends of final shear fracture (Fig. 10).

Slika 10. Tipičan duktilni lom završen konusom smicanja
Figure 10. Typical “cup and cone” ductile fracture by shear.

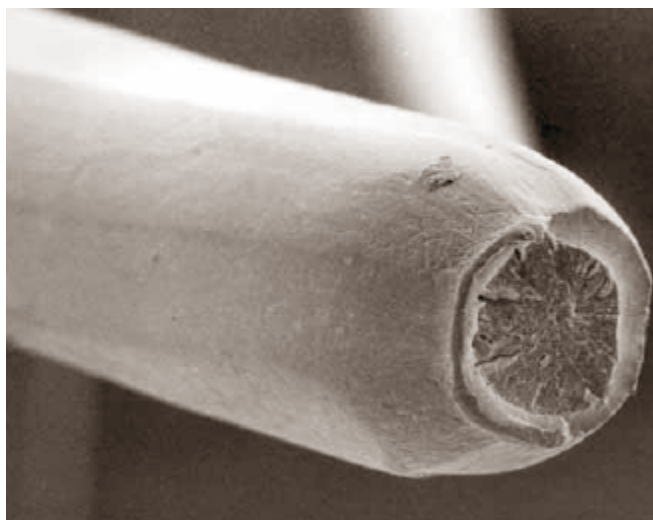
Slike 10 i 11 prikazuju tipične slučajeve loma žice zbog zateznog preopterećenja.

Figures 10 and 11 present typical examples of wire fracture due to tensile overloading.

Slika 11. vidljivo suženje na mestu peloma zatezanjem
Figure 11. Visible contraction at fracture in tension.

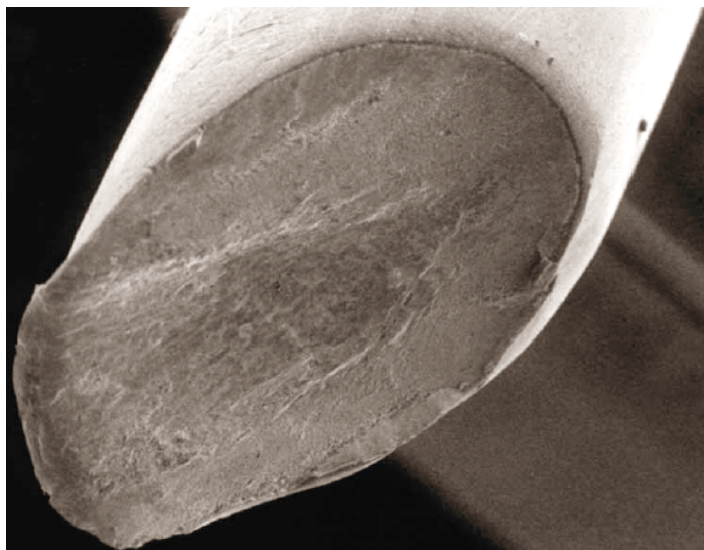
Smicajni lom se najčešće javlja kao kombinacija visokih zateznih napona i istovremenog dejstva sile upravne na strukove. Prelomna površina je pod uglom bliskim uglu od 45° u odnosu na uzdužnu osu žice, u pravcu maksimalnog tangencijalnog napona, sl. 12.

Fracture by shearing is most often experienced as combined tensile stress and simultaneous action of load perpendicular to strands. The fractured surface is at an angle close to 45° relative to the axial wire axis, in the direction of maximal shear stress, Fig. 12.

Slika 12. Tipičan lom žice smicanjem pod uglom od oko 45°, u pravcu maksimalnih tangencijalnih napona
Figure 12. Typical wire fracture by shear at about 45° in the direction of maximum shear stresses.

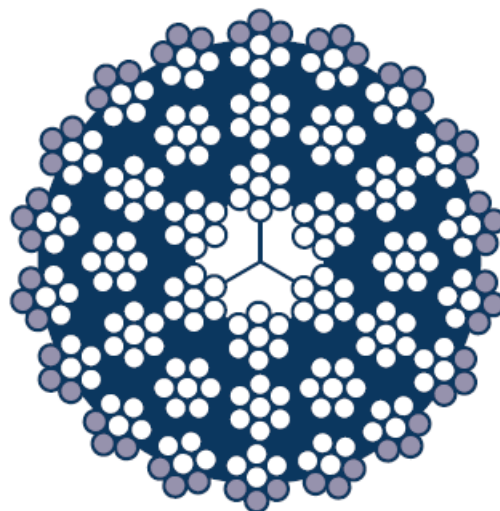
Slika 13. Samo 20% spoljnjih žica užeta se može ispitati vizuelno (svetlo sivo), dok 80% ostaje neispitano
Figure 13. Only 20% of rope outer wires can be visually inspected (light gray), while remaining 80% are not.

Tokom vizuelnog pregleda moguće je utvrditi samo stanje vidljivih delova spoljnjih žica. Međutim, površina poprečnog preseka spoljnjih žica predstavlja samo oko 40% ukupnog poprečnog preseka užeta. Zbog upredanja je samo polovina dužine spoljnjih žica vidljiva pri pregledu, sl. 13. Na osnovu toga se može zaključiti da je za vizuelni pregled dostupno samo oko 20% ukupnog poprečnog preseka žica užeta. Za preostalih 80% poprečnog preseka moguća je samo procena stanja, pre čemu se mogu očekivati manja oštećenja jer je njegov položaj zaštićen.

During visual inspection of rope it is possible to assess only the condition of visible parts of the outer wires. The metallic cross-section of outer wires, however, presents only about 40% of total cross-section of rope. Due to the lay, only half of outer wire length is visible (Fig. 13). Based on that, one can conclude that during visual inspection only about 20% of total metallic cross-section area of rope wires is accessible. Only the state can be evaluated for the remaining 80% cross section area, and one may expect less damage because of their sheltering location.
