**OPRAVKA DOBOŠA KOTLA SA PRSLINAMA OD NAPONSKE KOROZIJE
POSTUPKOM HLADNOG ZAVARIVANJA***

COLD WELD REPAIR OF A STRESS CORROSION CRACKED BOILER DRUM[#]

Stručni rad / Professional paper

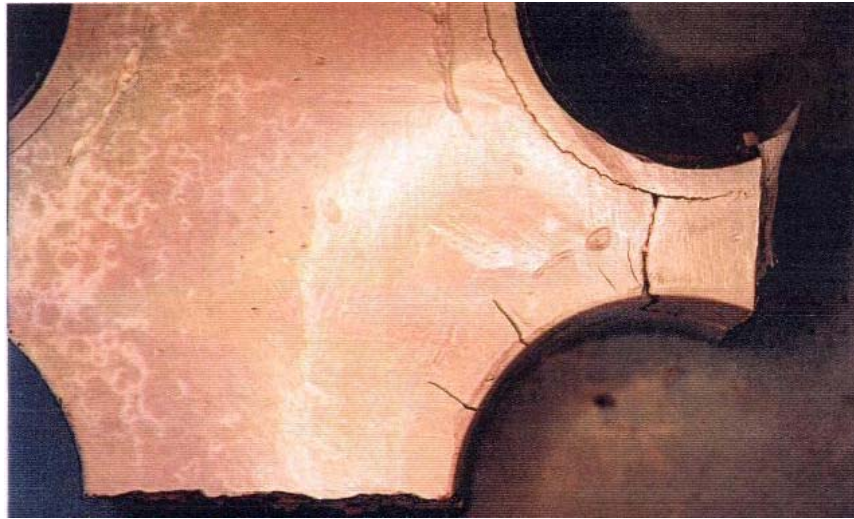
Prsline su otkrivene između susednih otvora za cevi na ligamentima cevne ploče. Detalji su prikazani na sl. 1. Kao što se sa sl. 1 vidi, postoje dva različita načina nastanka prslina, naime prsline duž zone uticaja toplote (ZUT) zaptivnih zavarenih spojeva između cevi i cevne ploče (kružna prsline na sl. 1) i zrakaste prsline u osnovnom metalu oko otvora za cevi.

Cracks were detected between neighboring tube holes on tubesheet ligaments. Details are presented in Fig. 1. As one can see from Fig. 1 there are two different trends of the cracking process, namely cracking along the heat affected zone (HAZ) of the sealing weld between the tubes and tubesheet (circular crack in Fig. 1) and cracking in base metal in a sunbeams shape around the tube hole.

The first damage can be the result of the poor welding process. There could exist other external factors such as vibrations produced by poor tube tightening rolling which subsequently led to the detachment of the tube from the tubesheet hole surface. Such factors will overlap on the initial one and subsequently increase the damage rate.

The second cracking type presents a typical damage in sunbeams form caused by thermal shock. The mechanism of this cracking appears to be the result of the "cold" water (compared to the tubesheet temperature), coming from the boiler water-wall through the tube and cools tubesheet inner surface. The immediate result of this is a strong contraction of the tubesheet material around the hole, causing sunbeams shaped cracking. This process can also produce cracking of the HAZ around the tubesheet holes. Anyhow, this driving mechanism cannot explain alone the intensive cracking of these drums. This damage scenario could take place only in the case of a boiler emergency shut-down as a result of a failure in the pressurized system. Even if this happens in some cases, must be considered as a usual case in these boilers. Since this process is taken into account during design, causal boiler operation shut-down must not affect the tubesheet integrity at tube holes. An accelerating cracking mechanism should be found in order to make the proposed scenario acceptable.

Slika 1. Presek cevne ploče doboša kotla sa prslinama
Figure 1 - Cracked section of the boiler drum tubesheet

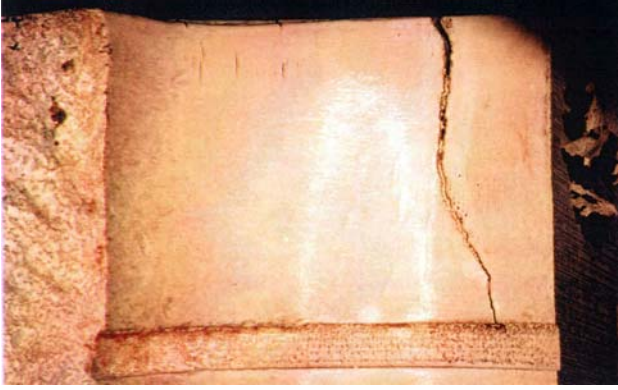
Slika 2. prikazuje putanju najveće prsline, otkrivene u ispitivanju, koja se zaustavila ispred zareza za uvaljivanje izvedenog približno na sredini cevne ploče debljine 80 mm. Prsline se može zaustaviti zbog promene pravca koncentracije napona kada vrh prsline uđe u područje zareza.

Figure 2 illustrates the propagation path of a main crack detected in investigation as arrested on the rolling notch located in the middle of the 80 mm tubesheet thickness. Crack could be arrested as the result of stress concentration direction change when the crack tip enter in the notch area.

Slika 2. Glavna prslina na unutrašnjoj površini otvora za cev
Figure 2 – Main crack on the inner surface of the tube hole

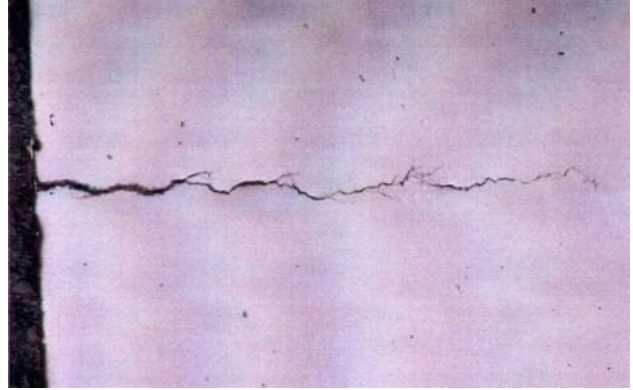
Slika 3. pokazuje račvanje prsline tokom njenog rasta. Korozioni talog je skinut sa površine prsline i analiziran da bi se utvrdila priroda procesa korozije. Rezultati hemijske analize doveli su do zaključka da bi pojava prsline zbog uticaja sredine (alkalne prirode) mogla da bude objašnjenje visokog stepen oštećenja. Ovi rezultati opredelili su stručnjake da pažnju usmere na postupak pripreme vode. Zaključeno je da je loš rad sistema uzrok zagađenja vode kotla alkalnim primesama.

Figure 3 reveals the crack branching in growth process. Corrosion products were taken from the crack surfaces and analyzed in order to assess the corrosion process nature. Chemical analysis results led to the conclusion that environmental-assisted cracking (of a caustic-nature) could explain high damage rate. These results directed the experts to pay the attention to the water treatment process. It was concluded that system malfunction was the cause of the boiler water caustic particles infection.

Slika 3. Mikrografija jedne od malih prslina
Figure 3 - Micrograph of one of the small cracks

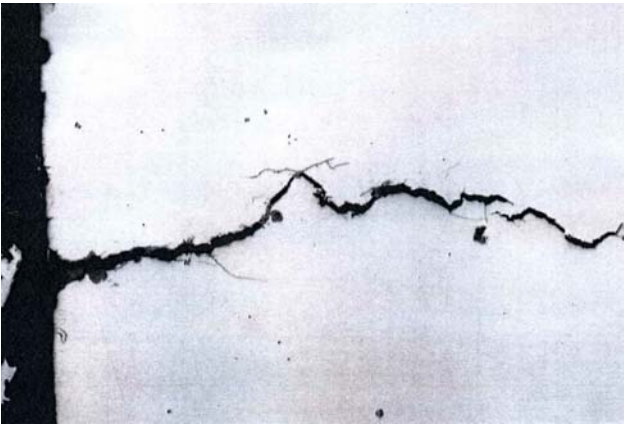
Slike 4. i 5. su potvrdile da je rast prsline sa grananjem obično prati prsline od naponske korozije (SCC). Kao što se može videti na sl. 5, pravac glavne prsline je jasan, ali, ponekad, on skreće u male ogranke. I pored izraženog račvanja, rast glavne prsline zadržava pravac upravan na najveći glavni napon (MPS). Grane ove prsline nastale su kao rezultat pratećeg bočnog prodiranja alkalne sredine, koja je dovela do korozije pretežno na granicama zrna, slabeći ih i skrećući na nekim mestima grananja pravac prsline čak do pravca paralelnog sa najvećim glavnim naponom (MPS). Na sl. 5. pravac MPS je upravan na ravan površine prsline. Zbog toga se ovi ogranci konačno gase i njihov rast zaustavlja. Glavna prsline nastavlja da raste u svom početnom pravcu.

Figures 4 and 5 confirmed that branching cracking usually follows Stress-Corrosion Cracking (SCC) cases. As one can see from Fig. 5, the main crack direction is clear, but, sometimes, it deviates in small branches. Nevertheless, the main path finally maintained its direction perpendicular on the maximum principal stress (MPS). Branches of this crack occurred due to collateral penetration of caustic medium, which produced the corrosion preferably at grain boundaries, weakening them, and diverting the crack path on directions somehow parallel to the maximum principal stress (MPS). In Fig. 5 the MPS would have normal direction to the crack surface. For that these branches were finally inhibited and their propagation arrested. The main crack continued to propagate in its initial direction.

Slika 4. Detalj grananja male prsline
Figure 4 – A detail of small crack branching

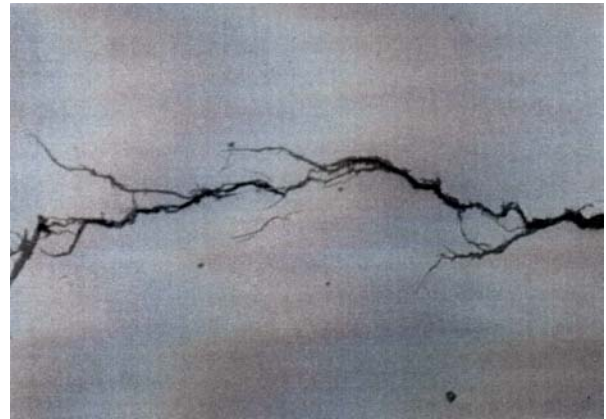
Slika 5. Uvećani detalj grananja male prsline
Figure 5 – Enlarged detail of small crack branching

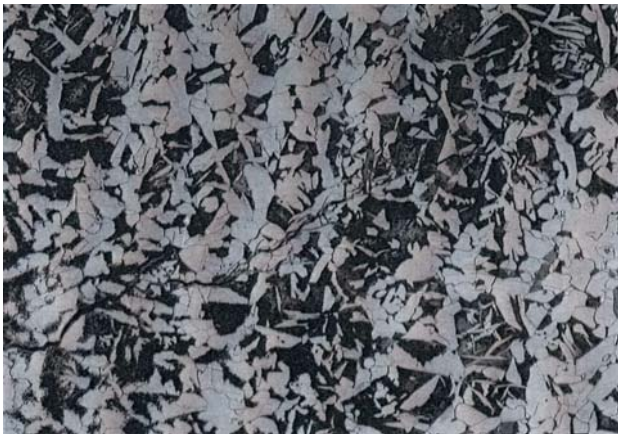
Hipoteza o mehanizmu pojave prsline naponske korozije je takođe istraživana iz mikrostrukturnog aspekta, koji može da bude odlučujući za pravi odgovor. Slike 6. i 7. pokazuju da je mikrostruktura materijala oko prsline oštećena kombinovanim lomom duž granica zrna i kroz zrna. Ovo objašnjava ne samo korozionu prirodu oštećenja (koja slabi granice zrna), kao i uticaj napona što dovodi do rasta prsline kroz zrno. Do povećanja napona dolazi zbog termičkog šoka i koncentracije napona zbog rasta prsline i slabljenja ligamenata na cevnoj ploči.

The hypothesis of stress corrosion cracking mechanism was investigated also in micro-structural aspect, which can be decisive for the right answer. Figures 6 and 7 show that microstructure of material surrounding crack is damaged by combined fracture along grain boundary and through the grains. This explains not only corrosive nature of damage (which weaken grain boundaries) but also the stress effect, producing crack growth through the grain. Stress increase is caused by thermal shock and stress concentration due to crack growth and reduced tubesheet ligaments.

Slika 6. Mikrostruktura oko prsline (x 100)
Figure 6 – Microstructure around the crack (x100)

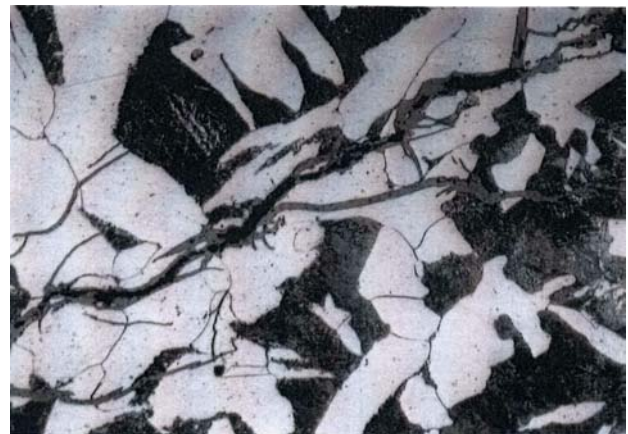
Slika 7. Mikrostruktura oko prsline (x 500)
Figure 7 – Microstructure around the crack (x500)

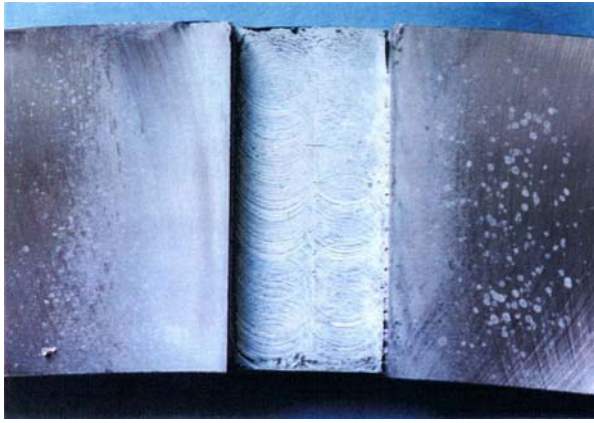
Ispitivanja kroz debljinu zida cevne ploče otkrila su i druga oštećenja, npr. unutrašnje prsline paralelne unutrašnjoj površini doboša (sl. 8). Ovo je rezultat povećanog gradijenta napona po debljini zida, između unutrašnje i spoljne površine zida. Termički šok je uzrok njihove pojave, ali u prisutvu grešaka u materijalu koje podstiču pojavu i rast prslina paralelno površini omotača.

Investigations through the tubesheet wall thickness revealed other defects, e.g. embedded cracks parallel to the inner drum surface (Fig. 8). This is the result of increased stress gradient across wall thickness, between the inner and outer wall surfaces. Thermal shock is cause of their occurrence, but in presence of defects in material, contributing to crack initiation and growth paralel to drum surface.

Slika 8. Skrивene prsline otkrivene u zidu dobošu
Figure 8 – Embedded cracks revealed in drum wall

Figures 8 and 9 reveal that the detected defects are not insulated case. There are many similar defects that did not developed to bigger size. Therefore it is considered as a generalized damage mechanism which complicated the so-far defined situation. Beyond these cracks, other material defects can be found in these Figures. This is confirmed by a close-up view of the main crack (Fig. 10).

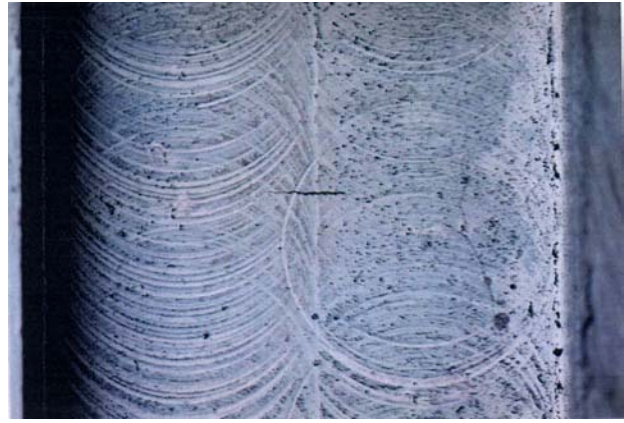
Slika 9. Detalj skrивene prsline otkrivene u zidu doboša
Figure 9 – Detail of embedded crack revealed in drum wal

Slike 8. i 9. pokazuju da otkrivene greške nisu usamljen slučaj. Otkriven je veći broj sličnih grešaka, koje se nisu razvile do većih dimenzija. Zbog toga se ovo može smatrati generalnim mehanizmom oštećenja koji dalje komplikuje do sada opisanu situaciju. Sem ovakvih prslina, na ovim slikama se mogu naći i druge greške u materijalu. Ovo potvrđuje i uvećani snimak glavne prsline (sl. 10).

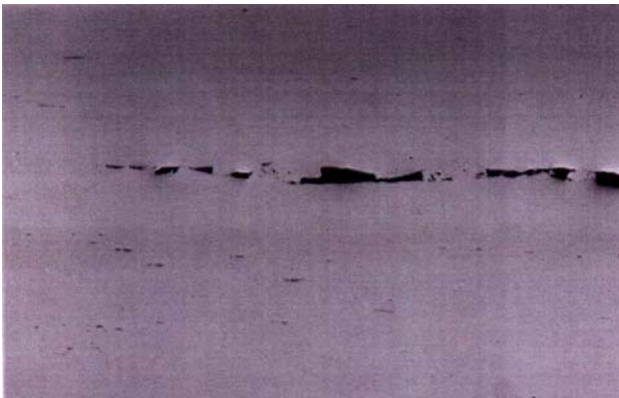
Slika 10. Potpovršinska prslina otkrivena na doboša
Figure 10 – Sub-surface crack detected on the drum

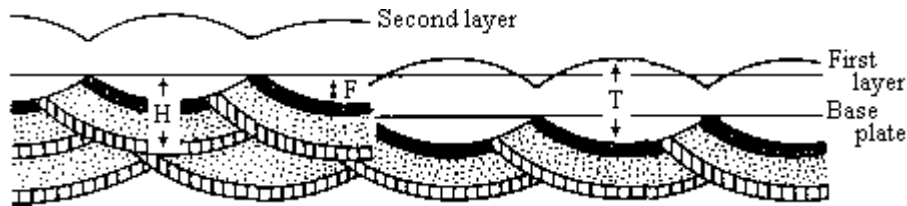
Slika 11. Shema nanošenja dva sloja puterovanja

Figure 11 – Scheme of buttering two layers deposition

The HAZ temperature interval (1100-1500°C) which determines the ferritic/pearlite grain coarsening effect (dark layer in Fig. 11) will be finally located in the weld metal. The layer located in the parent material will be normalized by the heat input of the next layer. Strict precautions were taken for the proper performance of this repair: accurate sequence of the layers, as well as cleaning of the weldment area (avoid to impeded the weld with iron oxides).

Furthermore, a buttering method was selected to deposit a first layers. This method, described in detail in /3/, has a main advantage to use the heat input of one pass to temper the HAZ of the previous run. A scheme of this principle for two buttering layers deposition is given in Fig. 11, and the same principle is also when one layer is to be deposited.

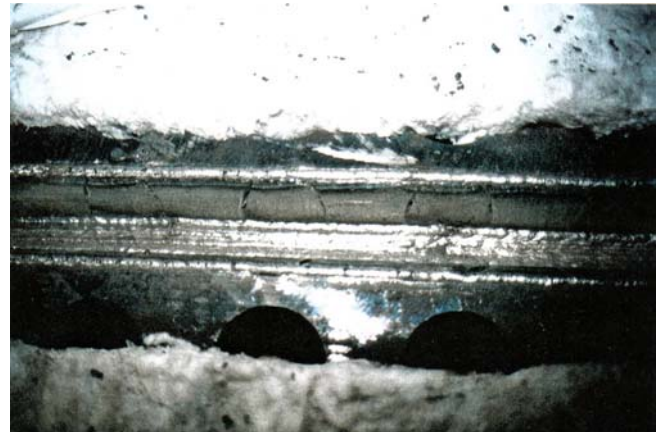
Način popunjavanja otvora na cevnoj ploči umecima od sličnog osnovnog metala (zajedno mašinski obrađenim) se vidi na detalju boka 1/3 puterovanog šava (sl. 15), što omogućava kontinualno nanošenje šava duž ispitne ploče.

Slika 15. Priprema U šava i umetak za ispunu otvora cevne ploče
Figure 15 – Weld U preparation and fill-up insert of tube-sheet hole

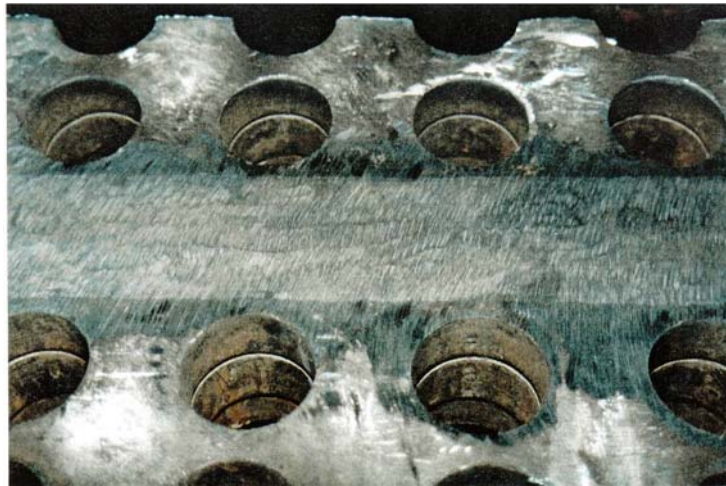
Popravljena ispitna ploča je prikazana na sl. 16. Makrofotografije poprečnog preseka (sl. 17) otkrivaju usku ZUT i vrlo čist metal šava (bez grešaka i nemetalnih uključaka). Mikrostruktura ZUT je sitnozrnasta (sl.18), čime je potvrđen uticaj otpuštanja narednim prolazom. Ovi rezultati su isključili prisustvo martenzita.

Slika 16. Zavarena ispitna ploča
Figure 16 - Welded test plate

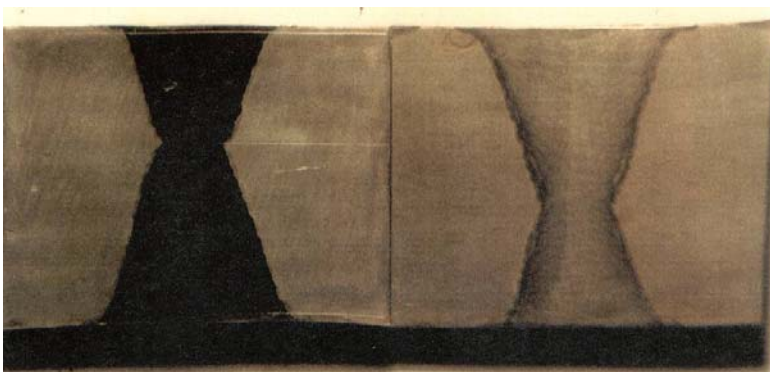
Slika 17. Makrosnimak poprečnog preseka popravljene ispitne ploče
Figure 17 - Macro photographs of repaired test plate cross-section

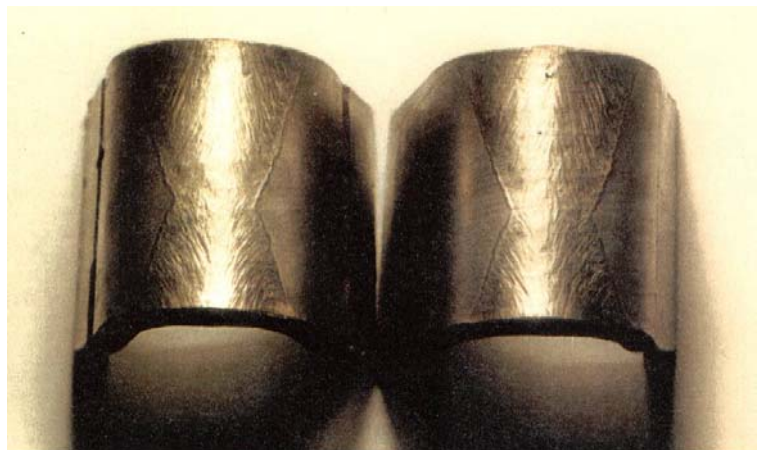
Samples had been extracted from this plate to assess mechanical, chemical and physical properties of the weld according to ASME Sect. IX. Transverse tensile test specimens fractured in parent metal (Fig. 19). Transverse side bend test revealed no HAZ cracking (Fig. 20). Hardness in HAZ is up to 264 HV 10.

Slika 20. Epruvete za savijanje oko trna
Figure 20 - Transverse side bend test specimens
