Taško Maneski¹
Dragan Ignjatović²

SANACIJE I REKONSTRUKCIJE ROTORNIH BAGERA REPAIR AND RECONSTRUCTION OF BUCKET WHEEL EXCAVATORS

Originalni naučni rad / Original scientific paper
UDK /UDC: 620.17:621.879.48
Rad primljen / Paper received: 10.6.2004.

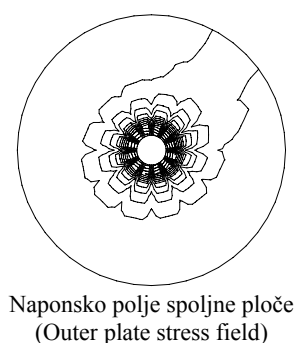
Rezultati proračuna postojećeg modela nedvosmisleno pokazuju da se najveći napon nalazi tačno na mestu popuštanja konstrukcije točka.

Raspodela normalnih i smicajnih napona ukazuje na veliko prisustvo smicajnih napona. Membranski naponi su dominantni. Analiza pokazuje nedvosmisleno da je uzrok havarije nedovoljna debljina spoljašnje ploče.

Numerical results of the existing model clearly point out that the largest stress is located at the position of yielding of the operating wheel.

The distribution of normal and shear stresses indicates large presence of shear stresses. Membrane stresses are dominant. The analysis undoubtedly shows that the failure is caused by insufficient thickness of the outer plate.

Slika 2. Naponsko polje i raspodele
Figure 2. Stress state and the distributions.

Uvođenje kružnog prstena povećane debljine (sa 0,8 mm na 2 cm) na spoljašnjoj ploči donosi znatno smanjenje napona u spoljašnjoj ploči (napon je smanjen sa 21,6 kN/cm² na 13,6 kN/cm²) uz značajno smanjenje učešća smicajnog napona. Točak uspešno radi.

Adding a ring of increased thickness (2 cm instead of 0.8 cm) to the outer plate led to significant stress decrease (from 21.6 to 13.6 kN/cm²) and also to a decrease in the shear stress effect. The wheel has continued to operate successfully.

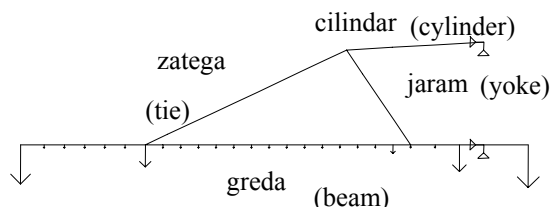
During excavator service life, poor dynamic behaviour of the unloading beam is frequent, i.e. with resonant oscillations, amplitudes up to 60 cm. This may result in cracking of certain cantilever elements. The structure consists of one beam element and three truss elements (tie, yoke and cylinder).

Slika 3. Ravanski model strele i deformacija strele ($f_{max} = 10.4$ cm)
 Figure 3. Planar model of the cantilever beam and deformation pattern ($f_{max} = 10.4$ cm).

Figure 3 shows the cantilever model and strain pattern. Strain energy is distributed as follows: beam (72.2%); tie (16.8%); cylinder (10.5%); yoke (0.5%). Static calculation has concluded: too large tilting of the beam in the support joint; the axial force in tie and cylinder is too large, but rather low in the yoke; the bending moment of the beam is large in yoke link; and dominant strain energy in beam.

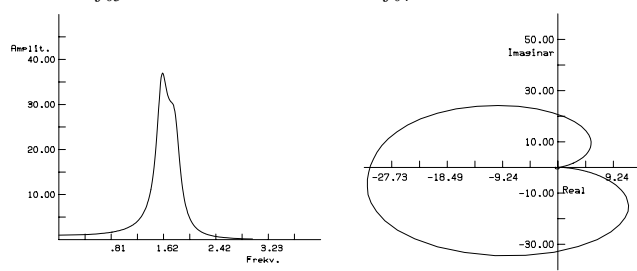
Zaključak dinamičkog proračuna (sl. 4): prve dve frekvencije su veoma niske i bliske, poklapaju se sa statičkom deformacijom; faktor dinamičkog pojačanja je vrlo velik; velik je imaginarni deo karakteristike (nestabilan sistem) i energije su dominantne na gredi i na spoljašnjim masama.

Slika 4. Prva četiri glavna oblika oscilovanja, raspodele i jedan frekventni odziv
 Figure 4. First four major forms of oscillation, distribution, and one frequency response.

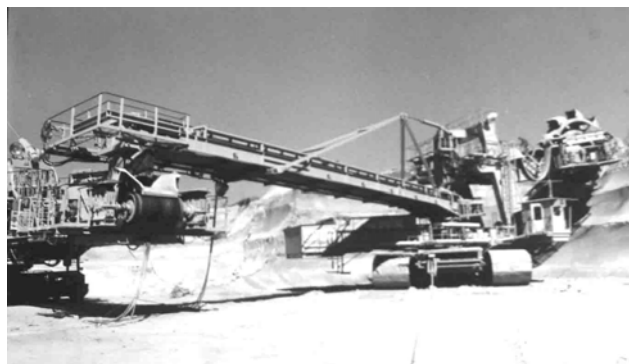
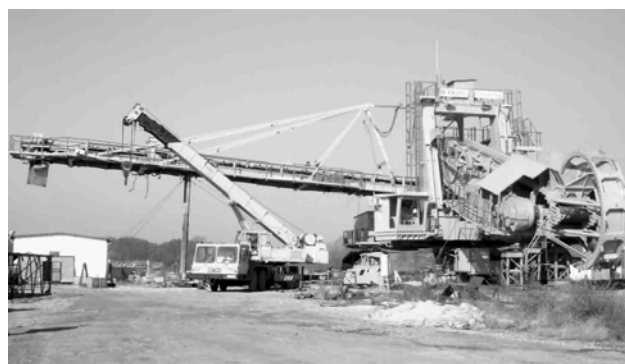
Slika 5. Rekonstrukcija strele
 Figure 5. Cantilever beam reconstruction.

Rekonstrukcija strele se odnosi na uvođenje dve nove zatege, pojačanje jarma strele i uklanjanje teške kućice (uvedene su kamere) (sl. 5). Model i rezultati proračuna prikazani su na sl. 6. Strela uspešno radi. Na rekonstruisanoj strelji izvršeno je merenje ubrzanja na zategama i gredi. Na sl. 8 prikazan je jedan izmereni signal. Vidi se da je ubrzanje ispod dozvoljene vrednosti (2 m/s^2) i nema odziva na sopstvenoj frekvenciji strele.

Cantilever reconstruction meant adding two new ties, yoke reinforcement and removal of heavy elements (cameras were placed) (Fig. 5). Numerical results and model are shown in Fig. 6. The cantilever operates successfully. Acceleration measurements were made on the reconstructed beam and ties. Figure 8 shows a measured signal. As can be seen, the acceleration is below the allowed value (2 m/s^2) and with no response of cantilever eigen-frequency.

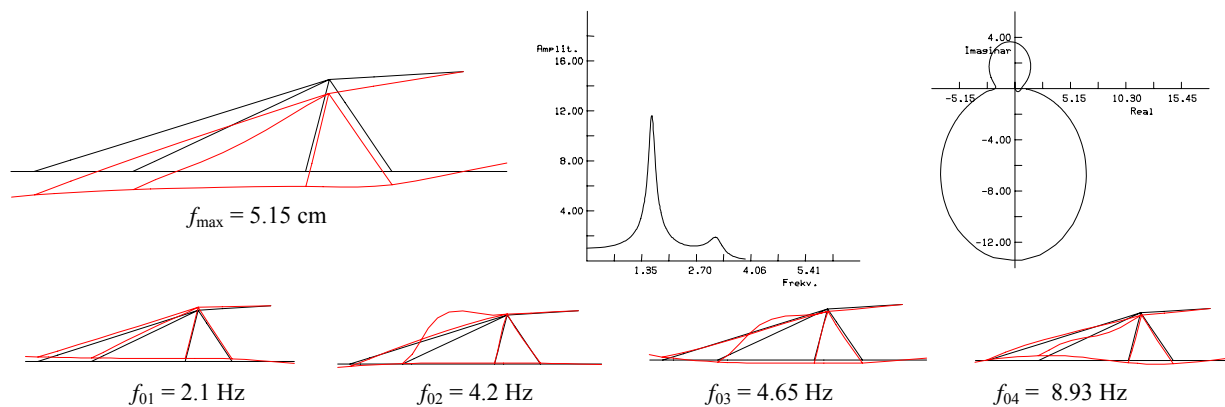
Slika 6. Rezultati statičkog i dinamičkog proračuna rekonstruisane strele
Figure 6. Static and dynamic numerical results of the reconstructed cantilever.

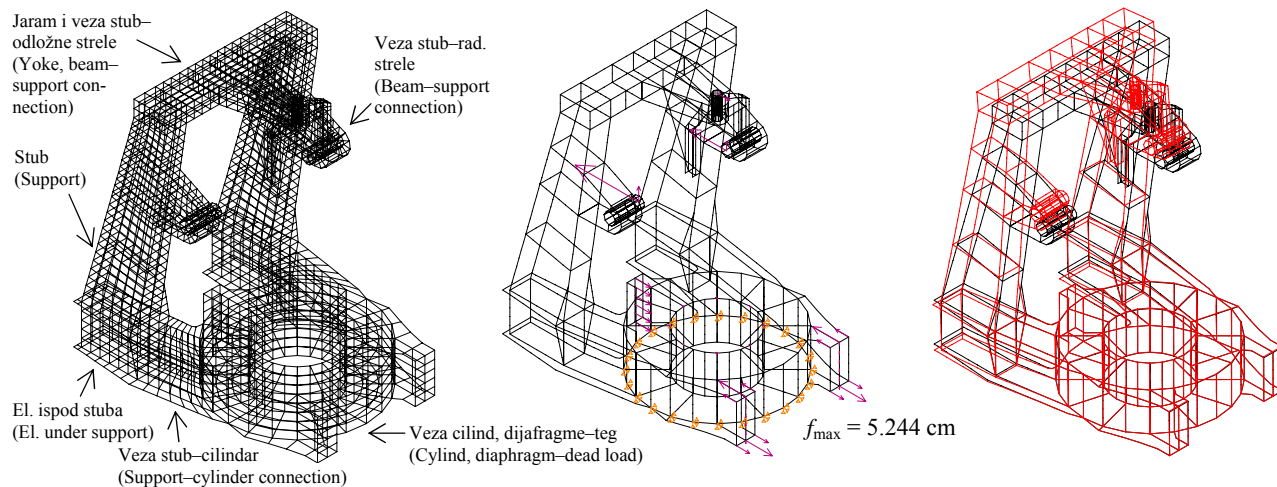
The analysis is aimed in determining and resolving cracking causes of support and cylinder connection and poor dynamic behaviour of upper assembly. Upper assembly numerical model and strain pattern with worst loading case are shown (Fig. 8). Upper element strength diagnostics and detailed analysis of lower assembly behaviour are shown below.

Slika 8. Računski model gornje gradnje bagera sa najnepovoljnijim opterećenjem i deformacijom
Figure 8. Numerical model of upper excavator assembly with worst case load and deformation.

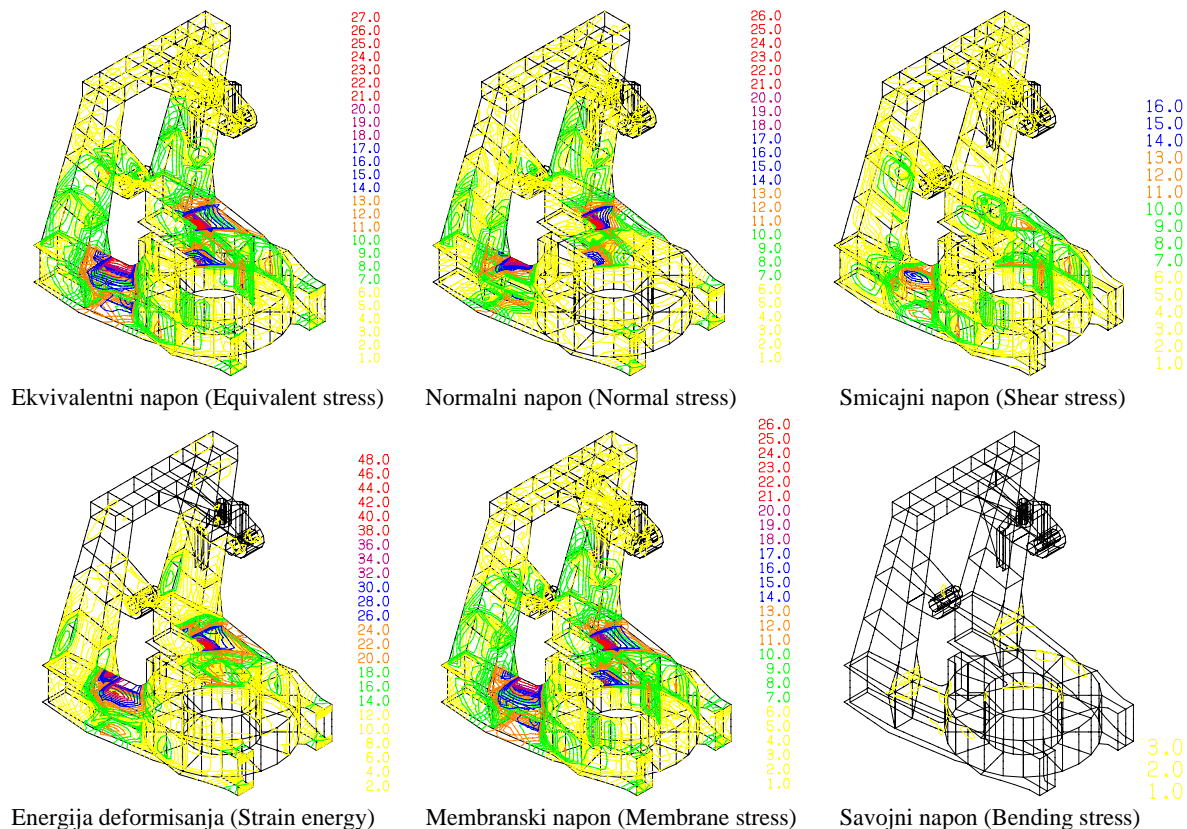
Slika 9. Raspodela napona [kN/cm²] i energije deformisanja [kNcm]
 Figure 9. Stress [kN/cm²] and strain energy [kNcm] distribution.

- najveći napon, koncentraciju i energiju deformisanja imaju elementi veze stuba i cilindra,
- stub i cilindri imaju nizak nivo napona na velikoj površini uz visok udeo u naponu i energiji,
- jaram ima najmanji uticaj na ponašanje.

- support–cylinder connecting elements have the largest stress, stress concentration, and strain energy,
- support and cylinders have a low stress level on a large surface with a high contribution of stress and energy,
- the yoke has the least significant effect on the behaviour.

Loše ponašanje gornje gradnje možemo popraviti povećanjem debljine gornje i donje horizontalne ploče elementa veze stuba i cilindra. Usvojeno povećanje debljine gornje ploče je za 15 mm, odnosno ukupno 39 mm, dok donje za 10 mm (ukupno 34 mm). Maksimalna deformacija je sada $f_{\max} = 4,669$ cm. Sledi prikaz elemenata dijagnostike čvrstoće rekonstruisane gornje gradnje (sl. 10), dok je na sl. 11. prikazana izvedena rekonstrukcija.

Inproper upper assembly behaviour can be corrected by increasing thickness of upper and lower horizontal plate connecting elements. An upper plate thickness increase of 15 mm, i.e. a total of 39 mm was approved, while lower plate thickness was increased 10 mm (34 mm total). The maximum strain value is now $f_{\max} = 4.669$ cm. Figure 10 shows strength diagnostics of reconstructed upper assembly elements, and Fig. 11 shows the reconstructed assembly.

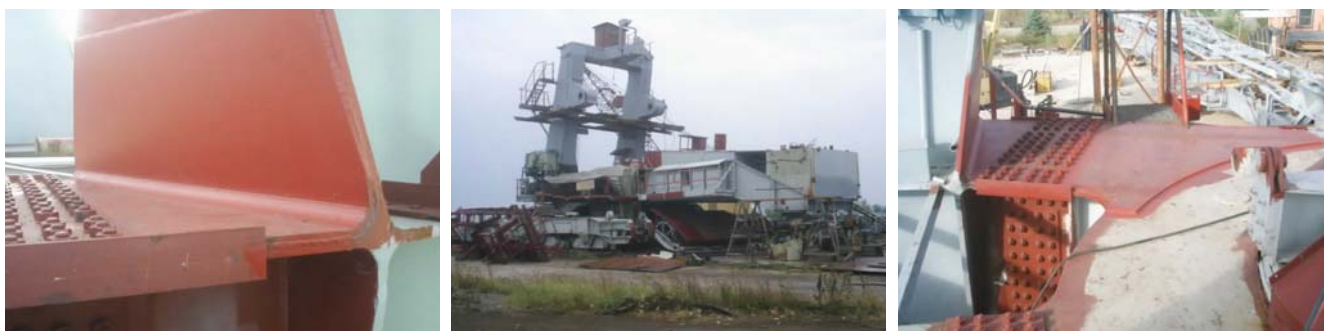
Slika 11. Izvedena sanacija i rekonstrukcija gornje gradnje
Figure 11. Performed repair and reconstruction of upper assembly.

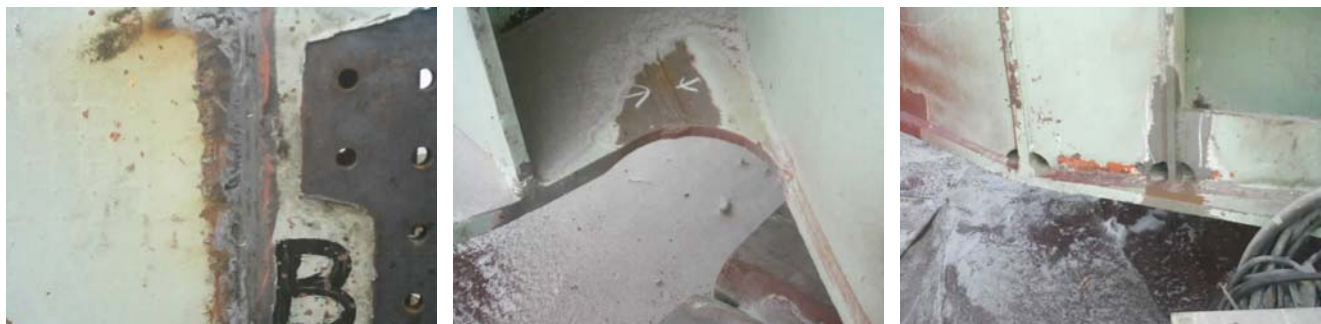
Konstrukcija donje gradnje bagera pretrpela je u više navrata delimična i potpuna pucanja veznih nosača donje gradnje i transportnog bagera (sl. 12). Računski model i rezultati proračuna dati su na sl. 13. i 14. Analiza starog i novog rešenja data je u tabeli 2.

The excavator lower assembly suffered several partial and complete cracking of assembly connection beams (see Fig. 12). Model and numerical results are shown in Fig. 13 and 14. Table 2 shows the analysis of the old and new solution.

Slika 12. Oštećenja veznih nosača donje gradnje transportnog bagera
Figure 12. Damaged connection beams in the excavator lower assembly.

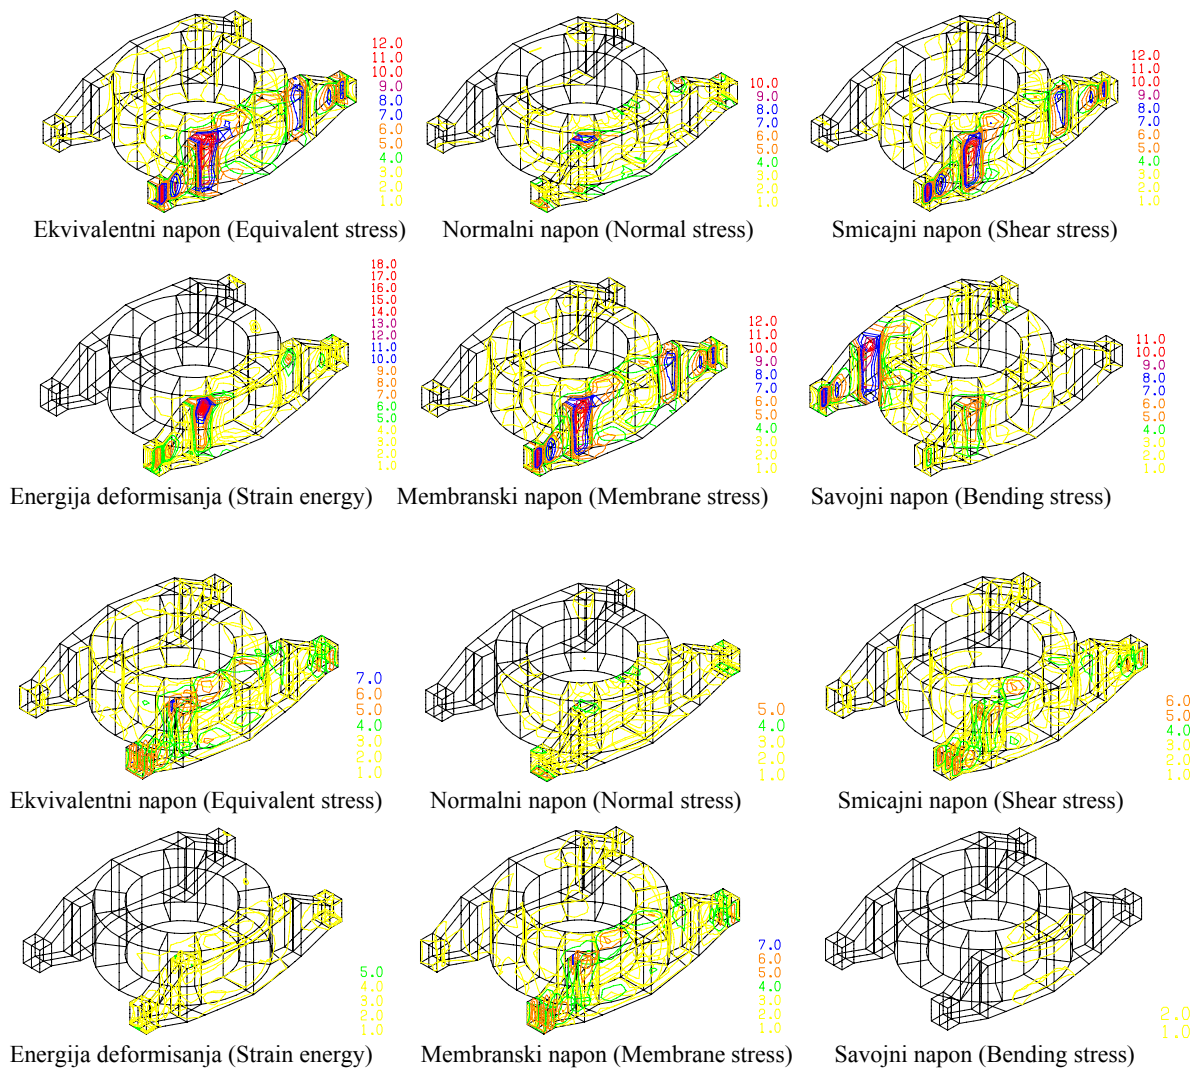
- najveći napon i energiju deformacije imaju vertikalne ploče,
- na horizontalnim pločama je velik napon na maloj površini,
- cilindri imaju nizak nivo napona na velikoj površini uz visok procentualni udeo u naponu i energiji,
- dijafragme imaju najmanji uticaj na ponašanje.

- vertical plates have the largest stress and strain energy,
- horizontal plates have a high stress level in a small area,
- the stress level in cylinders is low in a large area, along with a high percentage of the stress and energy,
- diaphragms pose the least significant effect on behaviour.

Figure 14. Stress [kN/cm^2] and strain energy [kNcm] distribution.

Loše ponašanje donje gradnje možemo popraviti dodavanjem vertikalnih ploča. Takođe, ponašanje bi se značajno popravilo povećanjem debljine horizontalnih ploča i cilindra, ali je ovo tehnički neopravdano.

Dodavanje vertikalnih ploča izvodi se zatvaranjem obe strane četiri nosača "I" preseka. Detaljno je ispitan uticaj debljine dodatih ploča. Usvojena debljina spoljašnjih ploča je 25 mm, a unutrašnjih 15 mm.

Inappropriate lower assembly structural behaviour can be repaired by adding vertical plates. Behaviour would also be significantly improved by increasing horizontal plate and cylinder thickness, but this is technically not reasonable.

The vertical added plates cover both sides of four "I" cross-sectional beams. The effect of added plate thickness was tested in detail. Approved plate thicknesses are 25 mm and 15 mm, for outer and inner plates, in respect.

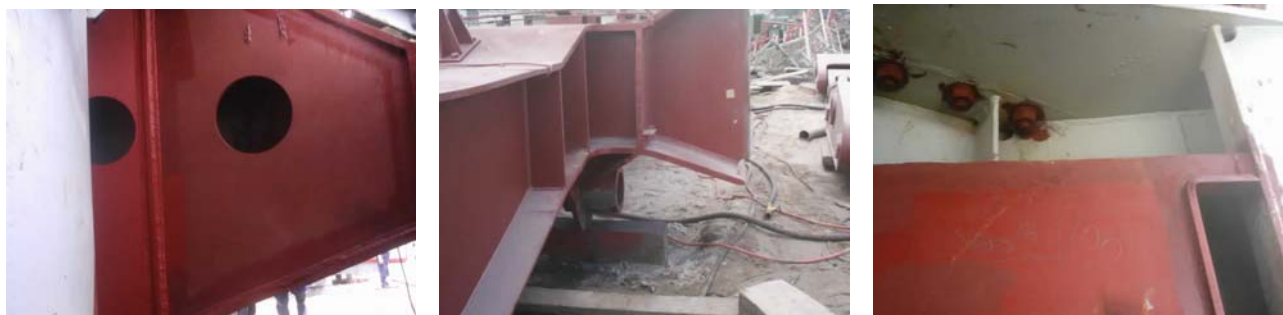
Slika 15. Rekonstrukcija donje gradnje
Figure 15. Reconstruction of lower assembly.

- maximum strain decrease by 33.9%,
- maximum stress decrease by 42.3%,
- stress relaxing of cylinders, horizontal plates, and existing vertical plates,
- strain energy decrease by 24.2%.

Prikaz konstrukcije pre i posle rekonstrukcije dat je na sl. 15.

The state before and after reconstruction is shown in Fig. 15.

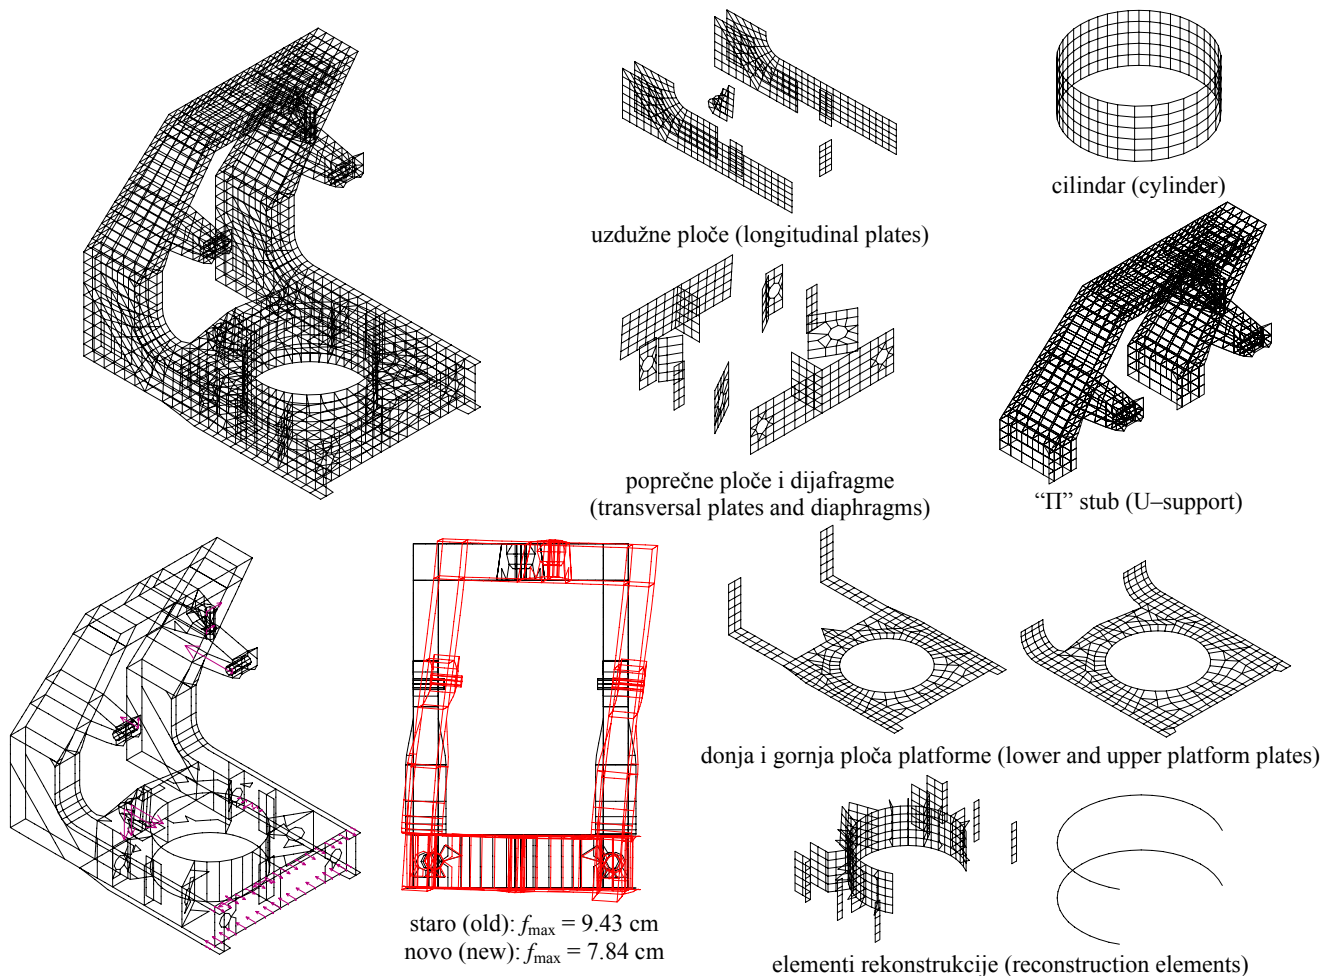
Slika 16. Model gornje gradnje bagera, njegova deformacija i elementi rekonstrukcije
Figure 16. The upper assembly structural model, its strain and reconstruction elements.

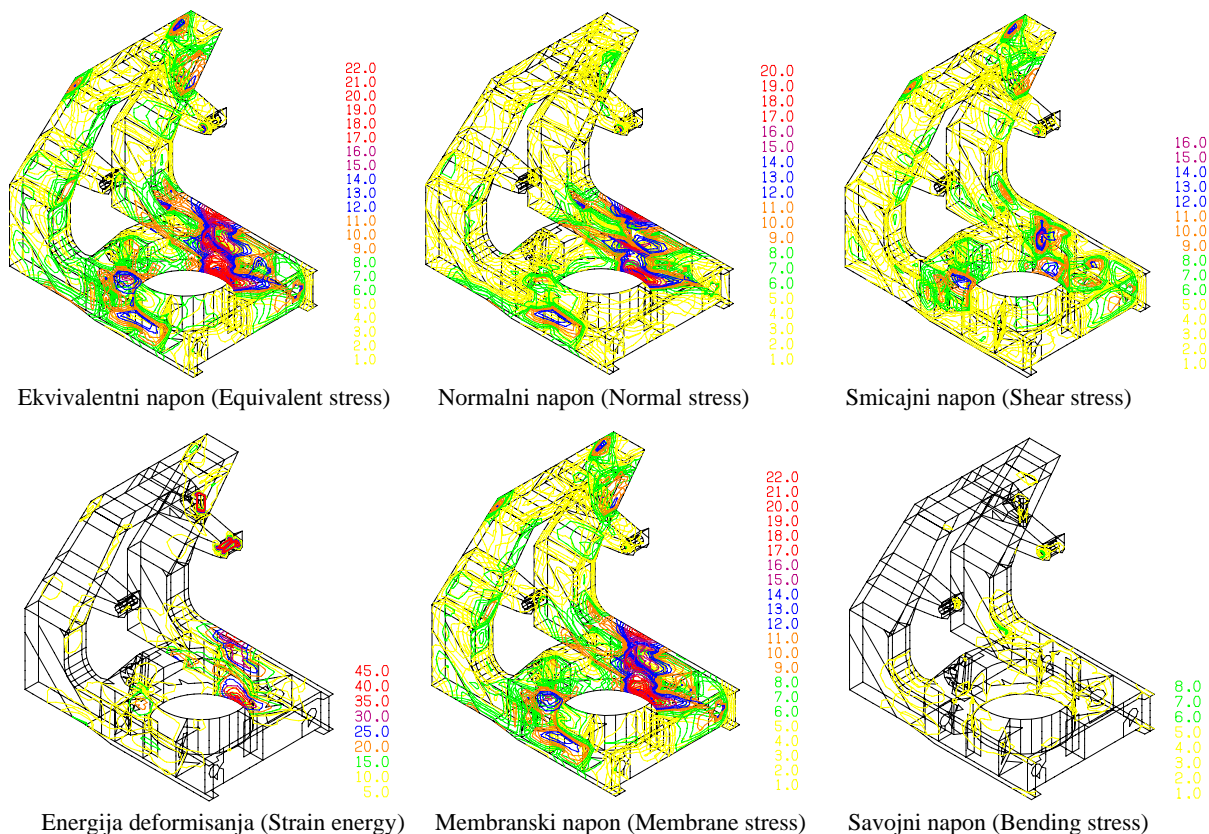
Zaključak dijagnostike je: velika deformacija, vrlo visok nivo napona i koncentracije napona, izražen normalni membranski napon i najveći naponi i energija deformisanja na istom mestu. Ovakvo ponašanje olakšava rešenje problema.

The excavator suffered constant cracking in the lower assembly. The hindering crack in the cylinder–lower horizontal plate joint was 2 m long. Also, cracks appeared at the top of support. Determining causes for cracking requires detailed structural strength diagnostics of the upper assembly for all dynamic loading cases. The computational model, worst load case, deformed structure pattern and reconstructed elements are shown in Fig. 16. Stress and strain energy distributions are given in Fig. 17. The reconstructed upper assembly is shown in Fig. 18.

Diagnostics conclude the following: large strain, very high level of stress and its concentration, high normal membrane stress and strain energy appearing in the same location. Such behaviour makes the problem easier to solve.

Slika 17. Raspodela napona [kN/cm²] i energije deformisanja [kNcm] stare konstrukcije
 Figure 17. Stress [kN/cm²] and strain energy [kNcm] distribution of the old construction.

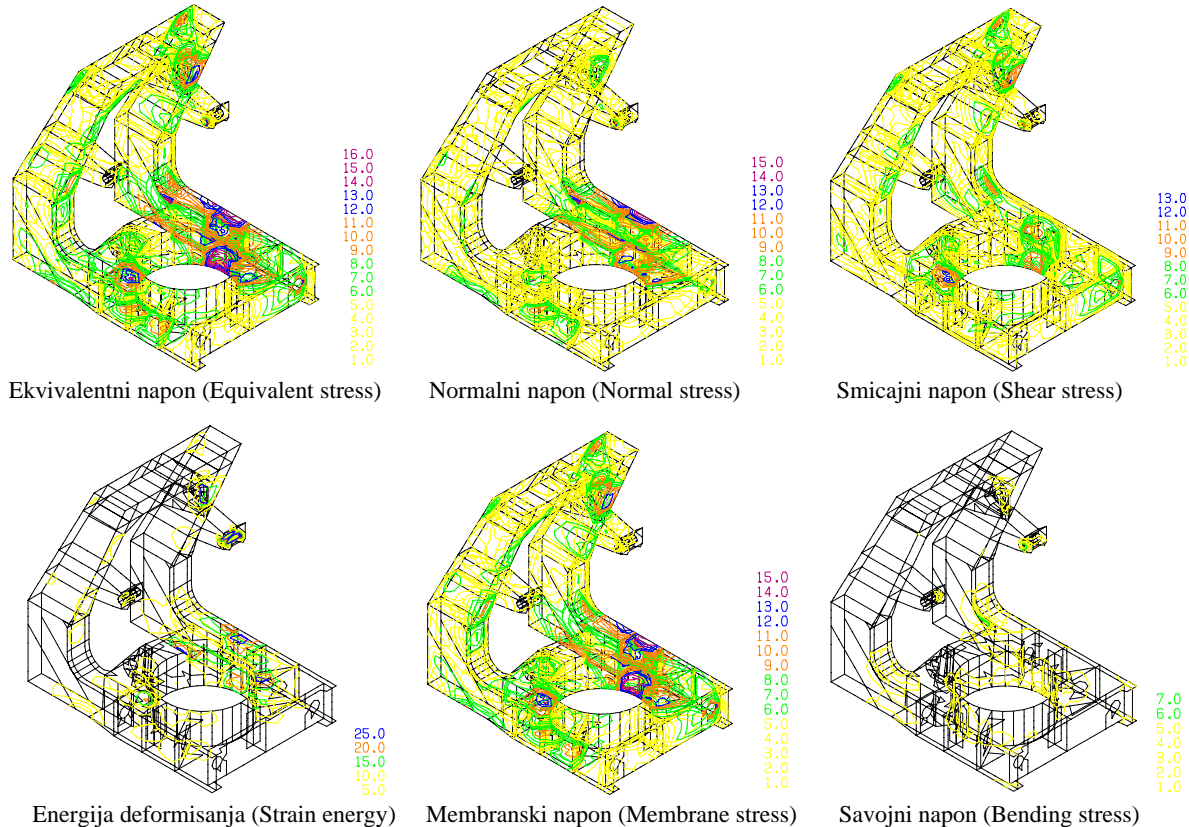
Slika 18. Raspodela napona [kN/cm²] i energije deformisanja [kNcm] rekonstruisane gornje gradnje
 Figure 18. Stress [kN/cm²] and strain energy [kNcm] distributions of the reconstructed upper assembly.

Structural behaviour of diagnostic parameter distribution is given in Table 3. Apparently, both lower and upper plates are relaxed, as well as the cylinder, while longitudinal plates are loaded, which was the goal.

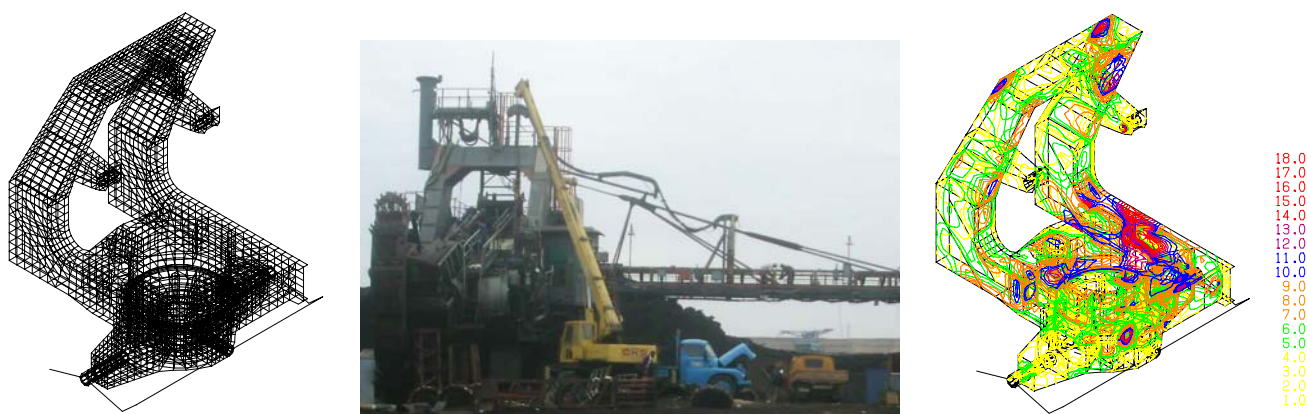
The lower assembly is added to this model in order to confirm the behaviour and accurately determine the load in between the lower and upper structures at the connection (bearing). Expected behaviour is confirmed (Fig. 19).

Slika 19. Model, rekonstrukcija i ekvivalentni napon donje i gornje gradnje
Figure 19. The model, reconstruction and equivalent stress of the lower and upper assembly.

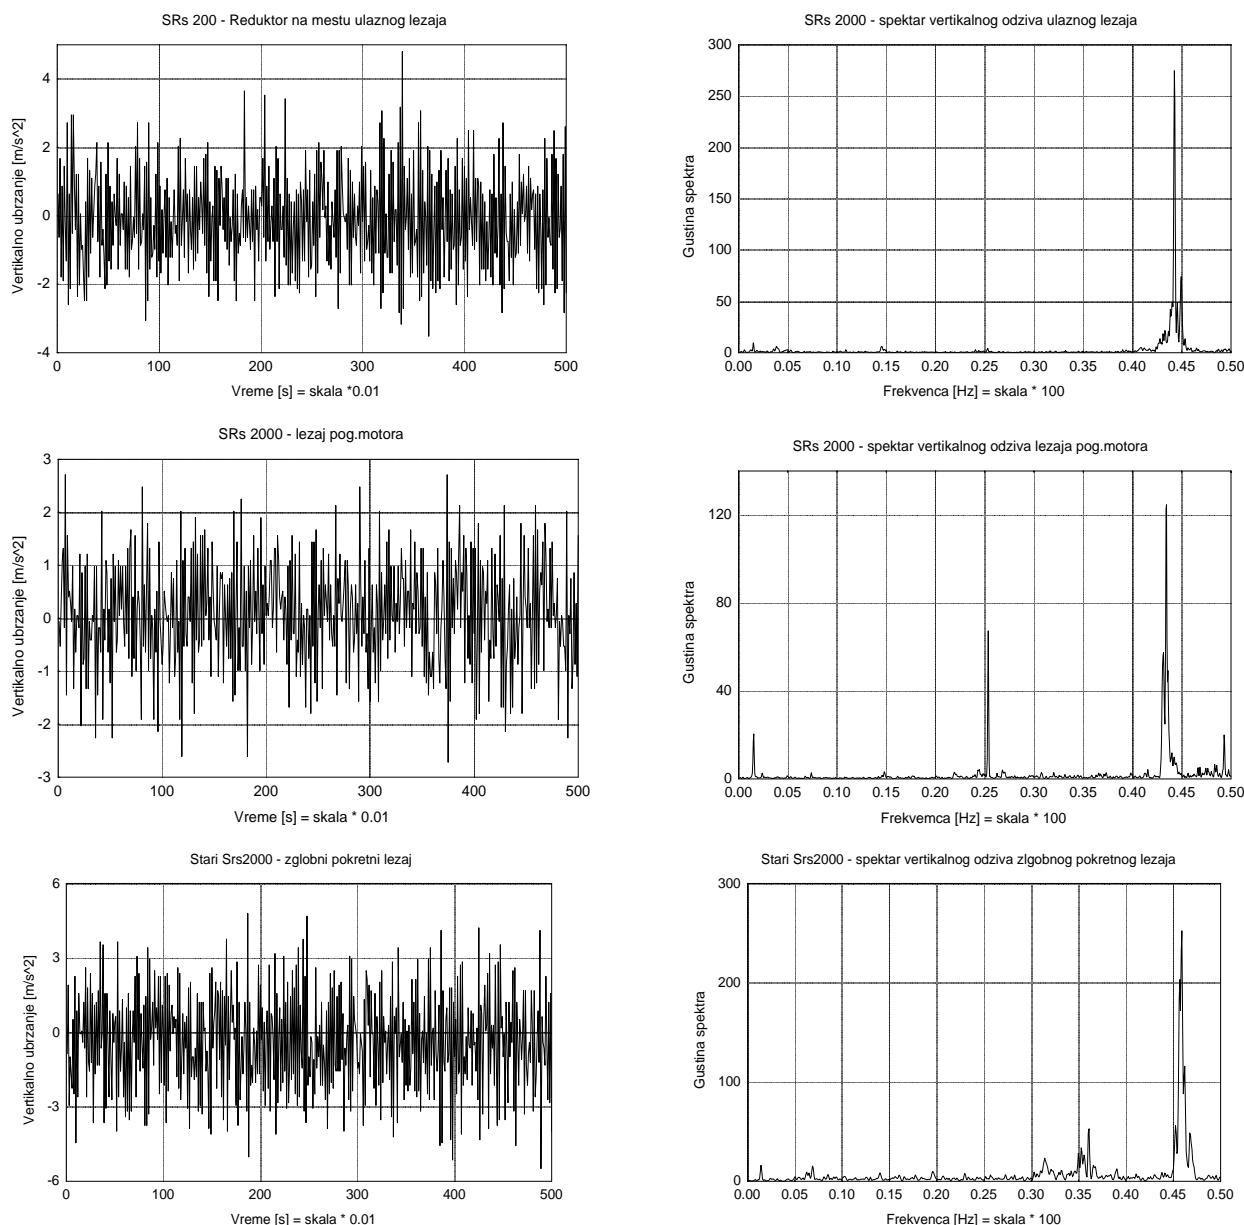
Combined numerical-experimental diagnostics of dynamic power system behaviour gives qualitative parameters for the cause of frequent bearing damage at the transmission driving shaft (after 7 days service). The excavator power system was monitored three times, during which the acceleration of motor- and transmission bearings, as well as the support structure were measured in all three directions. Visual control showed that the supporting structure and the power system/transmission joint had loosened, with significant gap in the spherical support transmission axle. Figure 20 shows measured acceleration in time and frequency domain. Accelerations are close to allowed, and oscillations of both bearings of about 44 Hz, are unacceptable. The cycles of the motor had caused an induced frequency of 24.6 Hz (14800/min) and next frequency of $2 \times 24.6 = 49.2$ Hz. Oscillations of motor bearings, about 1.5 Hz, being close to digging frequency suggests that the support structure of

cantilever-placed transversal motors must be reinforced. The similarity between induced frequencies of the motor and transmission bearings suggests that either the transmission or the driving shaft have very poor dynamic characteristics (the first eigen-frequency should be above 50 Hz). The frequency drop is caused by installed heavy couplings and from the dislocating their centre of mass to 150 mm from driving bearings. Free joint support oscillations with highly developed oscillations in bearings and with high accelerations and response amplitudes are also shown.

Slika 20. Vertikalno ubrzanje u vremenskom (levo) i gustina spektra u frekventnom domenu (desno)
Figure 20. Vertical acceleration in time (left) and spectrum density in frequency domain (right).

Successful transmission operation in the following four months (until replacement for other reasons) was achieved only by increasing the rigidity of transversal motor beams. It was impossible to replace the coupling with a lighter one.

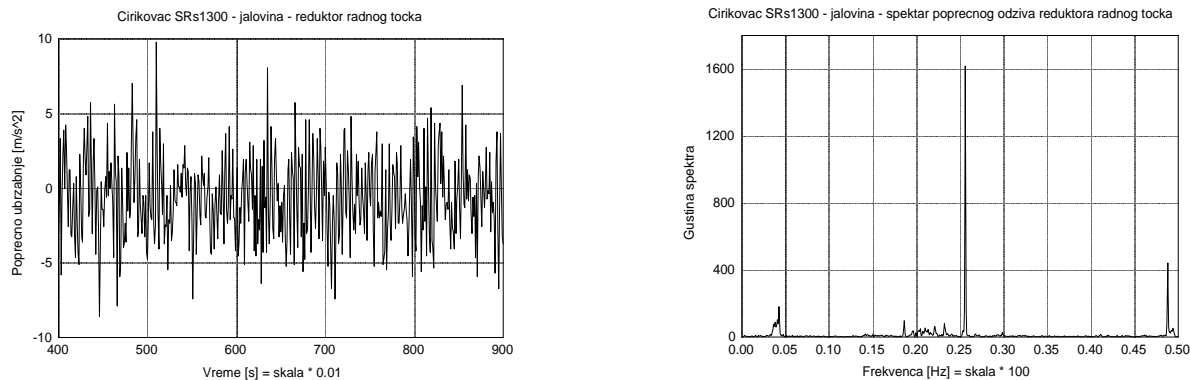
Slika 27. Poprečno ubrzanje u vremenskom (levo) i gustina spektra u frekventnom domenu (desno)
Figure 27. Transversal acceleration in time (left) and spectrum density in frequency domain (right).

Comment on measuring: the accelerations overpasses allowed values ($a_{dmax} = 2 \text{ m/s}^2$); the response of the digging system is a strong signal at frequencies 3, 4, 12, 14, 18, 25, and 49 Hz, and slightly weaker at frequencies 2, 5, 7, 9, 13, 15, and 23 Hz, and these frequencies are tightly correlated to the induced and eigen frequencies of digging transmission, i.e. the transmission may easily approach resonance in operation. This transmission had suffered failure. This type of transmission had failures and still has operating problems also at other basins. This confirms that poor behaviour is identified. Replacement, or global revitalisation of the digging transmission is recommended.
