**ISPITIVANJE PRITISKOM KAO UZROČNIK POJAVE PRSLINA
KOD OPREME POD PRITISKOM U EKSPLOATACIJI**
**PROOF PRESSURE TEST AS A CAUSE OF CRACK OCCURRENCE
IN PRESSURIZED EQUIPMENT IN SERVICE**

Originalni naučni rad / Original scientific paper

ABSTRACT

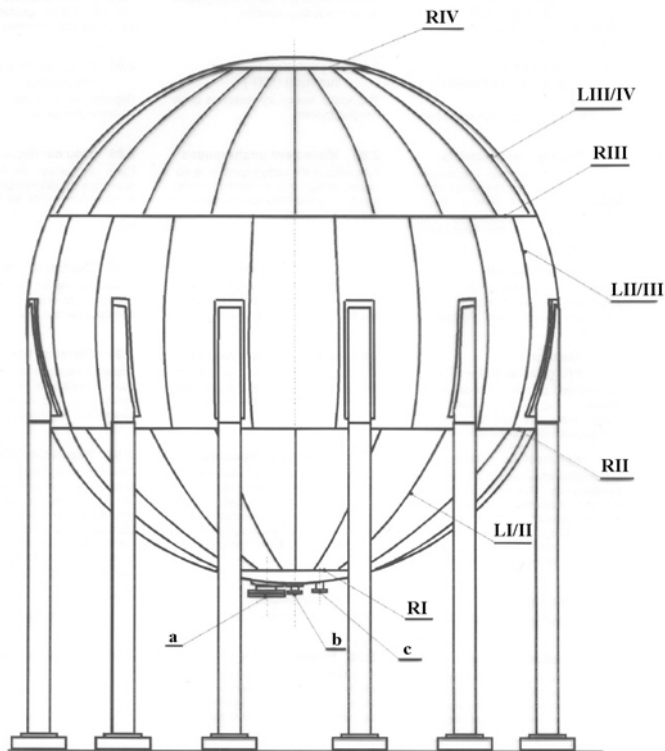
Slika 1. Sferni rezervoar

Figure 1. Spherical storage tank

- The cracks are typically located on the inner vessel side (Fig. 2), as longitudinal cracks (a) in weld metal or in heat-affected zone (HAZ), Of all tested vessels, only on one vessel the cracks were detected in the joint between the mantle and lid on the outer side, and on one vessel in the joint between support reinforcement and mantle. Only on one sphere the defects in columns are detected. In three cases the cracks were detected in parent metal (Fig. 2c), and their origin is probably the tack welding of temporary holders during sphere manufacturing. In some cases during grinding operation it had been confirmed that the crack ends in the pore or inclusion, involved during manufacturing. In all tested spheres cracks most frequently occurred in radial welded joints (R, Fig. 1), in

all tested spheres, typically in its middle (upper) part, at the border between liquid and gaseous phase.

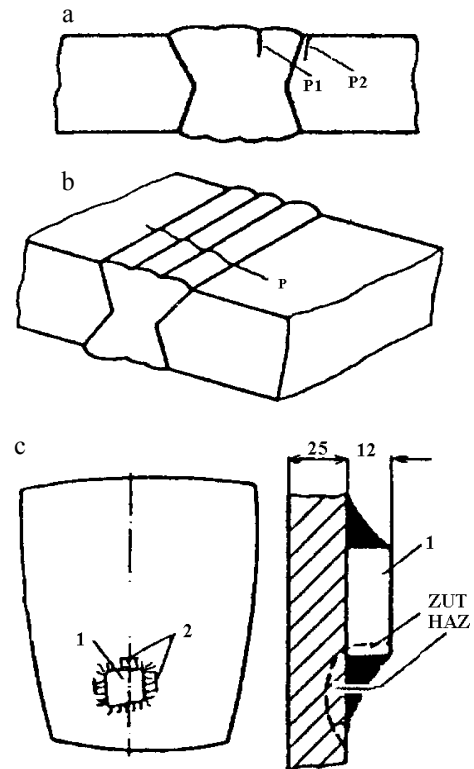
- By in-service testing of these vessels the cracks in welded joints have been detected, of different direction, length and depth (Fig. 2). The occurrence of cracks is particularly expressed in fine-grain microalloyed high strength steels, but the cracks were also detected in tanks of carbon steels after long-term service, as well as in fine-grain structural steels (for ammonia).

Slika 2. Karakteristične prsline u sfernom rezervoaru

Figure 2. Typical cracks in spherical storage tank

All together, it can be stated that the cause of crack initiation is local overstressing induced by the effect of test pressure. Therefore, the revised repair technology for this tank includes hammering of welded joints as well, in order to reduce residual stress.

- The experience has shown that the pressure vessel repaired by welding should not be subjected to pressure testing, but only to test periodically by ultrasonic the typical repaired positions from the outer side, e.g.:

- Immediately after repair (so-called "initial" state).
- After operating parameters are reached. If in these tests no crack has been detected, the tests should be repeated every 6 to 12 months, until the term of regular proof test.
