INTEGRITET CEVOVODA HIDROELEKTRANE

INTEGRITY OF PENSTOCK OF HYDROELECTRIC POWERPLANT

Originalni naučni rad / Original scientific paper
UDK /UDC: 621.643.2-112.81 669.15-462-112.81
Rad primljen / Paper received: 10.09.2005.

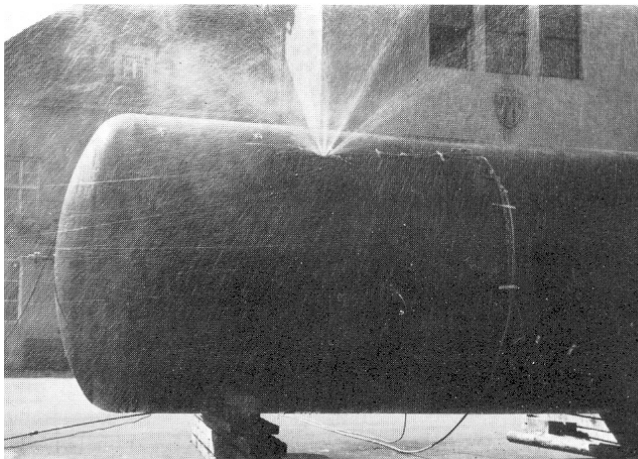
Na sl. 3. je prikazan prototip, isečen iz cevovoda i zatvoren kao posuda, u trenutku procurivanja pri pritisku od 29,8 bara, i ukupnoj deformaciji između 0,001 i 0,0001, zavisno od mernog mesta. Tome je odgovarao obimni napon od 240 MPa.

Figure 3 presents the prototype, cut from the penstock and closed to form a pressure vessel, in an instant of leak at pressure 29.8 bar, and total strain between 0.001 and 0.0001, depending on measuring point. Corresponding hoop stress was 240 MPa.

Slika 3. Procurenje prototipa cevovoda pri hidrostatičkoj probi
Figure 3. Leakage of penstock prototype during proof pressure.

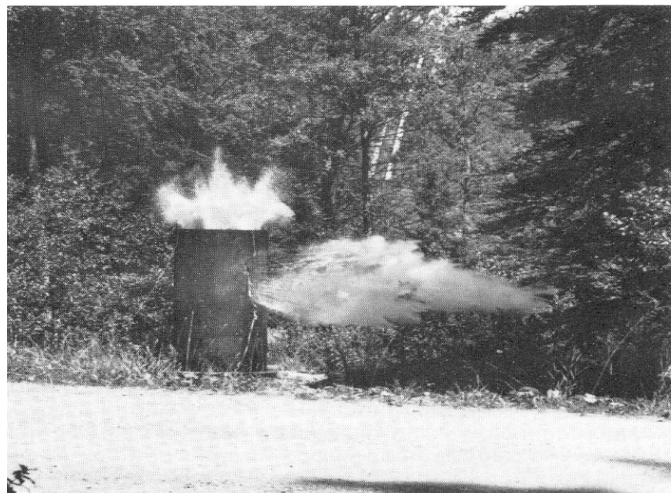
Na sl. 4. je prikazan prototip u trenutku eksplozije pri pritisku od 42 bara. Na osnovu izvedenih ispitivanja prototipova bilo je moguće napraviti dijagram sigurnosti od

Figure 4 presents the prototype in an instant of explosion at the pressure of 42 bar. Based on performed testings it was possible to design a diagram of safety against burst as

Slika 4. Eksplozivna proba prototipa
Figure 4. Explosion test of prototype.

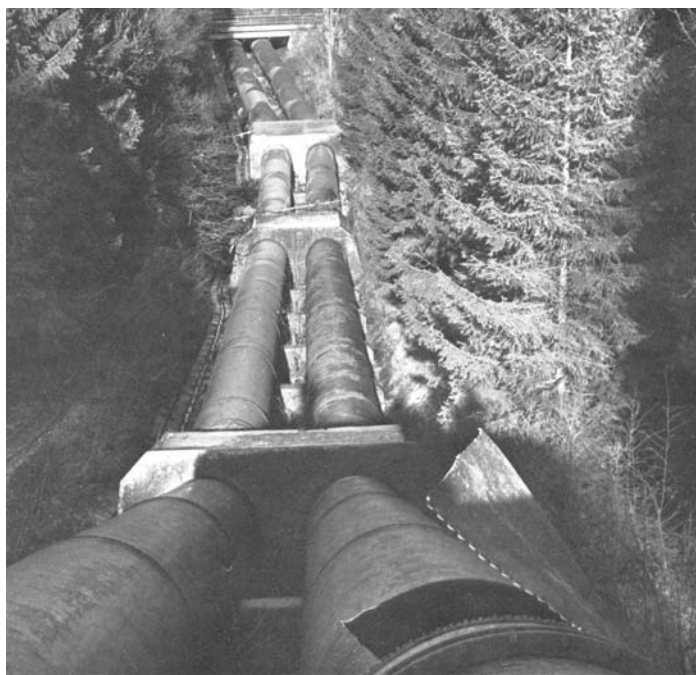
Slika 6. Krti lom cevovoda pri ispitivanju vodenim pritiskom
Figure 6. Brittle fracture of penstock during water proof pressure test.

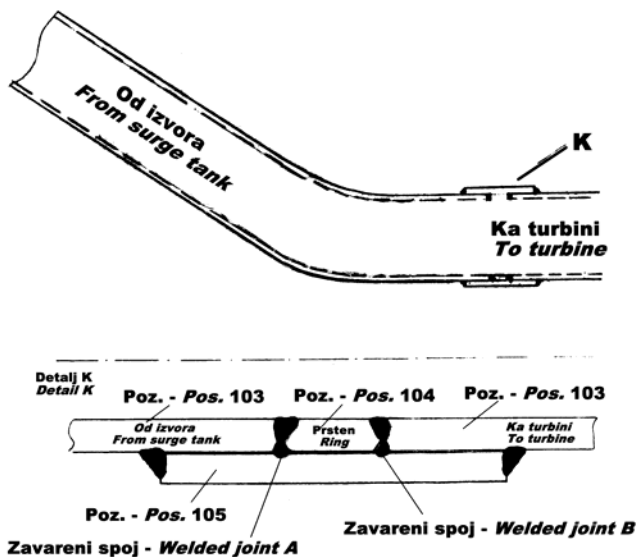
Prsline su se pojavile u zavarenom spoju prstena širine 100 mm, sastavljenom od 6 segmenata po obimu (poz. 104 na sl. 7). Prečnik dovodnog cevovoda (poz. 103 levo) se sa 4000 mm smanjuje na 3400 mm na uvodu (poz. 103 desno) u turbinu. Kako su ta dva cevovoda izradili različiti proizvođači, došlo je do veće nesaosnosti i većeg razmaka krajeva, što je rešeno obujmicom, koja se zavaruje pre prstena i prima opterećenje preko ugaonih spojeva (poz. 105), dok prsten služi kao ispuna. Posle zavarivanja je tunel oko cevovoda ispunjen betonom, a cevovod iznutra zaštićen premazom. Za obujmicu i prsten je izabran čelik napona tečenja 450 MPa, mikrolegiran sa vanadijumom. Posle 10 godina eksploatacije uočene su brojne prsline, dužine i nekoliko stotina milimetara, na oba zavarena spoja prstena „A” i „B” (sl. 8), od kojih su neke probile šav i doprle do ugaonog šava poz. 105, odnosno u prostor između obujmice i prstena. Pri pregledu ispražnjenog cevovoda je nađena je voda u prslinama, što je potvrdilo da je dubina prsline dostigla debljinu prstena, odnosno cevi. Praćenje prsline je pokazalo da one ne rastu ili da rastu sporo.

Ispitivanja su pokazala da su u pitanju hladne prsline, koje su se pojavile zbog nedovoljnog predgrevanja i zbog krutosti cevovoda pri zavarivanju prstena, a jednom inicirane rasle su dalje pod uticajem korozije. Od značaja za njihovu pojavu je i preopterećenje koje je cevovod pretrpeo u početnoj fazi rada, praćeno vibracijama. Prsline nisu direktno ugrožavale integritet konstrukcije, ali su dovele do kontakta unutrašnjeg zavarenog spoja obujmice sa vodom, što u sadejstvu sa delujućom koncentracijom napona može da inicira prsline i u nosećem spoju obujmice. Zbog toga je izvedena sanacija zamenom svih segmenata prstena.

Cracks occurred in welded joint of a ring, 100 mm wide, consisting of 6 circumferential segments (pos. 104 in Fig. 7). The diameter of penstock (pos. 103 left) is reduced from 4000 mm to 3400 mm in inlet line for turbine (pos. 103 right). Since two pipelines were produced by different manufacturers, significant misalignment and end distance occurred, what was solved by wrist, welded before the ring and accepting the loading by fillet welds (pos. 105), while the ring served to fill the gap. After welding the tunnel was filled with the concrete outside penstock, and penstock protected inside by lacquer. Steel of 450 MPa yield stress microalloyed by vanadium, was selected for wrist and ring. After 10 years of service numerous cracks were revealed, several hundreds millimeters long, in both ring welded joints „A” and „B” (Fig. 8), some of them passing through the weld and reaching fillet weld of pos. 105, i.e. the space between wrist and ring. During the examination of emptied penstock the water was found in cracks, confirming that crack depth reached the thickness of the ring, i.e. tube. The monitoring of cracks showed that they did not grow, or grow slowly.

The examination had shown that cold cracks are in question, occurred due to improper preheating and the rigidity of penstock at ring welding, and once initiated developed further under effect of corrosion. Significant for their occurrence was an overloading of penstock in early stage of service, followed by vibrations. Cracks did not endanger directly the integrity of structure, but affected the contact of inner welded joints of wrist with the water, what in addition to acting stress concentration could initiate cracks also in loaded welded joint of wrist. For this reason the repair is performed by change of all segments of a ring.

Slika 7. Konstrukcijsko rešenje obzjmice (poy. 105) i prstena (poz. 104) za spajanje krajeva cevovoda
 Figure 7. Design solution of obzjmica (pos. 105) and ring (pos. 104) for joining of penstock ends.

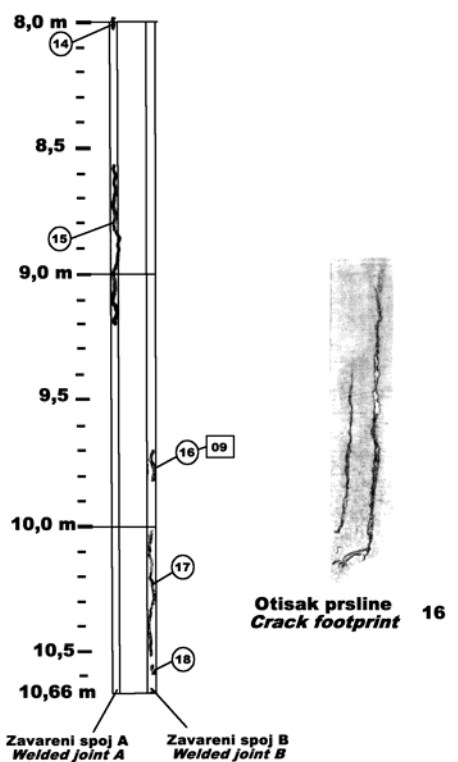
Slika 8. Delimični prikaz rasporeda prsline na kružnim spojevima prstena
 Figure 8. Part presentation of cracks didistribution on circumferencial welded joints of the ring.

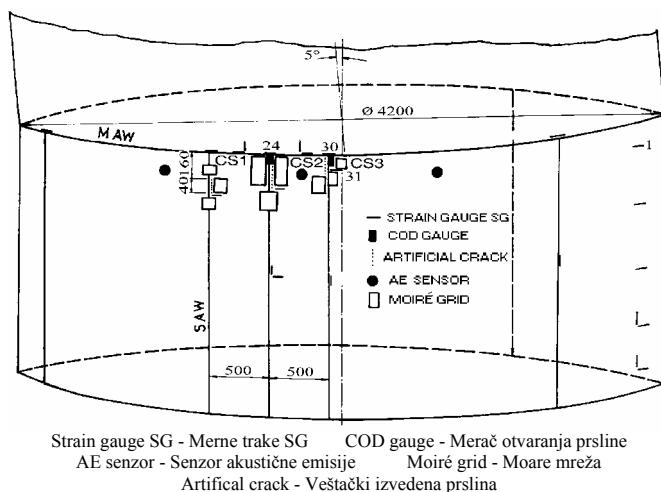
Figure 10 shows the disposition of instrumentation, the artificial surface cracks CS2 and CS3, starting in weld crossings and spreading along longitudinal welds, and crack CS1 embedded in the third longitudinal weld. The instrumentation consisted of two crack opening displacement (COD) gauges (over CS2 and CS3), 22 strain gauges, 9 moiré grids, 3 acoustic emission sensors, pressure transducer and a measuring system of outer periphery elongation.

Surface cracks CS2 and CS3 in weldment were sharpened by controlled explosion from machined notches to final size (CS2:180 × 4.3 mm; CS3:50 × 6 mm) in order to obtain similarity to fatigue crack, required by fracture mechanics tests. The embedded crack CS1 (sized 40 × 3 mm) was made during welding process.

Slika 10. Pripreda omotača prototipa za ispitivanje raspucavanjem
 Figure 10. Preparation of prototype mantle for burst test.

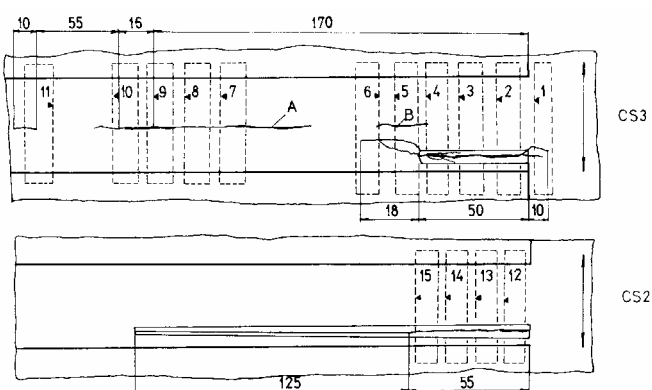
Interesantno je uočiti da plastična deformacija prati brzinu eksplozivnog opterećenja, što ukazuje na stabilni rast prsline, kako je i naknadno utvrđeno akustičnom emisijom, za pritisak 117 bar (drugo statičko opterećenje) i 140 bar (treće statičko opterećenje, uz zadržavanje dva časa). Tek kada se pritisak približavao nivou od 151 bar u trećem statičkom opterećenju akustična emisija je počela naglo da raste, ukazujući na nestabilni razvoj prsline /9/. Eksperiment je zaustavljen, jer je opasnost od brzog loma postala očigledna. Ispitivanje bez razaranja područja sa prslinama je pokazalo da je prsina CS3 napredovala za 28 mm u dužinu (10 mm i 18 mm na stranama, sl. 11), dok prsina CS2 nije napredovala u dužinu. Dve nove prsline, nastale u ispitivanju, označene su sa A i B na sl. 11.

Detaljna analiza je pokazala da se lom razvijao kroz krto područje ZUT, blizu linije stapanja. Kako krto područje može biti vrlo usko, jasno je da vrh prsline ne može biti precizno postavljen u njemu i da izvesna energija mora biti utrošena pre nego što započne brzi, krto lom.

It is interesting to note that the plastic deformation could follow the explosion loading rate, indicating stable crack growth, as additionally confirmed by acoustic emission, for the pressure of 117 bar (second static loading) and 140 bar (third static loading for 2 hours holding). Only when approaching the pressure of 151 bar in the third static loading, acoustic emission started to grow significantly, indicating unstable crack propagation /9/. The experiment was stopped, since the danger of fast fracture became obvious. The non-destructive examination of pre-cracked region showed that CS3 crack propagated for 28 mm in length (10 mm and 18 mm on sides, Fig. 11), while CS2 crack did not propagate in length. Two new cracks, initiated during testing, denoted by A and B in Fig. 11.

Detailed analysis revealed that fracture developed through brittle region in HAZ, close to fusion line. Since the brittle region can be very narrow it is clear that pre-crack tip can not be positioned precisely in it and some energy must be spent before fast, brittle fracture initiated.

Slika 11. Izgled razvoja prsline posle ispitivanja eksplozijom
 Figure 11. View of crack development after explosion test.
