SANACIJA OŠTEĆENJA U CILJU OBNAVLJANJA INTEGRITETA REAKTORA I PRODUŽETKA VEKA EKSPLOATACIJE

REACTOR DAMAGE OVERHAUL IN THE COURSE OF INTEGRITY RESTORING AND SERVICE LIFE EXTENSION

Stručni rad / Professional paper

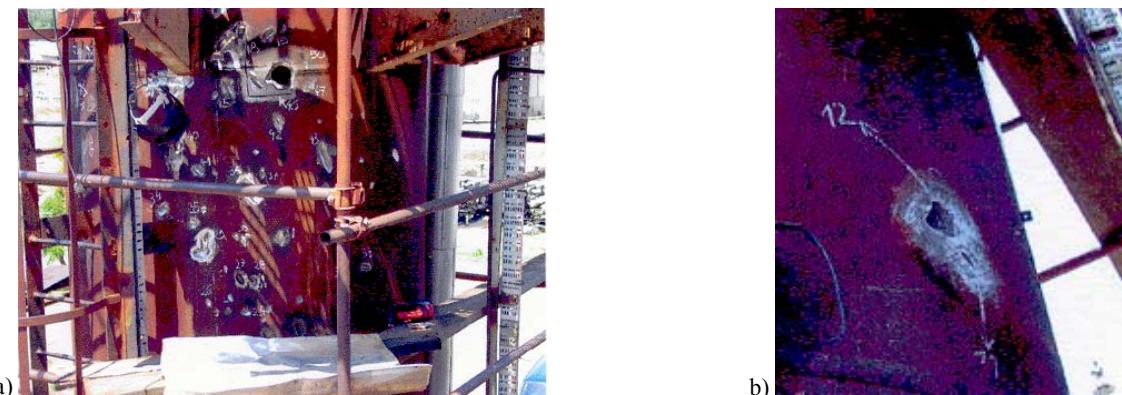
Nakon izvršene pripreme i čišćenja, prema programu su izvršena ispitivanja bez razaranja, kojima je utvrđeno 79 kraterskih oštećenja različitih veličina, dubine do 40 mm, i na poz. 46 probaj nepravilnog oblika (sl.1). Tipična oštećenja su uvećano prikazana sa spoljašnje i unutrašnje strane na sl. 2: (a) probaj, poz. 46, (b) krater, poz. 40, sa prslinama na spoljašnjoj strani izazvanim velikom deformacijom, što je nađeno i na poz. 68, i (c) krater, poz. 48.

After finished preparation and cleaning, according the programme non-destructive tests were performed, detecting 79 crater-like-damages of different size, up to 40 mm deep, and at location 46 a perforation of irregular shape (Fig. 1). Typical damages on exterior and interior are presented enlarged in Fig. 2: (a) perforation, loc. 46, (b) crater, loc. 40, with cracks on the exterior produced by large strain, what is found also at loc. 68, and (c) crater, loc. 48.

Slika 1. Tipična oštećenja sa spoljašnje strane reaktora R-50201: a) brojni krateri i b) proboj (poz. 46)
Figure 1. Typical damages on the reactor R-50201 exterior: a) numerous craters and b) perforation (loc. 46).

Projekt definiše da se sanacija svih nađenih oštećenja izvede brušenjem, reparaturnim zavarivanjem sa spoljašnje i unutrašnje strane reaktora, a na poz. 46 (probaj), predviđena je ugradnja cevnog priključka sa slepom prirubnicom.

Repair of all detected damage is provided by grinding, repair welding on the reactor exterior and interior, and on loc. 46 (perforation), the pipe connector with a blind flange is provided.

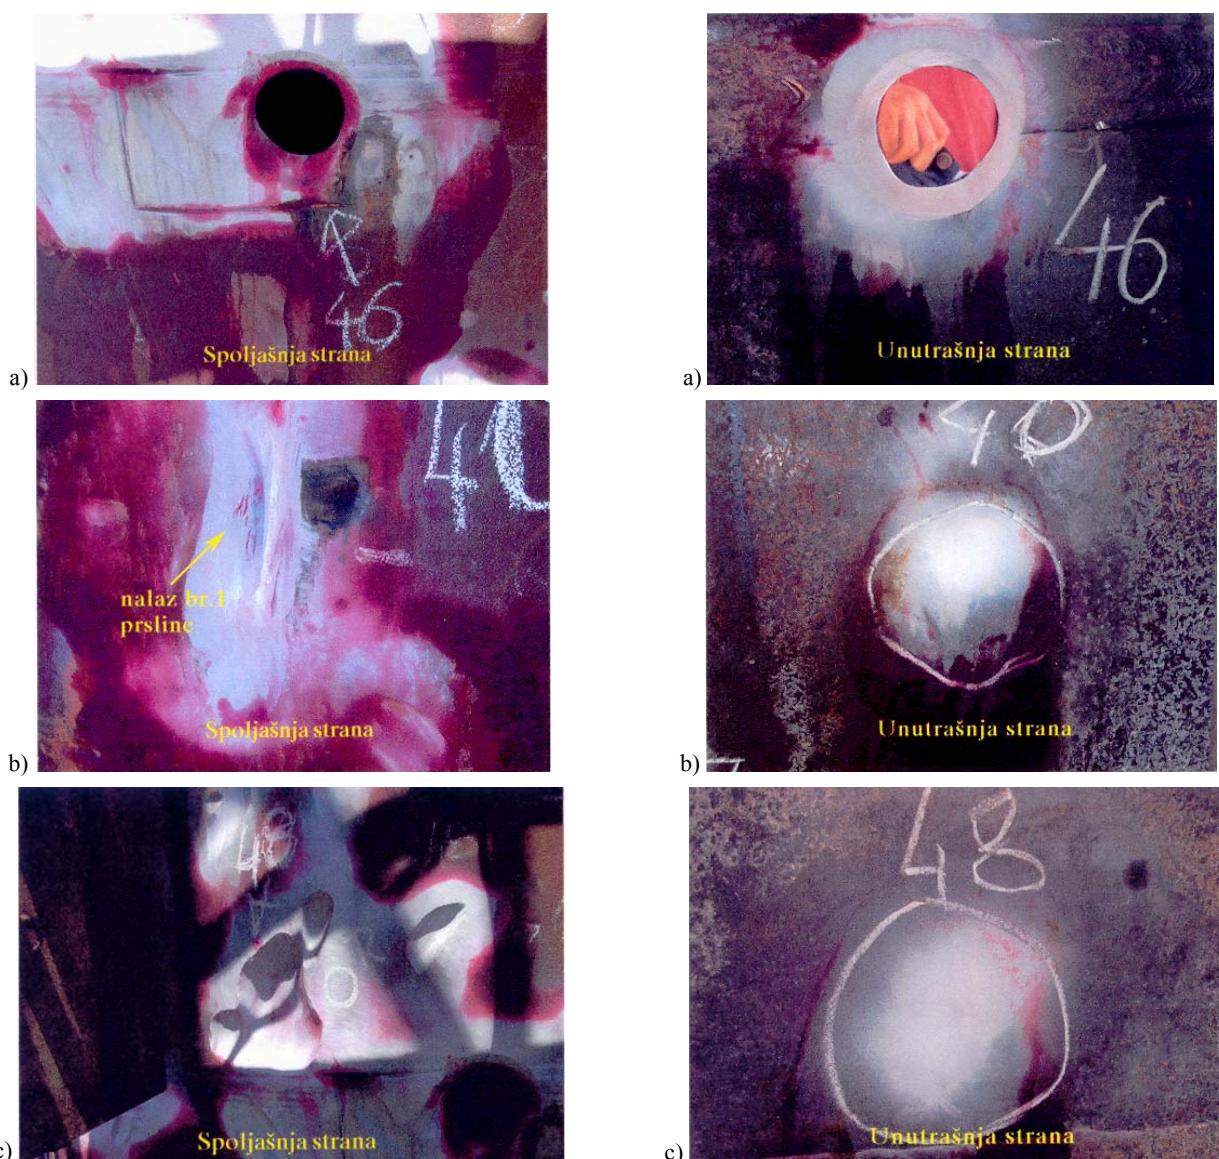
Slika 2. Tipična oštećenja reaktora R-50201 izazvana bombardovanjem: (a-gore) - proboj (poz. 46); (b-sredina) – krater dubine 34,7 mm (poz. 40) sa prslinama na spoljašnjoj strani i ispupčenjem kladininga na unutrašnjoj strani; (c-dole) - krater dubine 21,9 mm (poz. 48)
Levo – spoljašnja strana; desno unutrašnja strana

Figure 2. Typical damages of reactor R-50201 caused by bombardment: (a-up) – perforation (loc. 46); (b-middle) – crater 34,7 mm deep (loc. 40) with cracks on exterior and bulge of cladding on interior; (c-down) – crater 21,9 mm deep (loc. 48)
Left – exterior; right - interior

- Mechanically clean deep and large craters, where bulging of cladding are located on the inside, in a way to remove at least 1 mm and produce a clean surface without notches, overlaps or other defects. On craters loc. 40 and 68 completely remove by grinding to required depth the cracks detected by penetrants

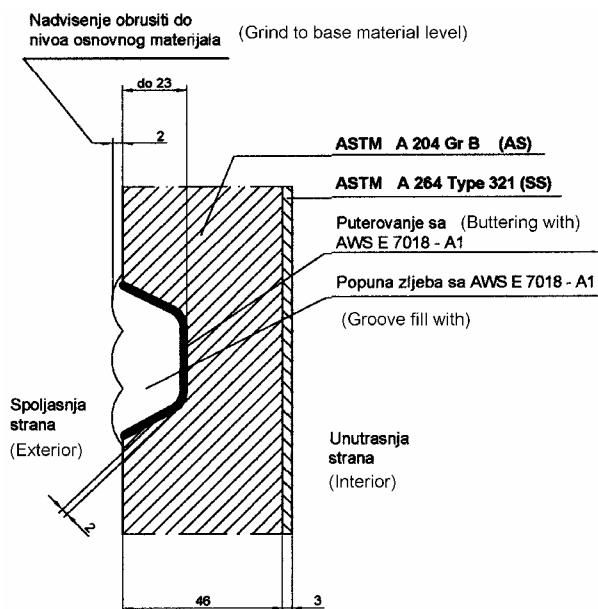
Slika 3. Reparaturno zavarivanje kratera sa spoljašnje strane plašta, bez deformacije kladinga sa unutrašnje strane reaktora.

Figure 3. Repair welding of craters on the exterior of skin structure, with no cladding deformation on the interior.

Initial repairs were performed by welding craters on the skin exterior, with no deformed cladding in the interior (*Technology for reactor R-50201 overhaul*, No. 194-17).

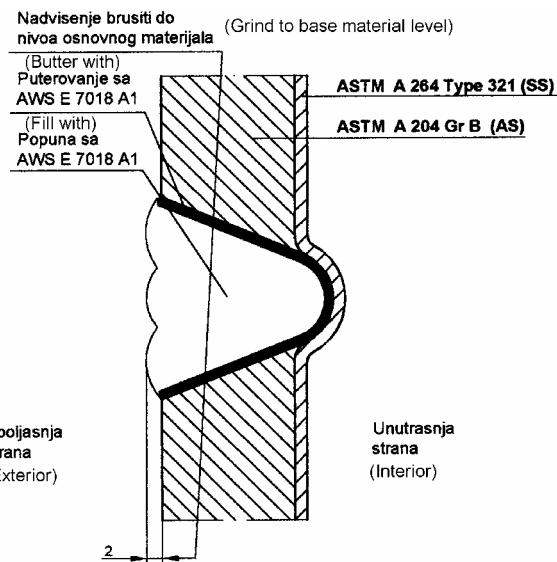
Slika 4. Krateri sa spoljašnje strane plašta sa deformacijom kladinga sa unutrašnje strane reaktora (pozicije: 37, 40, 48, 68 i 74).

Figure 4. Craters on the outer skin structure with deformed cladding on the inner reactor surface (locations: 37, 40, 48, 68 and 74).

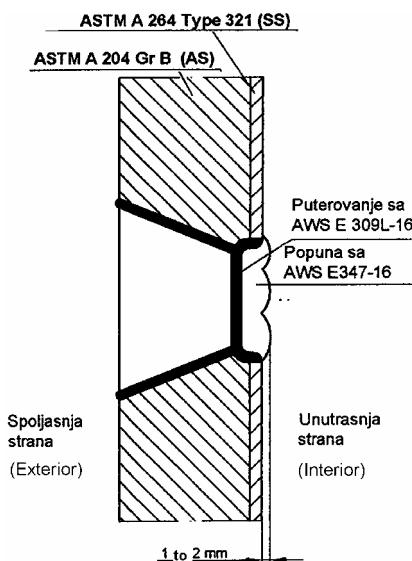
Slika 5. Kladiranje zavarivanjem, nakon brušenja deformisane zone kladinga sa unutrašnje strane.

Figure 5. Cladding by welding, after grinding, of the deformed cladding zone on the interior.

Finally, the deformed zone of the cladding (loc. 40) was repaired on the interior (*Technology*, No. 194-20).

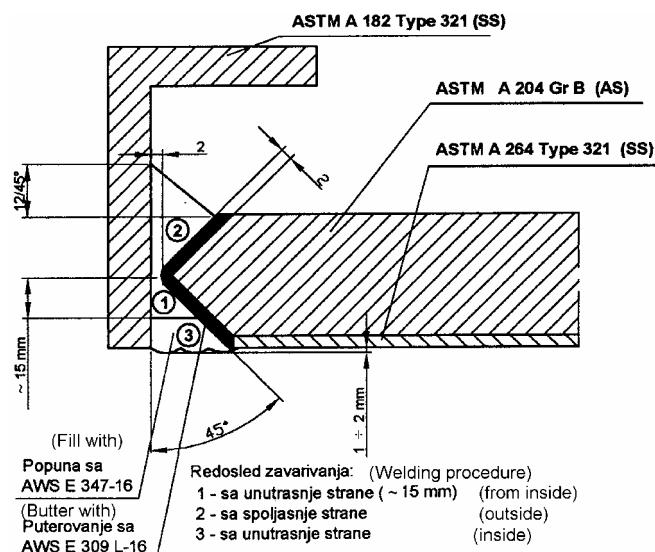
Slika 6. Zavarivanje priključka na mestu probroja nakon puterovanja žleba.

Figure 6. Welding of the connector at the perforation after groove buttering

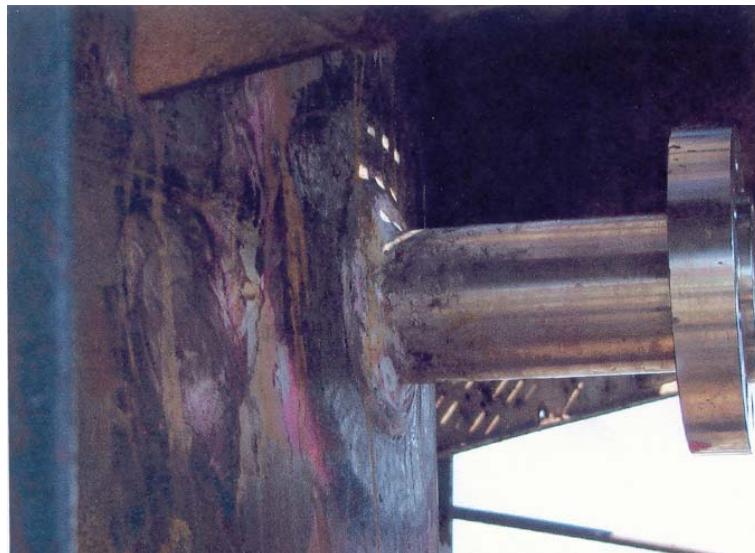
Slika 7. Cevni priključak sa spoljašnje strane nakon ugradnje, zavarivanja i ispitivanja (poz. 46).
Figure 7. Tube connector at exterior after placement, welding and testing (loc. 46).

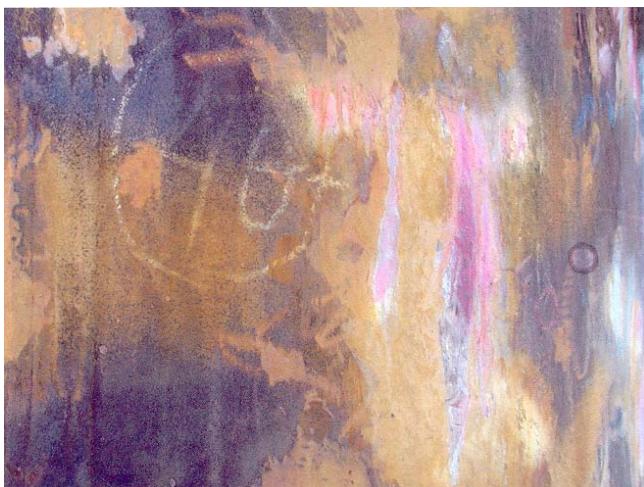
Slika 8. Izgled pozicije 40 sa spoljašnje strane nakon reparaturnog zavarivanja i ispitivanja.
Figure 8. View of location 40 on exterior after repair welding and testing.

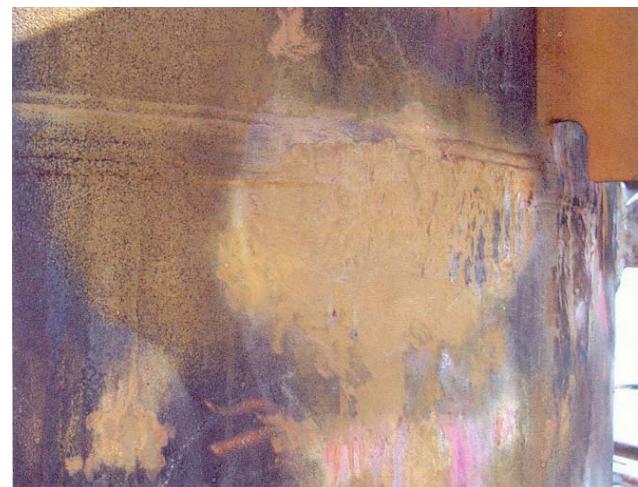
Slika 9. Izgled pozicije 37 sa spoljašnje strane nakon reparaturnog zavarivanja i ispitivanja.
Figure 9. View of location 37 on exterior after repair welding and testing.
