Russell Wanhill

## KRTOST ARHEOLOŠKOG SREBRA I GVOŽĐA **EMBRITTLEMENT OF ARCHAEOLOGICAL SILVER AND IRON**

Originalni naučni rad / Original scientific paper UDK /UDC: 904(37):669, 620.179:669 Rad primljen / Paper received: 10.12.2008.	Adresa autora / Author's address: National Aerospace Laboratory (NLR), Amsterdam, the Netherlands, <u>wanhill@nlr.nl</u>		
Ključne reči	Keywords		
• arheometrija	• archaeometallurgy		
• srebro	• silver		
• gvožđe	• iron		
• krtost	• embrittlement		
konzervacija	conservation

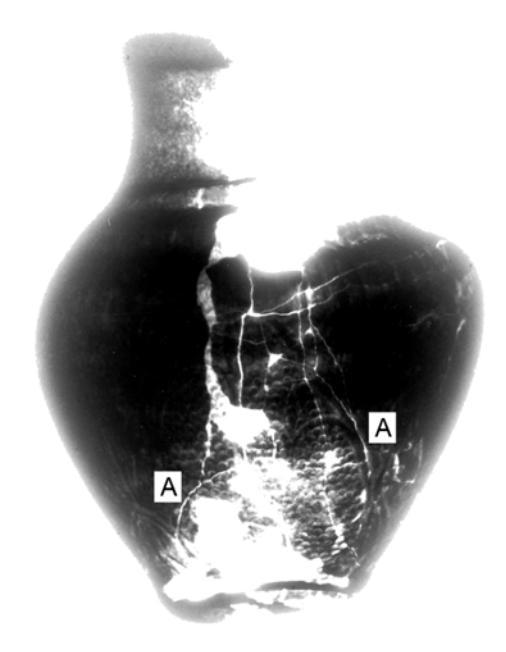
Vaza je ukrašena ugraviranim i utisnutim ukrasima cveća i lotusa i bodljikavog lišća. Radiogram na sl. 2 pokazuje da je vaza detaljno obnovljena (to je stara restauracija, koja datira iz kasnih godina 19.-tog veka). Slika 2 takođe otkriva prsline koje prate spoljnje žlebove gravure i mesta ukrštanja na umreženim prslinama sličnim krtom lomu "ljuske jajeta".

Slika 2. Radiogram egipatske vaze: prsline A slede žleb gravure Figure 2. Egyptian vase radiograph: cracks A follow chasing groove.

Žnačajan aspekt koji se odnosi naročito na restauraciju i konzervaciju, što je ilustrovano egipatskom vazom i vizantijskim nafornjakom. To je uticaj dekorativnog graviranja ili utiskivanja na korozijsko oštećenje. Prsline duž žleba gravure na sl. 2, tumačenje sl. 6, i pojava loma duž kružnog žleba na nafornjaku ukazuju da tankozidni predmeti sa ugraviranim ili utisnutim ukrasima treba da se ispitaju na korozijsko oštećenje posebno na odgovarajućim lokacijama na *unutrašnjim* ili *leđnim površinama*. Ako je to tako, moguće mere sanacije se sastoje u nanošenju zaštitnih prevlaka na te površine, /4/.

An important aspect particularly relevant to restoration and conservation is illustrated by the Egyptian vase and the Byzantine paten. This is the effect of decorative chasing and stamping on the corrosion damage. The cracks along the chasing grooves in figure 2, the interpretation of figure 6, and the breakages along the circular grooves of the paten, suggest that all thin-walled objects with chased or stamped decorations should be examined for corrosion damage especially at the corresponding *internal* or *rear surface* locations. If this is so, a possible remedial measure is to apply a protective coating to these surfaces, /4/.

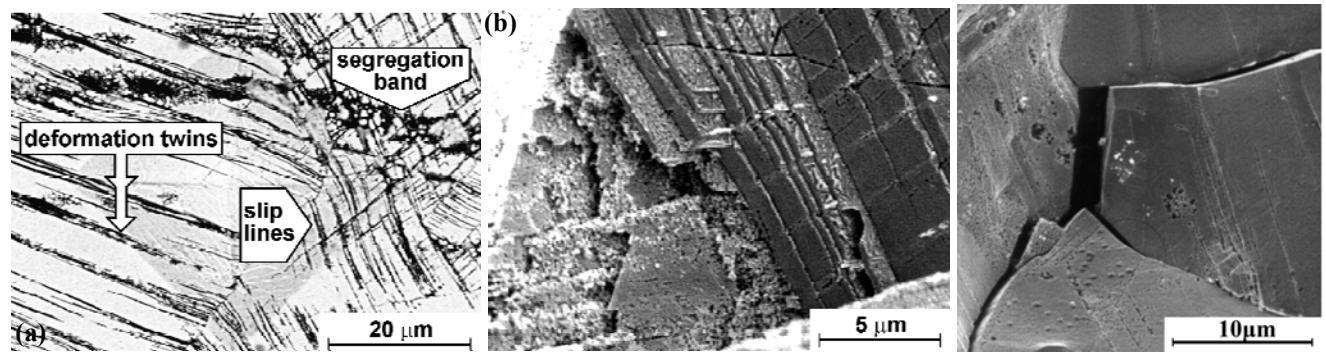
- Pojave krtosti izazvane korozijom duž linija klizanja, deformacija na granicama dvojnika i traka segregacija.
- Krtosti izazvane mikrostrukturom; hemijski sastav (0,7% Pb, nema Bi) upućuje na olovo kao glavni uzrok, /1-4, 8/.
- Sinergijska krtost.

- Corrosion-induced embrittlement along slip lines, deformation twin boundaries and segregation bands.
- Microstructurally-induced embrittlement, chemical composition (0.7% Pb, no Bi) suggests lead as perpetrator, /1-4, 8/.
- Synergistic embrittlement.
- A link between retained cold-work and corrosion damage.

Slika 3. Krtost egipatske vaze izazvane korozijom: a) korozija duž linija klizanja, granica dvojnika i traka segregacija; b) kristalografski prelom zbog korozije duž linije klizanja i dvojnika: SEM snimci

Figure 3. Corrosion-induced embrittlement in the Egyptian vase: a) corrosion along slip lines, twin boundaries and segregation bands; b) crystallographic fracture due to corrosion along slip lines and twins: SEM metallograph and fractograph.

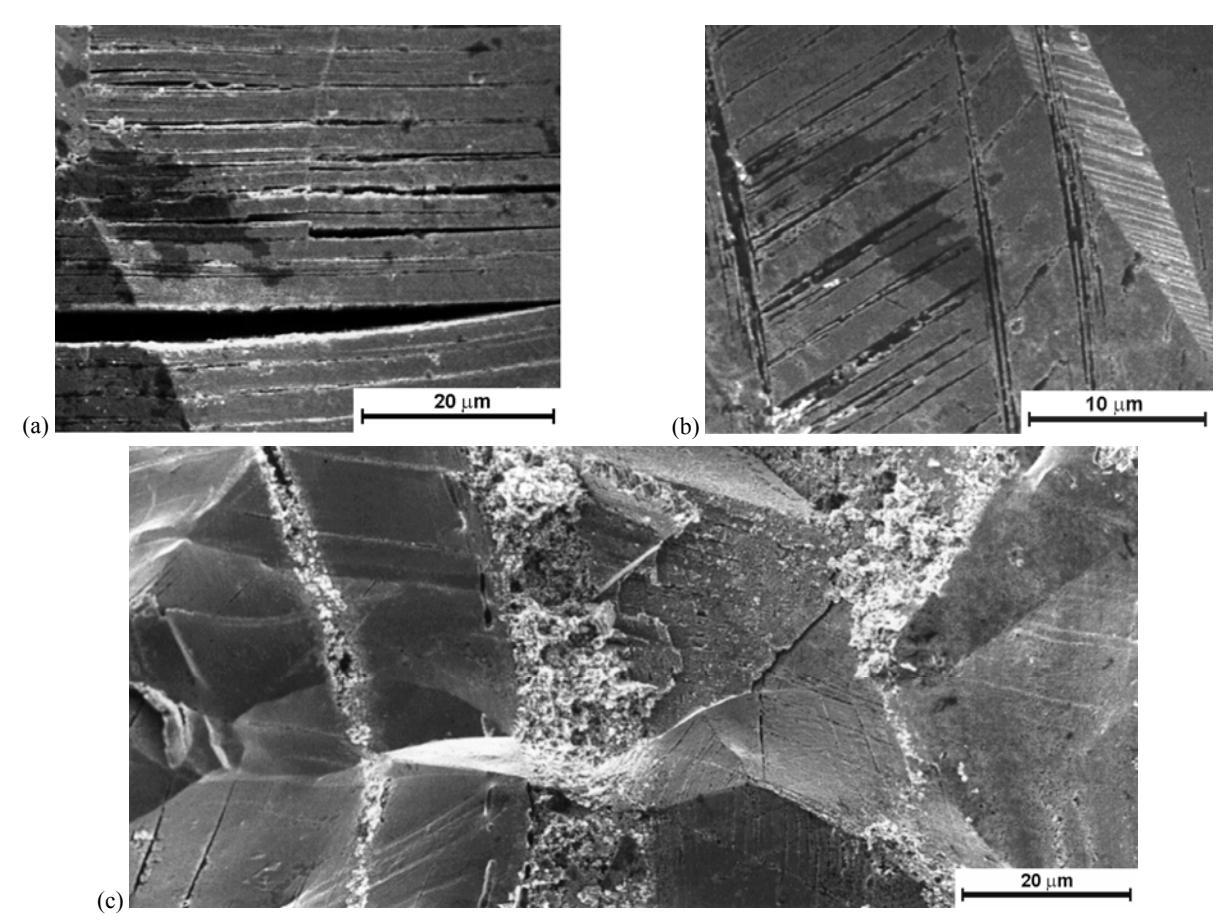
Slika 4. Krti interkristalni lom izazvan prisutnom mikrostrukturom egipatske vaze: SEM snimak Figure 4. Microstructurally-induced brittle intergranular fracture in the Egyptian vase: SEM fractograph.

Slika 5. Sinergijska krtost egipatske vaze: a) korozija (uzrok loma) duž linija klizanja preseca fasete granice zrna; b) korozija duž deformacijskih dvojnika preseca granice zrna; c) korozija duž traka segregacija preseca fasete granica zrna; SEM fraktogrami Figure 5. Synergistic embrittlement in the Egyptian vase: a) corrosion (causing fracture) along slip lines intersecting grain boundary facets; b) corrosion along deformation twin boundaries intersecting a grain boundary; c) corrosion along segregation bands intersecting grain boundary facets: SEM fractographs.

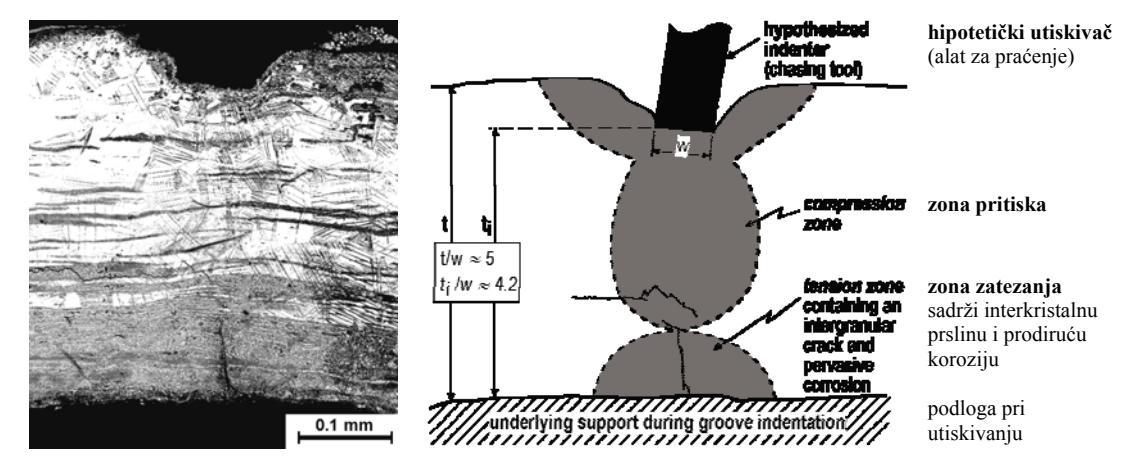
Veze zaostale hladne deformacije i korozijskog oštećenja.
 Na slici 6 je prikazana značajna uzajamna povezanost

zaostale hladne deformacije i korozije. BSE slike otkrivaju oblik lokalne deformacije. Pridružena shema objašnjava ovaj oblik deformacija na osnovu teorije polja linija klizanja od otiska, /9/. Osim područja pritiska, ova teorija predviđa da se, ako je  $t_i/w = 4,4$ , formira zona zatezanja na površini suprotno od otiska: utvrđena vrednost  $t_i/w$  od 4,2, je dovoljno bliska da se ovakvo tumačenje prihvati. Veoma je značajno pri tom da se u zoni zatezanja pojavljuje korozija i interkristalni lom na i u blizini *unutrašnje površine* vaze, što znači da je izazvano "skriveno" oštećenje. The vase is decorated with chased and stamped representations of flowers and lotus and acanthus leaves. The Xray radiograph, Fig. 2, shows that the vase has been much restored (this is an old restoration, done in the late 19<sup>th</sup> century). Figure 2 also reveals cracks following external chasing grooves and criss-crossing in a brittle similar to the "eggshell" crack pattern.

Figure 6 illustrates an especially significant link between retained cold-work and corrosion. The BSE imaging revealed a local deformation pattern. The adjacent schematic interprets this deformation pattern from the slip-line field theory of indentation, /9/. Besides the compression zone, this theory predicts that when  $t_i/w = 4.4$  a tension zone forms from the surface opposite the indentation: the actual value of  $t_i/w$  is 4.2, close enough to justify the interpretation. The significant point is that the tension zone promoted corrosion and intergranular fracture at and near the *internal surface* of the vase, i.e. it caused "hidden" damage.

Slika 6. Struktura preseka dobijena metalografijom povratnog rasejanja elektrona (BSE) i shematski prikaz žleba spolja graviranog ukrasima na egipatskoj vazi. Uzorak je sa donjeg zida vaze.

Figure 6. Through-thickness BackScattered Electron (BSE) metallograph and schematic of an external chased decorating groove in the Egyptian vase. The sample is from the vase lower wall.

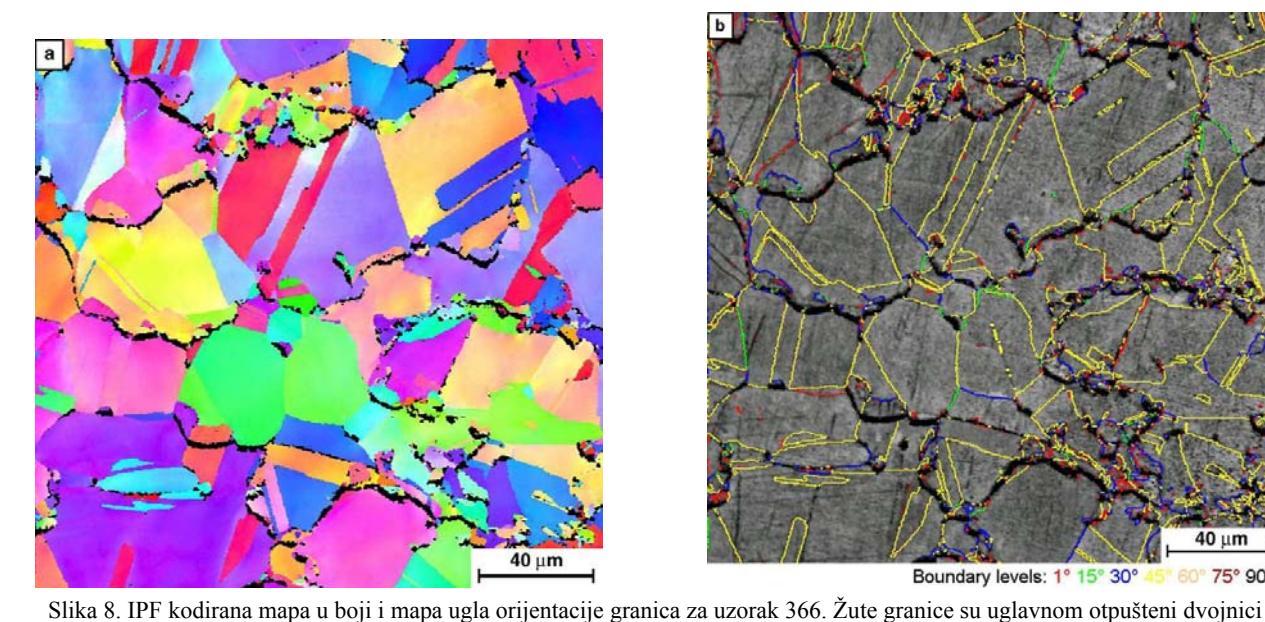
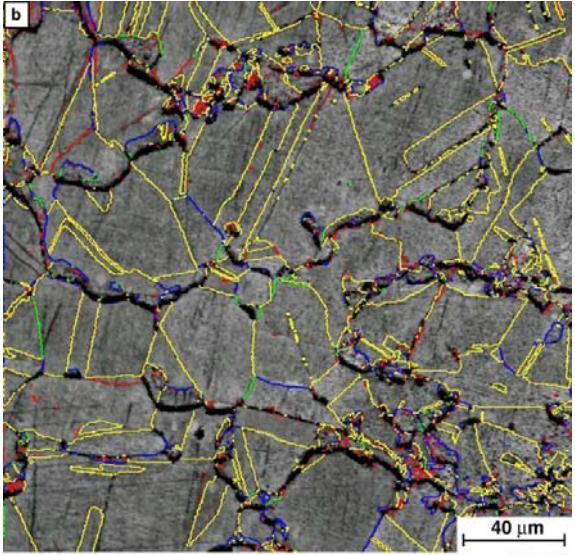
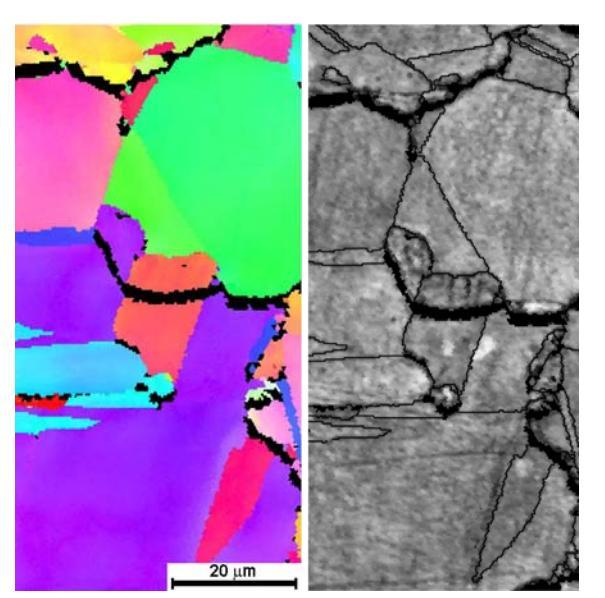
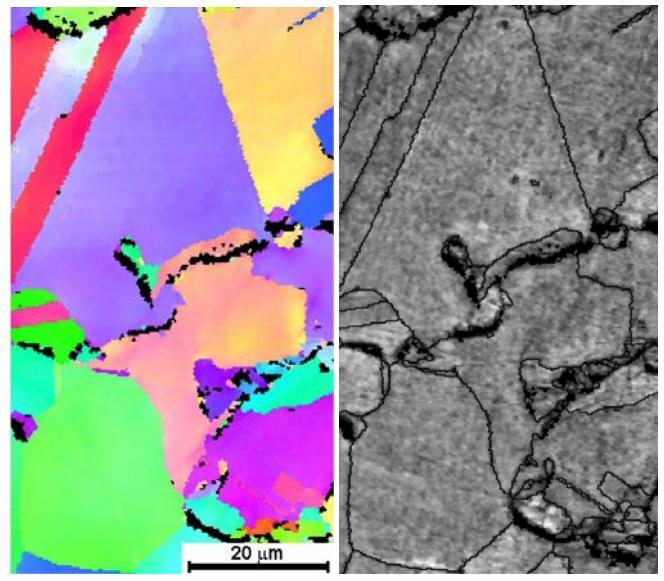
(1) Sample 366: This sample was essentially annealed and corrosion-free, of a random microtexture, Fig. 8a, and extensive grain boundary precipitation of copper, giving the grain boundaries a meandering appearance, Fig. 8b. The details in Fig. 9 prove discontinuous precipitations, /13–15/.

Talog se stvara na prvobitnoj granici "zelenog" zrna, raste u "zeleno" zrno, menja orijentaciju rešetke ka susednom zrnu "purpurne" matrice i "crvenkasto-mrkom" otpuštenom dvojniku.

Precipitate behaviour: nucleation at original "green" grain boundary, growth into "green" grain, changing its lattice orientation to that of the contiguous grain having the "purple" matrix and "reddish-brown" annealing twin.

Talozi se posebno stvaraju na prvobitnoj granici "purpurnih" i "ružičastih" zrna, rastu u suprotnim smerovima: jedan u "ružičasto" zrno, menja pravac rešetke ka susednom "purpurnom" zrnu; a drugi u "purpurno" zrno, pravac ka susednom "ružičastom" zrnu.

Precipitate separate nucleations at boundary between "purple" and 'pink" original grains, growth in opposing senses: one into the "pink" grain, changing its lattice orientation to contiguous "purple" grain; one into the "purple" grain, orientation to contiguous "pink" grain.

Figure 8. IPF colour-coded map and boundary rotation angle map for sample 366. The yellow boundaries are mainly annealing twins.

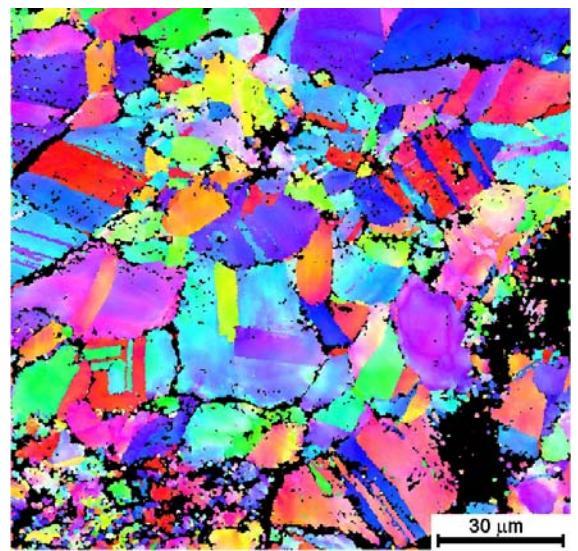
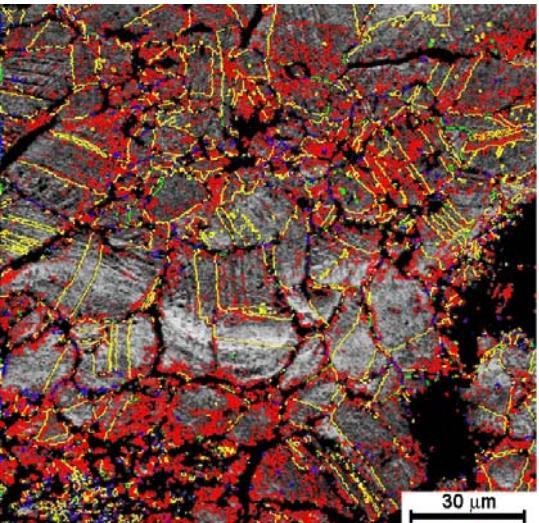
Slika 10. IPF kodirana mapa u boji i mapa ugla orijentacije granica za uzorak 361 Figure 10. IPF colour-coded map and boundary rotation angle map for sample 361.

(2) Uzorci 361, 363, 365: Nađen povećani udeo zaostale hladne deformacije i korozijskog oštećenja. Na sl. 10-12 je zaostala hladna deformacija crveno područje (klizanje) i žuto područje nepravilne granice (dvojnici). Korozijska oštećenja su crna područja, koja predstavljaju uglavnom interkristalne prsline, ali i transkristalne prsline (bolje se vidi na sl. 12a). Međutim, nema dokaza o isprekidanom talogu.

(2) Samples 361, 363, 365: Increasing amounts of retained cold-work and corrosion damage is found. In Figs. 10-12 the retained cold-work are red regions (slip) and irregular yellow boundaries (twins). The corrosion damage are black regions, representing mainly intergranular cracks, but also transcrystalline cracks (best seen in Fig. 12a). However there was no evidence of discontinuous precipitation.

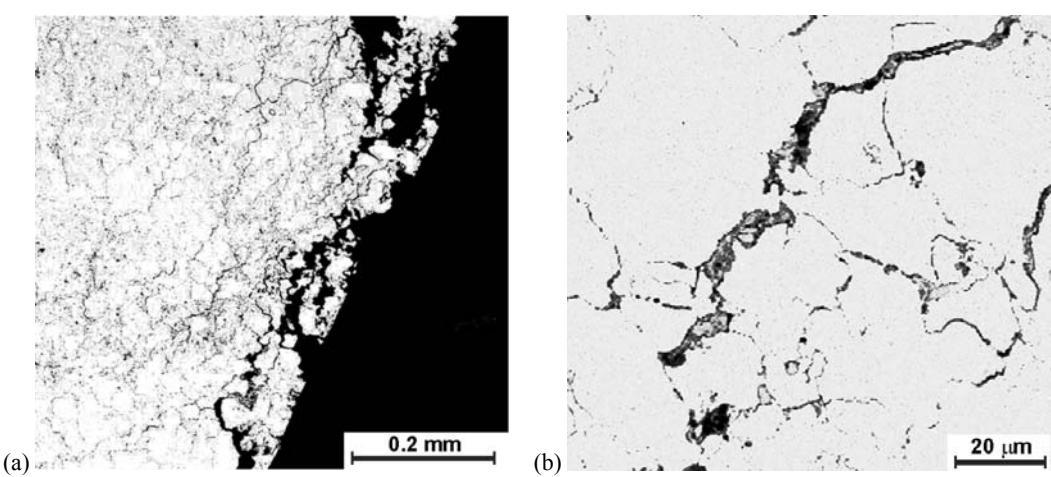
Mali uzorak sa nafornjaka je ispitan SEM metalografijom i pomoću EDX analize u prethodnom istraživanju Holandskog instituta za kulturno nasleđe (ICN) iz Amsterdama. Na uzorku je jasno vidljiva površinska (plitka) interkristalna korozija, sl. 14a, a pri većim uvećanjima se vide i isprekidani talozi bakra na granicama zrna, sl. 14b. Ovi talozi daju grani-

A small sample from the paten was examined by SEM metallography and EDX in a preliminary investigation at the Netherlands Institute for Cultural Heritage (ICN) in Amsterdam. The sample showed surficial (shallow) intergranular corrosion, Fig. 14a, and at higher magnifications discontinuous precipitation of copper at the grain boundaries,

Fig. 14b. This precipitation gave the grain boundaries a meandering appearance, similar to that in Fig. 8b.

Slika 14. Interkristalna korozija (a) i isprekidani talog bakra na granicama zrna (b) na vizantijskom nafornjaku. EDX analiza je pokazala u prvom redu srebro na lokaciji 1, a srebro i bakar na lokacijama 2-4. SEM snimci i analiza ljubaznošću Ineke Justen, ICN

Figure 14. Intergranular corrosion (a) and discontinuous precipitation of copper at grain boundaries (b) in the Byzantine paten. EDX analyses showed primarily silver at location 1, and silver and copper at locations 2-4. SEM metallographs and analyses courtesy of Ineke Joosten, ICN.

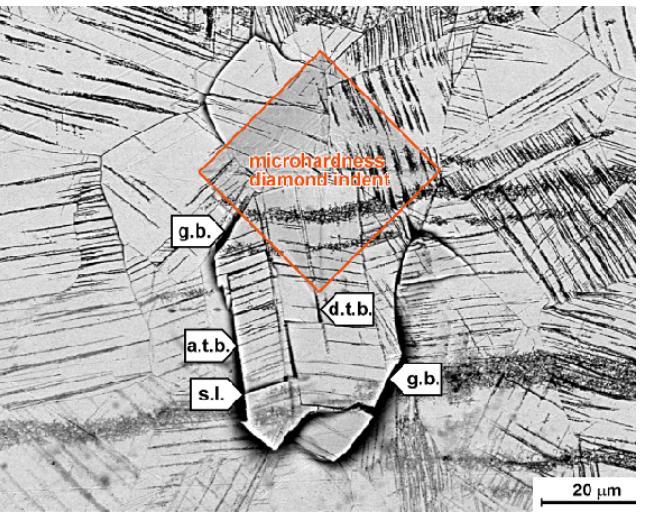
Slika 15. Ispitivanje tvrdoće za krtost srebra: egipatska vaza, SEM snimak (oznake prslina: b.g.– na granici zrna; s.l.– na liniji klizanja; d.t.b.–na granici deformacionog dvojnika; a.t.b.–na granici otpuštenog dvojnika). Tekst na slici: mikrotvrdoća otisak dijamanta. Figure 15. Microhardness test for silver brittleness: Egyptian vase, SEM metallograph (key: b.g.–grain boundary crack; s.l.–slip line crack; d.t.b.–deformation twin boundary crack; a.t.b.–annealing twin boundary crack).

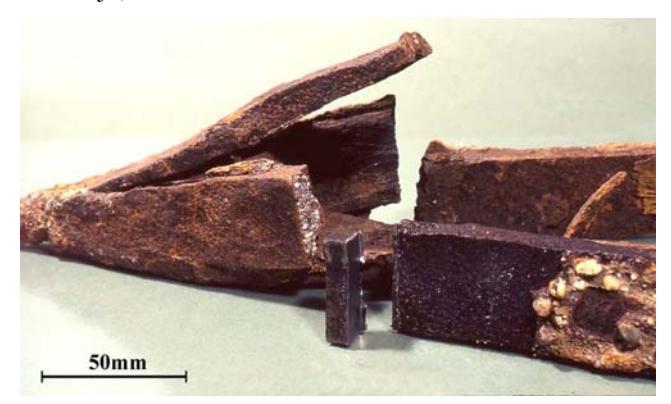
Odsečeni komad, sl. 16, je čekićem udaren na bočnoj površini, što je dovelo do krtog loma u veće fragmente. Tako je potvrđena udarna krtost na temperaturi okoline na mestu inicijalnog preloma. Fragmenti su zatim podvrgnuti istraživanju, tab. 2.

Slika 16. Prelomljena stopa sa odsečenim delom i gornjom prelomljenom pvršinom nedavnog loma Figure 16. The broken pile-shoe with a sawn-off slice with the upper fracture surface of the recent break.

Figure 16 is a detail of the pile-shoe, showing all three broken bars and the sawn-off slice, which included the upper fracture surface of the recent breakage. "N" indicates nail head attaching it to the wooden pile. Figure 17 is a macrophotograph of the lower fracture surface. During the centuries in the riverbed the bar corroded evenly to about 0.5 mm. The large internal fracture consisted of shiny uncorroded facets, some of which up to 3 mm in diameter. This unusual and obviously brittle fracture prompted a collaborative investigation using several diagnostic techniques.

The sawn-off slice, Fig. 16, was struck on a side surface with a hammer, resulting in brittle fracture to large fragments. This confirmed the ambient temperature impact brittleness at the location of the original breakage. The fragments were then used for the investigation, Table 2.

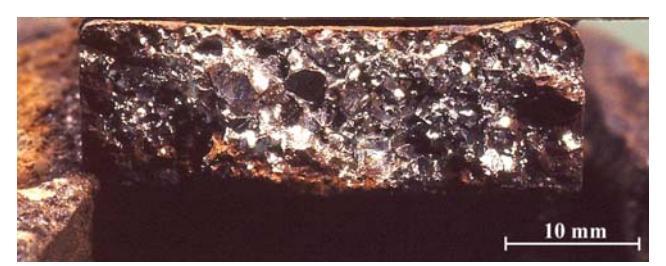
Slika 17. Donja površina preloma nedavnog loma Figure 17. The lower fracture surface of the recent break.

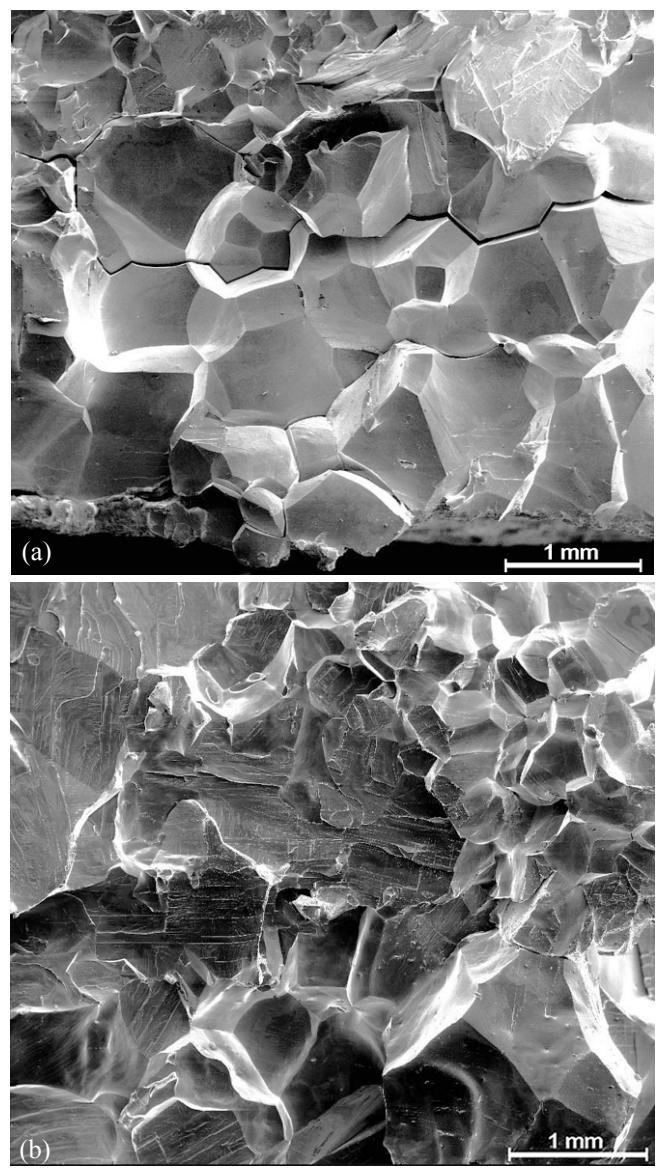
Summarised results for the main topics in Table 2 are: (1) *Fractography:* Figure 18 shows FEG-SEM images of the brittle fracture, which was almost entirely intergranular at, and near the outside surfaces, and a mixture of intergranular and cleavage fracture towards the centre of the bar. The grain size varied from 0.25 mm to more than 2 mm.

Slika 18. FEG-SEM fraktografije uzorka odsečenog dela: (a) na, i blizu spoljnje površine, (b) bliže centru Figure 18. FEG-SEM fractographs of a sample from the sawn-off

slice: (a) at, and near the external surface, (b) nearer the centre.

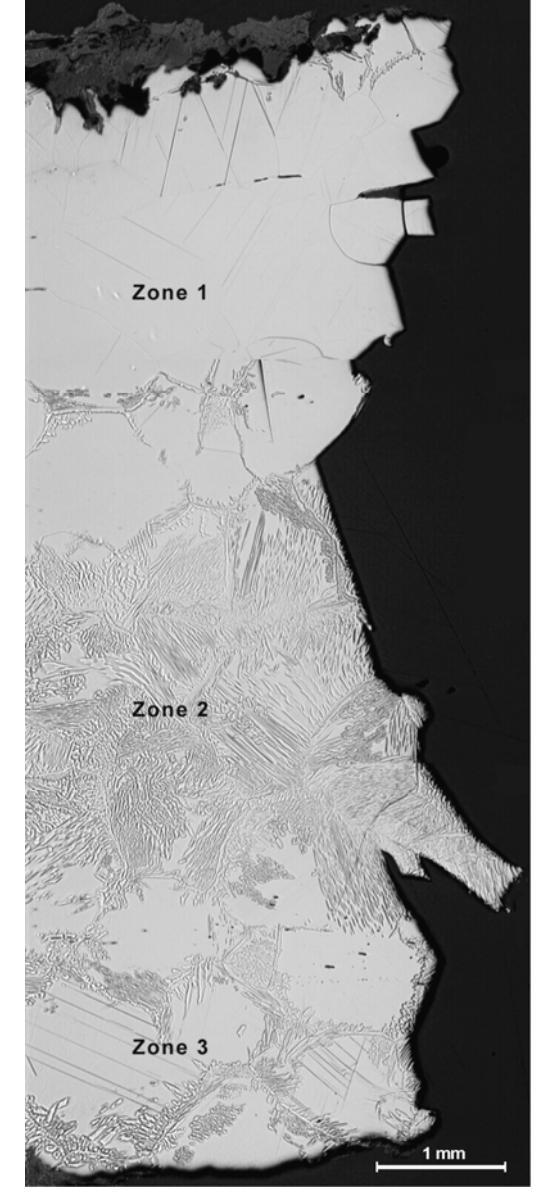
(2) *Metalografija:* na sl. 19 je poprečni presek, uključujući površinu preloma. Tri zone su rezultat zavarivanja tri gvozdene trake u jedinstveni štap. Mikrostruktura se sastoji od velikih nedeformisanih zrna ferita, nešto deformisanih dvojnika u blizini spoljnjih površina i neuobičajenog uticaja nagrizanja, izraženog u zoni 2. Ovo je uticaj segregacija fosfora i tipičan je za antičko gvožđe sa fosforom, /23, 24/.

(2) *Metallography:* Figure 19 shows a cross-section including the fracture surface. The three zones are the result of hot-welding three strips of iron together to form the bar. The microstructure consists of large undeformed ferrite grains, some deformation twinning close to the outside surfaces, and an unusual etching effect especially in zone 2. This effect is due to phosphorus segregation and typically occurs in ancient phosphoric iron, /23, 24/.

Krtost šipke je pripisana lokalno ekstremno niskom sadržaju ugljenika u kombinaciji sa relativno visokim sadržajem fosfora, /6, 7/. Značajna veličina feritnih zrna upućuje na to da je do niskog sadržaja ugljenika došlo zbog lokalnog razugljeničavanja tokom konačne izrade stope stuba, /26/. Ovaj niski sadržaj ugljenika je omogućio visoko temperaturnu segregaciju fosfora po granicama zrna, i posledičnu osetljivost na krti udarni lom na temperaturi okoline, /27–30/. Faktor koji doprinosi krtosti je uticaj zareza zbog neravnomernog razvoja korozije koja prodire u štap.

Embrittlement of the bar was attributed to the *locally* extremely low carbon content combined with the relatively high phosphorus content, /6-7/. The large ferrite grain sizes suggest that the low carbon content was due to local decarburisation during final manufacture of the pile-shoe, /26/. This low carbon content enabled high-temperature segregation of phosphorus to the grain boundaries, resulting in susceptibility to brittle impact fracture at ambient temperatures /27-30/. A contributing factor to the brittleness is a notch effect owing to non-uniform corrosion developed in the bar.

Slika 19. Mikrostruktura po debljini slomljenog uzorka: gornja i donja ivica su prvobitne površine: SEM metalografski snimak Figure 19. Through-thickness microstructure of a broken sample: top and bottom edges are the original surfaces: SEM metallograph.

There are two aspects to conserving the other recovered pile-shoes. Firstly, these must be expected to have surface corrosion layers containing akaganeite. Since akaganeite is hygroscopic, corrosion will continue unless actively prevented by drying out the corrosion layers and either storing stuba u okruženje niske vlažnosti, /25/, ili primenom zaštitnih (organskih) prevlaka. Kao drugo, neke ili nekoliko ovih stopa stuba mogu imati ekstremno nizak sadržaj ugljenika na sličnim lokacijama duž štapova. Na taj način, ako se neke stope iznesu iz skladišta, ili ako su ili nisu pričvršćene za stubove, sa njima se mora pažljivo rukovati i moraju se transportovati vrlo pažljivo kako bi se izbegao lom.
