Radomir Jovičić¹, Zoran Radaković², Sanja Petronić¹, Emina Dzindo¹, Katarina Jovičić Bubalo³

INSPECTION, NON-DESTRUCTIVE TESTS AND REPAIR OF WELDED PRESSURE EQUIPMENT

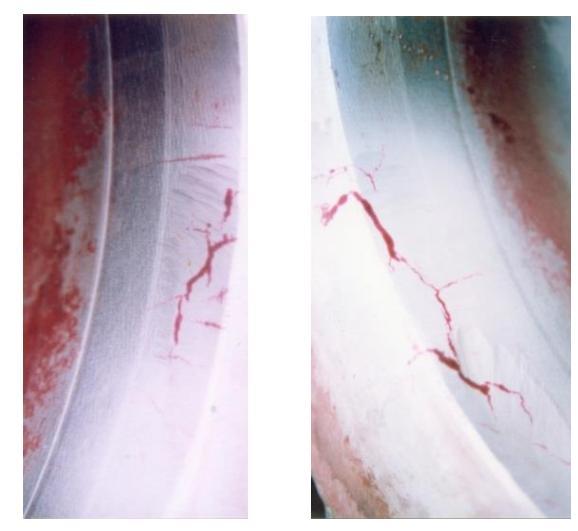
Figure 1 shows cracks detected in the flange of a revision opening in a tank during its exploitation tests, /6/. Cracks are detected by visual inspection and penetrant tests.

Figure 1. Cracks in the revision opening flange.

Figure 1 shows that the attempt to remove cracks by grinding results in the reduction of their number and/or size. The nature and causes of the occurrence of these cracks are not studied here. Due to a large number of cracks and their significant depth, it is decided to cut out the flange and replace it with a new one. For the purpose of welding the new flange, a technology recommended by the tank manufacturer in the Collection of documents is used. In this way, the time required for tests is reduced, along with the costs, since the classification of the welding technology for the flange is avoided. Regulations for manufacturing welded pressure equipment require use of non-destructive and destructive methods in order to prove that the welding technologies used for this equipment provide welded joints of sufficient quality.

The flange and the weld which connects it to the tank are again tested using NDT after the tank is tested using internal water pressure, and no defects are detected.

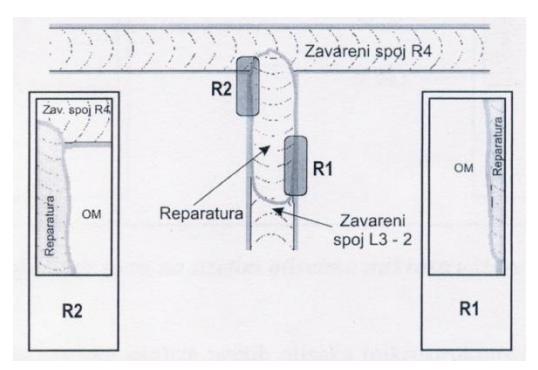
Exploitation test programme for the tank required testing all of its welded joints using magnets and ultrasound, both before and after internal water pressure tests. The crack is detected by magnetic tests before the pressure test. It is detected at the middle of the weld metal of a longitudinal welded joint in the tank mantle near the location of a circular weld, Fig. 4. Crack length is 42 mm. The reasons for crack initiation are not determined.

Figure 4. Location of crack repair.

The crack is removed by grinding. At the same time, magnetic tests are performed. The crack is removed after grinding to the depth for the remaining wall thickness of 9 mm. Since the minimal analytical wall thickness for this tank is 9.5 mm, and the tank owner did not want to reduce the maximal working pressure in the tank, and the wall thickness needed to be restored to its initial value. It is achieved by surfacing the repaired location in accordance with the technology prescribed for such situations.

Performing surfacing with this technology is characterised by following conditions: relative high carbon content, required high surface layer quality (B according to SRPS ISO 5817), welding in an inadequate position and impeded surface layer contraction. Taking into account that surfacing is supposed to be done inside the tank at the height of 8 m, on a relatively small surface, the MMAW procedure is selected. Conditions, such as high carbon percentage in the parent material (max. 0.20%), welding in a vertical position (only possible with smaller electrode diameters and weaker current, which results in lower energy input and quicker cooling), working at heights in the open (occasionally causes accelerated cooling due to draft) and cooling of the welded joint in limited (impeded) contraction (which results in significant residual stresses), all contributes to the occurrence of hard and brittle structures and high residual stresses, which results in cold cracks. For the purpose of preventing this, the preheating and interpass temperatures are increased by around 20% relative to those obtained analytically and are carefully maintained during surfacing. Further slowing of cooling and the reduction of residual stresses is achieved by controlled cooling of the welded joint during surfacing.

The repaired location is tested using magnets and ultrasound, both on the inner and outer sides of the tank. Since no defects are detected, the tank is subjected to pressure tests. After pressure testing, the repaired location is again tested using magnets and ultrasound, and in addition, the microstructures are tested by using the replica method and the hardness is measured by using the portable Vickers method. Tests determined that the parent material has a homogeneous, fine-grain ferrite pearlite structure, and its hardness ranges from 160 to 176 HV. No defects are detected in HAZ. HAZ microstructure consists of bainite with traces of martensite and hardness ranging from 198 to 208 HV. The weld metal structure consists of proeutectoid ferrite and upper bainite with hardness ranging from 176 to 180 HV.

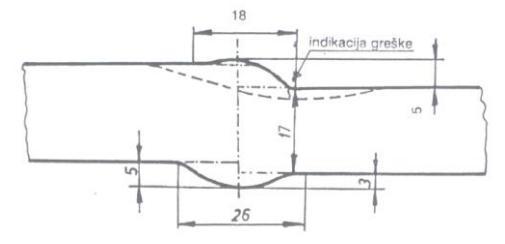
Figure 5 shows the cross-section through a welded joint of a tank in which a crack in the fusion line is detected during exploitation tests, /2/.

Figure 5. Cross-section of welded joint at the crack location.

The exploitation test programme for the tank required magnetic and ultrasonic testing all its welded joints, both before and after internal water pressure tests. The crack is detected by magnetic tests before the pressure test on the fusion line of the circular welded joint between two mantle segments. The crack had a length of 60 mm and a depth of 3 mm. Exact position of the crack (fine-grain or coarse-grain HAZ) could not be determined. The reasons for crack initiation are not determined.

Crack shown in Fig. 5 will continue to grow perpendicularly to the sheet surface due to highest stresses. It is known from literature, $\frac{2}{}$, that residual tensile stresses are highest on the surface and they spread up to 20% of wall thickness. This means that, during crack growth, its tip will reach the area of reduced residual stresses. Taking into account that the considered welded joint is welded as an X groove, the crack will, during its growth, pass through HAZ and reach the fine-grain structure of the parent metal, with significantly higher toughness. If the crack tip starts to follow the fusion plane, then the angles of crack propagation and the direction of principal stresses are reduced, which also reduces the acting stresses. In this way, crack growth could stop at a certain depth, due to an increase in material toughness. Favourable conditions for crack growth remain in the lateral direction i.e. along the fusion line. Due to this, the possibility of repairing this crack is considered.

Taking into account that the maximum crack depth is 3 mm, it can be expected that, after the crack is removed by grinding, the remaining wall thickness at this location will be 14 mm. Stress in the tank wall, in the circumferential direction, at test pressure and for thickness of 14 mm will be 279 MPa, which is below material yield stress (the plate containing the crack has a yield stress of 584 MPa), /2/. Based on the above, it is concluded that the crack can be repaired by grinding. In order to avoid stress concentration, the repair location is made in spherical form with a slight transition from thinner to thicker cross-section, shown by the dotted line in Fig. 8. Magnetic tests are performed alternatively with grinding. The crack is removed after grinding to the point where the remaining wall thickness is 14 mm.

The repair location is tested using magnets and ultrasound at both inner and outer sides of the tank. Since no cracks are detected, the tank is subjected to pressure tests. After the pressure tests, the repair location is again tested by magnets and ultrasound, and no cracks are detected. Test results are evaluated as satisfying and the tank is put into further service. The repair location is denoted as a mandatory location for future exploitation tests of the tank.
