STIFFENER AS A SPECIAL DESIGN SOLUTION FOR PRESSURE VESSEL REPAIR UKRUTNI PRSTEN KAO POSEBNO KONSTRUKTIVNO REŠENJE ZA SANACIJU POSUDE

The reparation of vessel 970 is shown, since the risk is very high (close to the worst case of both probability and consequence, being the highest). Since the defect location was not suitable for digging out and repair welding, it was decided to make a circumferential stiffener, to reduce the stress acting on the welded joint, so that both the stress intensity factor and net stress are reduced significantly.

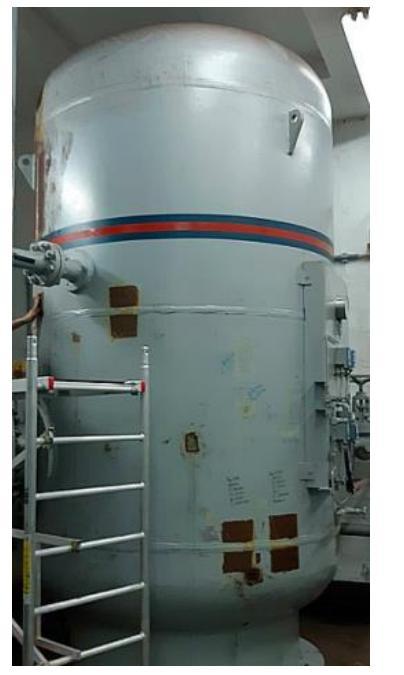
After long-term operation, defects are found in welded joints in pressure vessel 970, Fig. 1. Given the high price and often the inability to purchase new working parts, there is a need for repairs. As mentioned above, after a long exploitation of the parts, defects are noticed, that can compromise the integrity of the structure.

Figure 1. The pressure vessel 970, before repair.

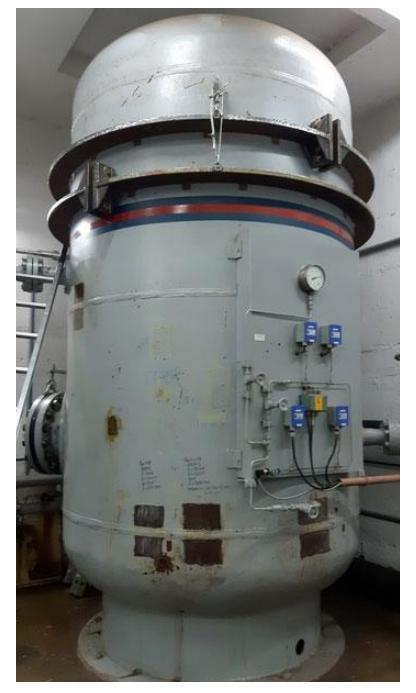
Figure 2. The pressure vessel 970, after repair with stiffener.

Risk-based analysis has been successfully used in recent years to evaluate possible effects on pressure vessel safety, /6-12/. As for the pressure vessel 970, since the risk was at a very high level, close to the worst case of the probabilities and consequences, and the position was not suitable for the repairer by welding, it was decided to make a stiff ring in order to reduce the stress on the welded joint, so that both the stress intensity factor and the stress acting on the defect 5.6 become significantly reduced.

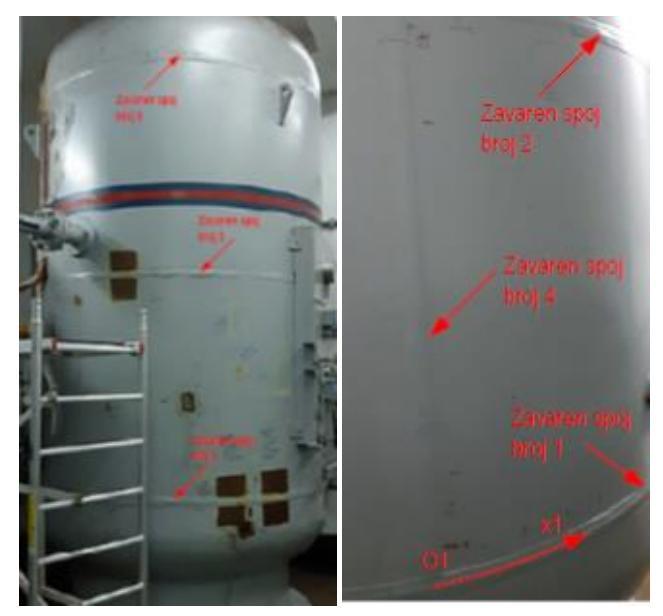
Vessels are made of microalloyed steel Nioval 50, with pressure in vessel 970 p = 81 bar; thickness t = 50 mm; and diameter D = 2150 mm. The vessel 970 was inspected by 100 % ultrasonic testing of two vertical and three circular welded joints. Nine unacceptable indications (1.1-1.4, 5.1-5.4 and 5.6), as well as one with an echo height above the registration level (5.5) were detected.

Figure 3. Tested welded joints (marked by red arrows) on vessel 970, before repair.

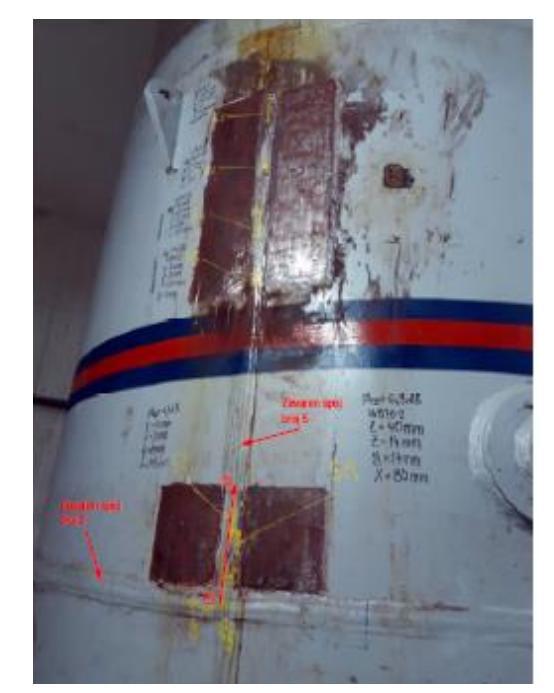
Figure 4. Tested welded joint 5 on vessel 970, before repair.

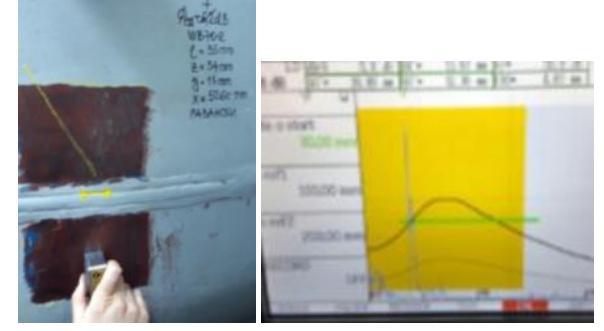
After the final UT testing of the vessel 970, defects 1.4 and 5.6 were found out to be the most dangerous with the following geometry and location:

- defect 1.4; length 35 mm and width / depth 22 mm in the central circular seam, from 28 to 50 mm,
- defect 5.6; length 75 mm and width / depth 20 mm in the central circular seam, from 18 to 38 mm.

Figure 5. Position and size of defect 1.4 in vessel 970.

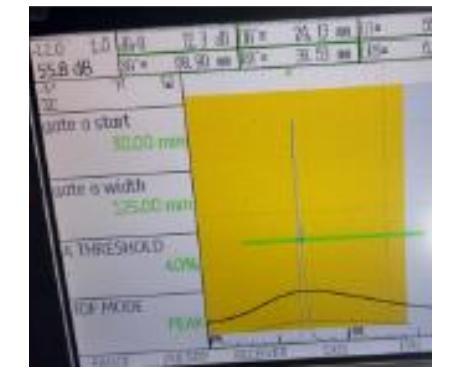
Figure 6. Position and size of defect 5.6 in vessel 970.

Defect 5.6 in vessel 970 presents a high risk, but in this case removal by repair welding was not a practical solution, so a special design solution is successfully made in the form of a stiffener to reduce the stress.

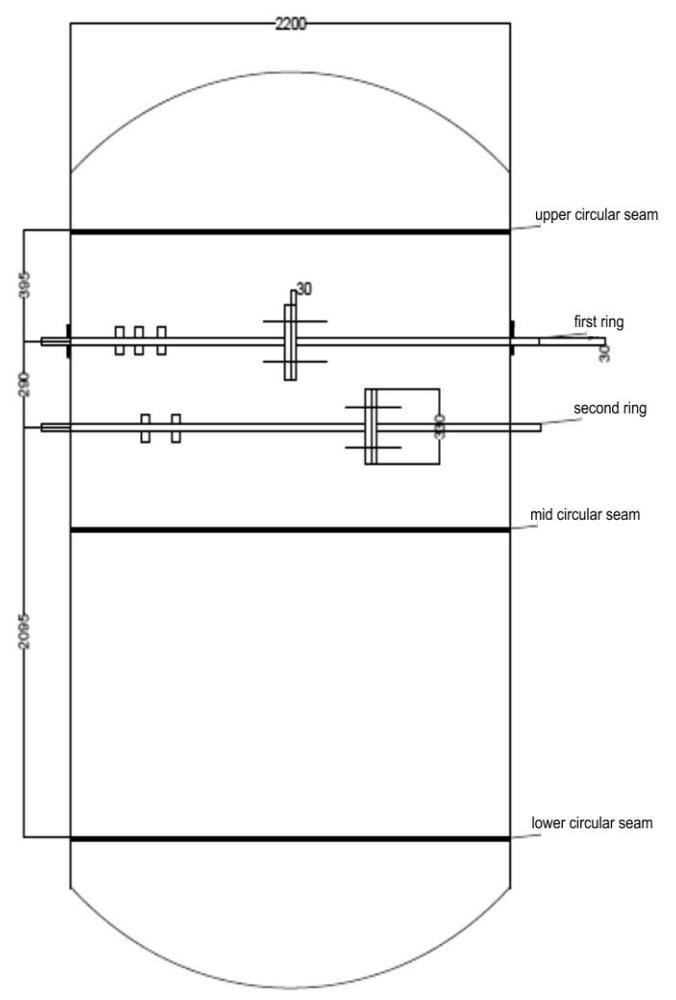
Figure 7. Scheme of vessel 970 reinforcement with outer stiffeners.

After the finished calculation, the sheme for installation and assembly of the stiffener on the vessel 970 are made, Figs. 7-9. The first stiffener had 16 plates, the second one 17, all of them are 5×50 mm.

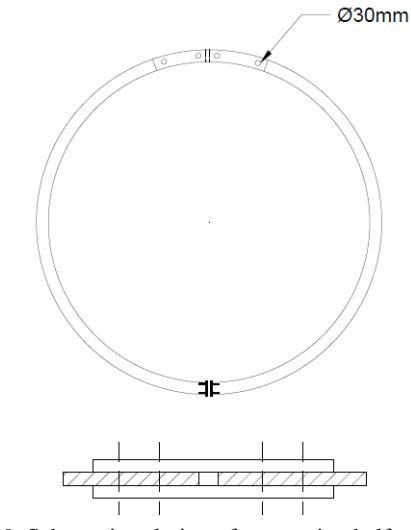
Figure 9. Schematic solution of connecting half of the rings.

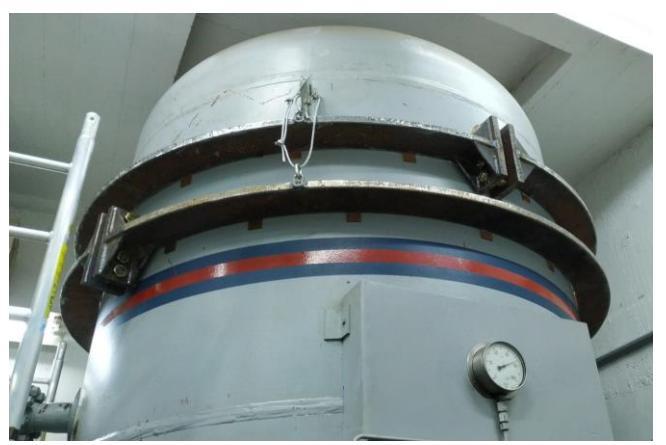
Figure 10. Details of the two-ring reinforcement solution.

After making the plan for the assembly and erection of the stiffener, it was successfully installed on vessel 970. Details are shown in Figs. 10-12.

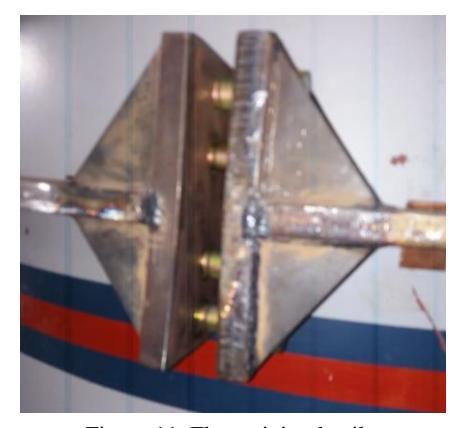
Figure 11. Flange joint details.

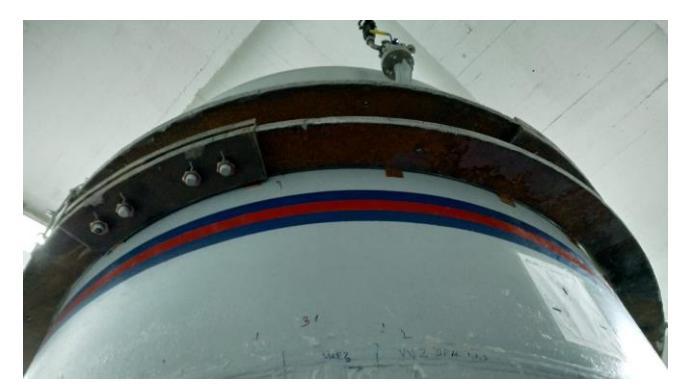
Figure 12. Stiffener bonding with 4 screws M30 (class 8.8).

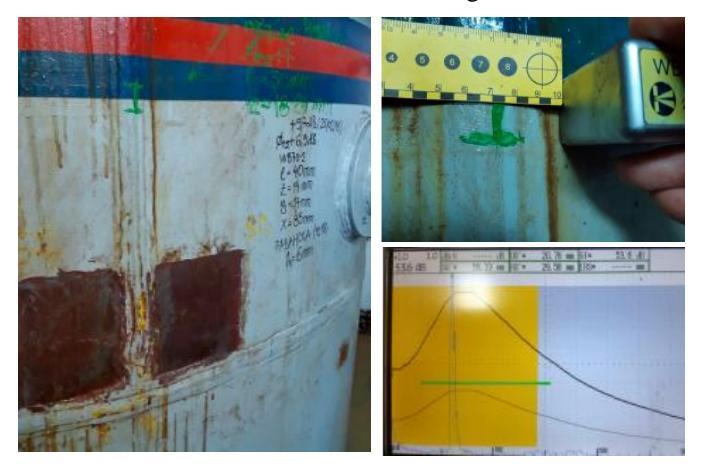
Only some details of the NDT inspection of vessel 970 after the erection of stiffener is presented. Figure 13 shows details of NDT inspection of vessel 970. It should be noted that after placing the stiff ring, the NDT methods show that the defect on the vessel 970 has not changed.

Figure 13. Ultrasonic examination of vessel 970, after repair.
