UTICAJ USLOVA OPTEREĆENJA NA LOM ZAVARENOG TANKOZIDNOG REZERVOARA LOADING CONDITION EFFECT ON THE FRACTURE OF WELDED THIN-WALLED **STORAGE TANK**

| Stručni rad / Professional paper UDK /UDC: 621.642-988-112.81:539.42 Rad primljen / Paper received: 17.01.2007. | Adresa autora / Author's address: ¹⁾ Zavod za zavarivanje, Beograd, Srbija, <u>zzz@bitsyu.net</u> ²⁾ Fakultet tehničkih nauka, Novi Sad,Srbija ³⁾ Tehnološko-metalurški fakultet, Beograd, Srbija |

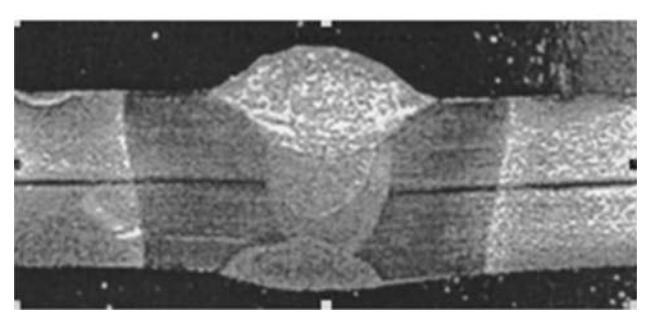
The parent metal microstructure is heterogeneous due to laminated pearlite (macrograph of welded joint, Fig. 2). The HAZ microstructure is coarse bainite with acicular ferrite inside austenite grains and proeutectoid ferrite mesh on austenite grain boundaries, Fig. 3. Inclusions and coarse austenite grains favoured the acicular ferrite occurrence. The proeutectoid ferrite is coarse and brittle, prone to brittle fracture.

Slika 2. Makro snimak zavarenog spoja čelika S355J2G3 Figure 2. Macrograph of welded joint - S355J2G3 steel.

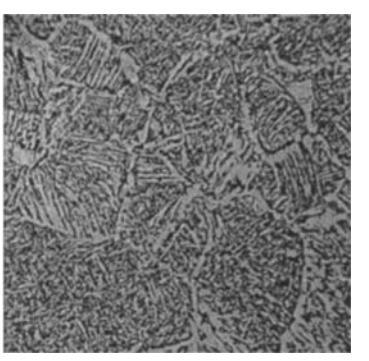
Slika 3. Grubozrno područje u zoni uticaja toplote (posuda I) Figure 3. Coarse grain zone in the heat-affected-zone (vessel I).

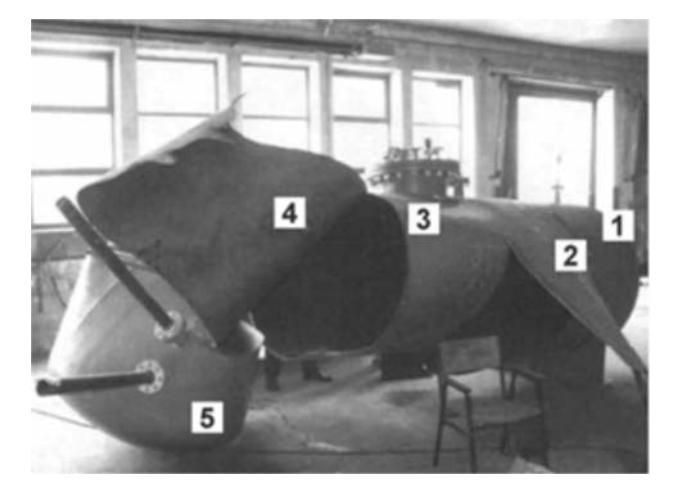
The appearance of storage tank (vessel I) after brittle fracture is shown in Fig. 4. Plastic collapse of the mobile tank with visible bulging is shown in Fig. 5. In both vessels the crack initiated in HAZ. In vessel I, the crack propagated in the longitudinal direction, perpendicular to the circumferential welded joint. In vessel II the crack initiated in fillet weld longitudinally and deviated to follow circumferential joint.

Slika 4. Krti lom podzemnog rezervoara (posuda I) Figure 4. Brittle fracture of the underground storage (vessel I).

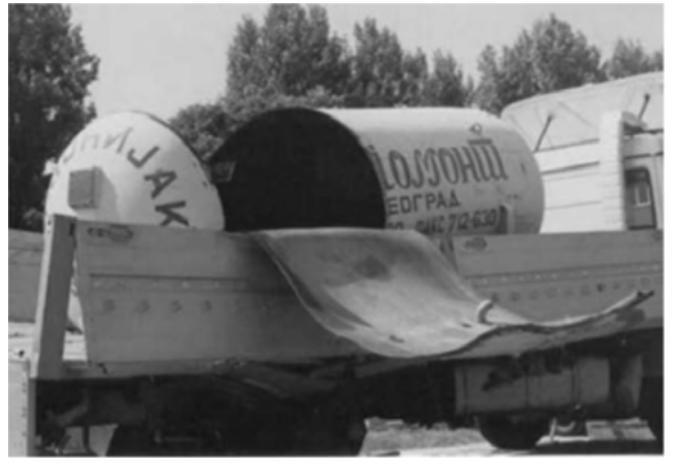
Slika 5. Žilavi lom cisterne (posuda II) Figure 5. Ductile fracture of the storage tank (vessel II).

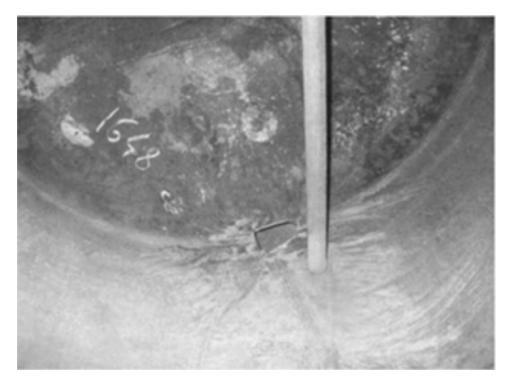
In vessel I, the crack occurred in the vessel mantle lower part. One piece of material was punched out from the lower part, Fig. 6. The crack initiated in circumferential weld HAZ, Fig. 7, in the final bead coarse microstructure, Fig. 3, then on one side propagated perpendicularly to the longitudinal vessel axis, along circumferential weld HAZ segment 2, Fig. 8. When the crack reached the region of higher toughness in welded joint, it deviated and arrested in the parent metal. On the other side, the crack propagated through parent metal longitudinally. In segment 3, Fig. 9, after initiation the crack did not follow HAZ, but developed through parent metal perpendicularly to weld, where it was again arrested.

Slika 6. Lom donjeg dela rezervoar (posuda I) Figure 6. Fracture on lower part of the storage tank (vessel I).

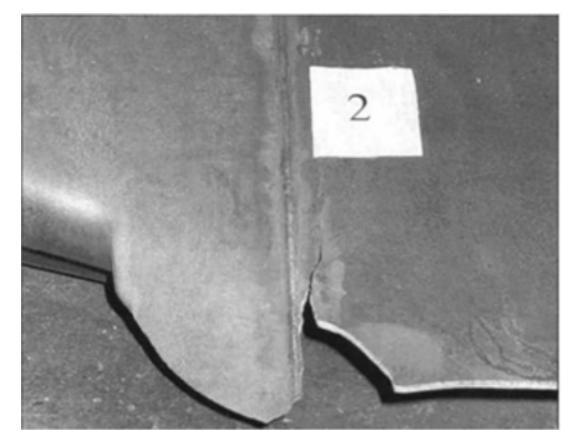
Slika 8. Prslina je skrenula u segmentu 2 iz zone uticaja toplote (ZUT) u osnovni metal Figure 8. Crack deviated in the segment 2 from the heat-affectedzone (HAZ) into the parent metal.

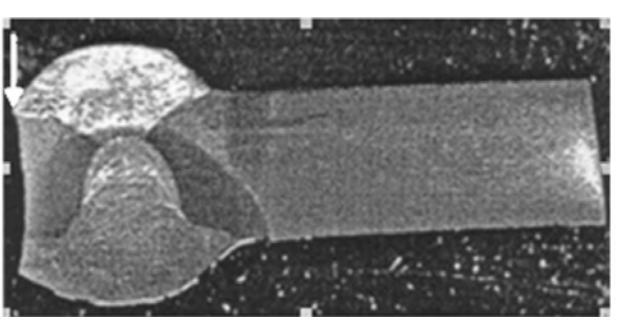
Slika 7. Prslina je inicirana i rasla kroz ZUT Figure 7. Crack initiated and developed through HAZ.

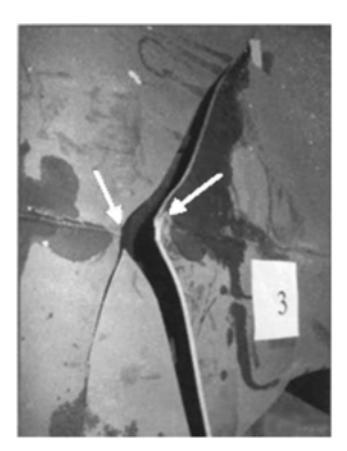
Slika 9. Prslina je skrenula u segmentu 3 iz zone uticaja toplote (ZUT) u osnovni metal Figure 9. Crack deviated in the segment 3 from the heat-affectedzone (HAZ) into the parent metal.

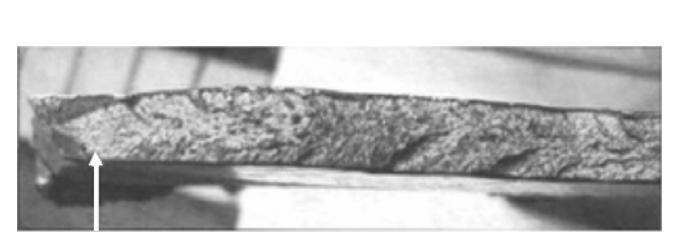
Analysis revealed that the fracture surface is flat and perpendicular to the plate surface on both sides of the initiation point along HAZ which is typical for brittle fracture, without plastic deformation, Fig. 10.

Chevron patterns, easily found in Fig. 10, can be

followed back to the crack initiation point. After the flat

fractured surface, normal to loading direction, corresponding to brittle fracture, the separating process ends by shear

mechanisms in plane stress condition in direction of maximal shear stress inclined 45°, Fig. 10, for vessel segment 2,

Slika 10. Površina preloma segmenta 2 sa strelastim tragom loma. Strelica označava prelaz iz krtog u plastični lom.Figure 10. Fracture surface of segment 2 with chevron pattern. Arrow indicates transition from brittle to ductile fracture.

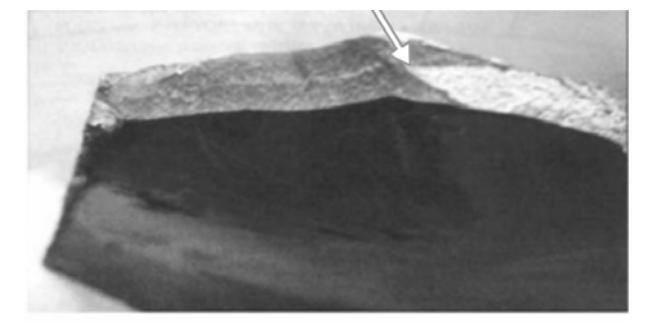
and more clear in Fig. 11 for segment 3, with typical brittle

to ductile transition fracture, with shear lips.

Slika 11. Površina preloma segmenta 3 sa strelastim tragom loma. Strelica označava prelaz iz krtog u plastični lom.Figure 11. Fracture surface of segment 3 with chevron pattern. Arrow indicates transition from brittle to ductile fracture.

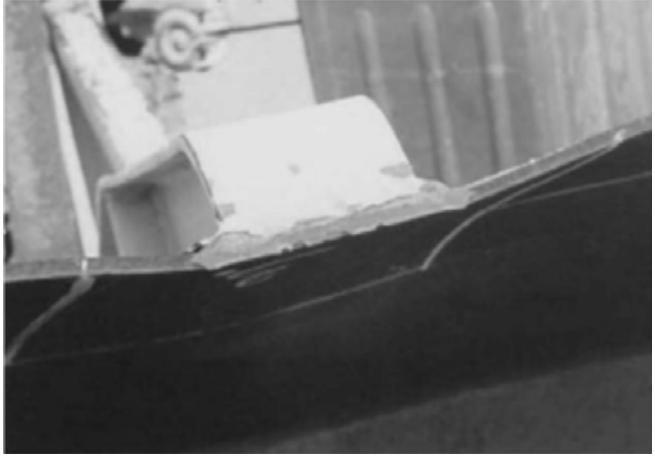
Slika 12. Položaj inicijacije prsline sa tragom rasta prsline Figure 12. Crack initiation location and crack growth path.

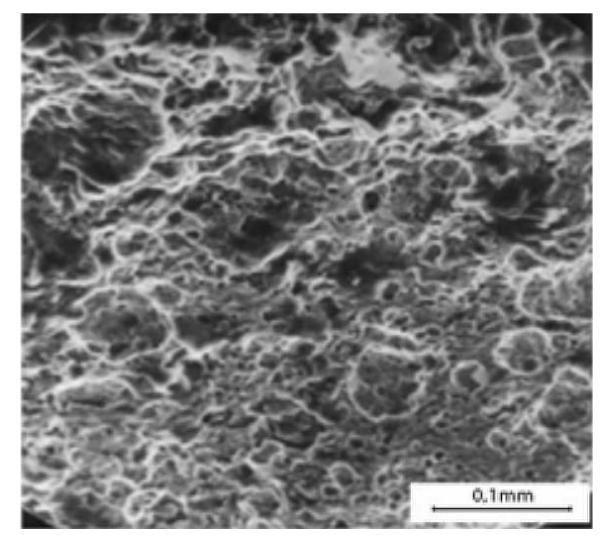
Analysis of the fractured surface has shown ductile fracture that followed prior plastic deformation. Scanning electron microscopy revealed fibrous ductile fracture, Fig. 14, /9/, and through thickness crack growth of semi-elliptic shape. Shear lips are typical for crack growth in this case, and the fracture surface is inclined by 45° , in direction of maximal shear stress, Fig. 15.

Slika 14. Površina žilavog loma cisterne za prevoz amonijaka Figure 14. Ductile fracture surface of tank for ammonia transport.

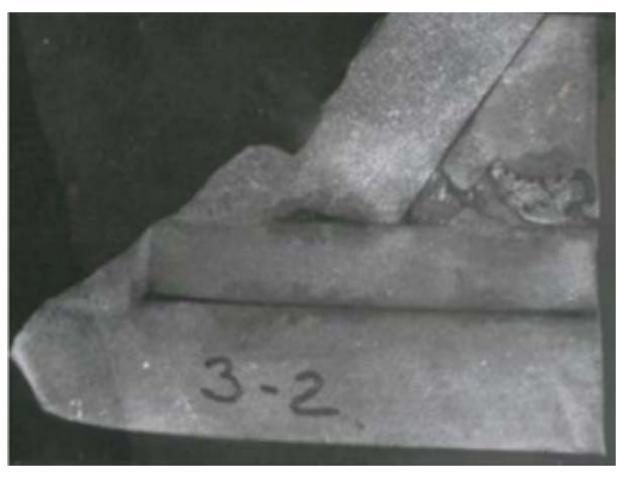
Slika 13. Makro snimak ugaonog šava sa zajedom Figure 13. Macrograph of fillet weld with undercut.

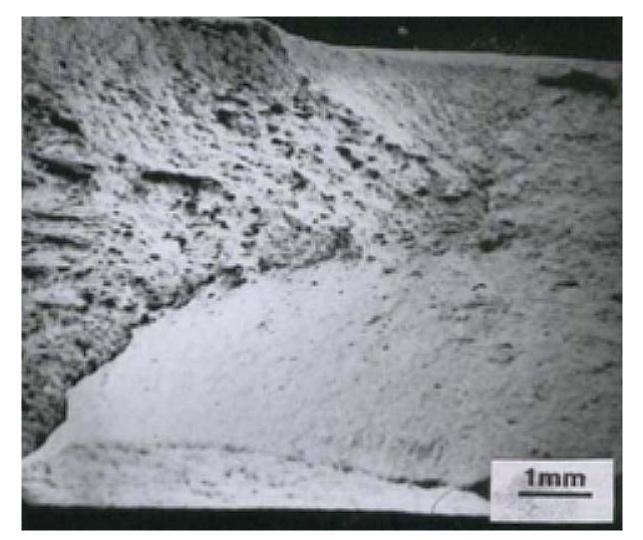
Slika 15. Lom mehanizmom klizanja sa usnama klizanja Figure 15. Fracture by shear mechanism with shear lips.
