SANACIJE I REKONSTRUKCIJE TRANSPORTERA I ODLAGAČA REPAIR AND RECONSTRUCTION OF BELT WAGONS AND STACKERS

REPAIR AND RECONSTRUCTION OF THE SUPPORT ON THE LOWER ASSEMBLY OF THE ARS1400 O&K STACKER (OPEN-CAST MINE *TAMNAVA ISTOK*)

REPAIR AND RECONSTRUCTION OF ROTATING STACKER PLATFORM ARS 1400 O&K

REPAIR AND REVITALIZATION OF THE SUPPORT ON BELT WAGON BRS/ARS O&K

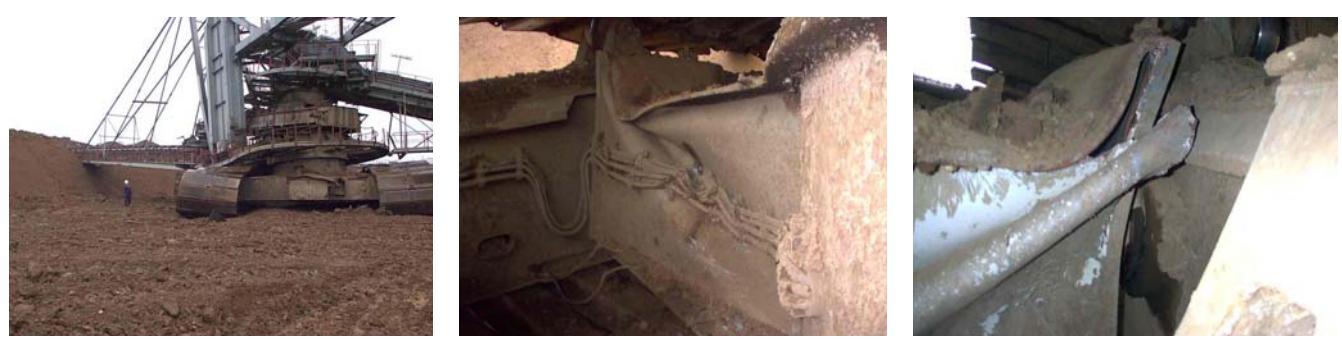
This stacker has suffered severe damages during service. The latest failure is shown in Fig. 1.

The conclusion is that the given plate has been working under very unsuitable stress field. Its buckling, followed by cracking, occurred due to close values of the working and critical stress. This is what had caused failure.

Slika 1. Havarija na odlagaču ARS1400 O&K Figure 1. Damage on the ARS1400 O&K stacker.

Performed repairs and reconstruction had included: two existing vertical plates of identical width had remained, a vertical stiffener was added on the half length of the plate, and two vertical plates 2.5 cm thick were added at 10 cm distance from the vertical plate. The supporting element on the other side was merely reconstructed.

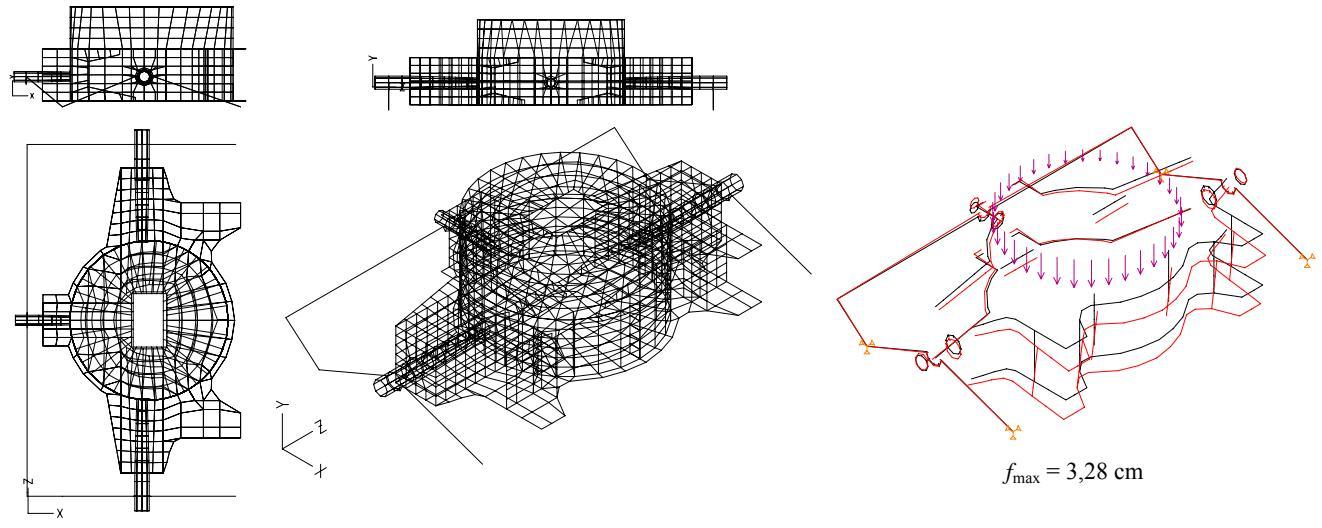
The numerical model of the structure is given in Fig. 2. The most unfavourable load value of 4560 kN is centred at a radius of 100 cm and 60° from the longitudinal axis.

The strain is shown in Fig. 2. Stress and energy distributions are given in Fig. 3. High stress level in a vertical critical plate, a high stress concentration and dominant shear stress are noticeable. The critical calculated Euler's shear stress value in this plate is 13 kN/cm^2 (calculations give a value of 11.5 kN/cm^2).

Slika 2. Računski model i deformacija Figure 2. Numerical model and strains.

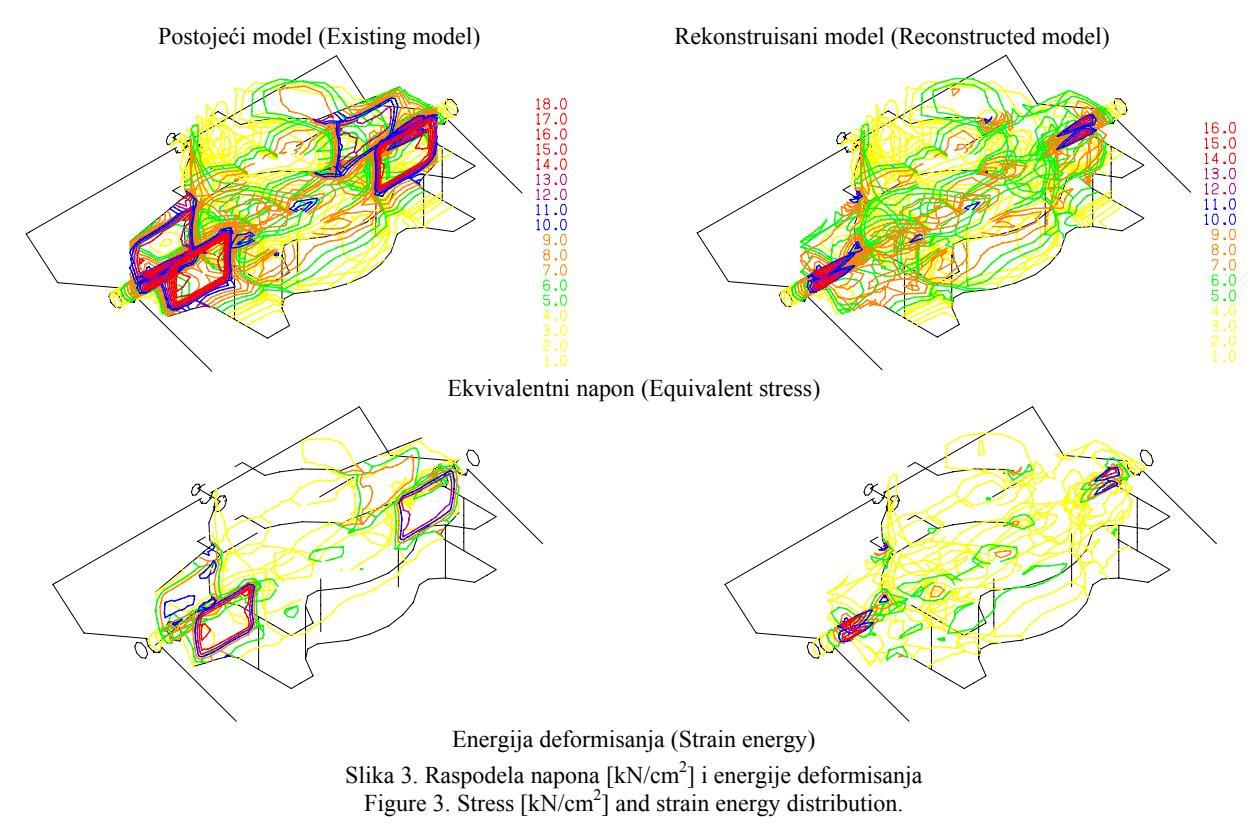
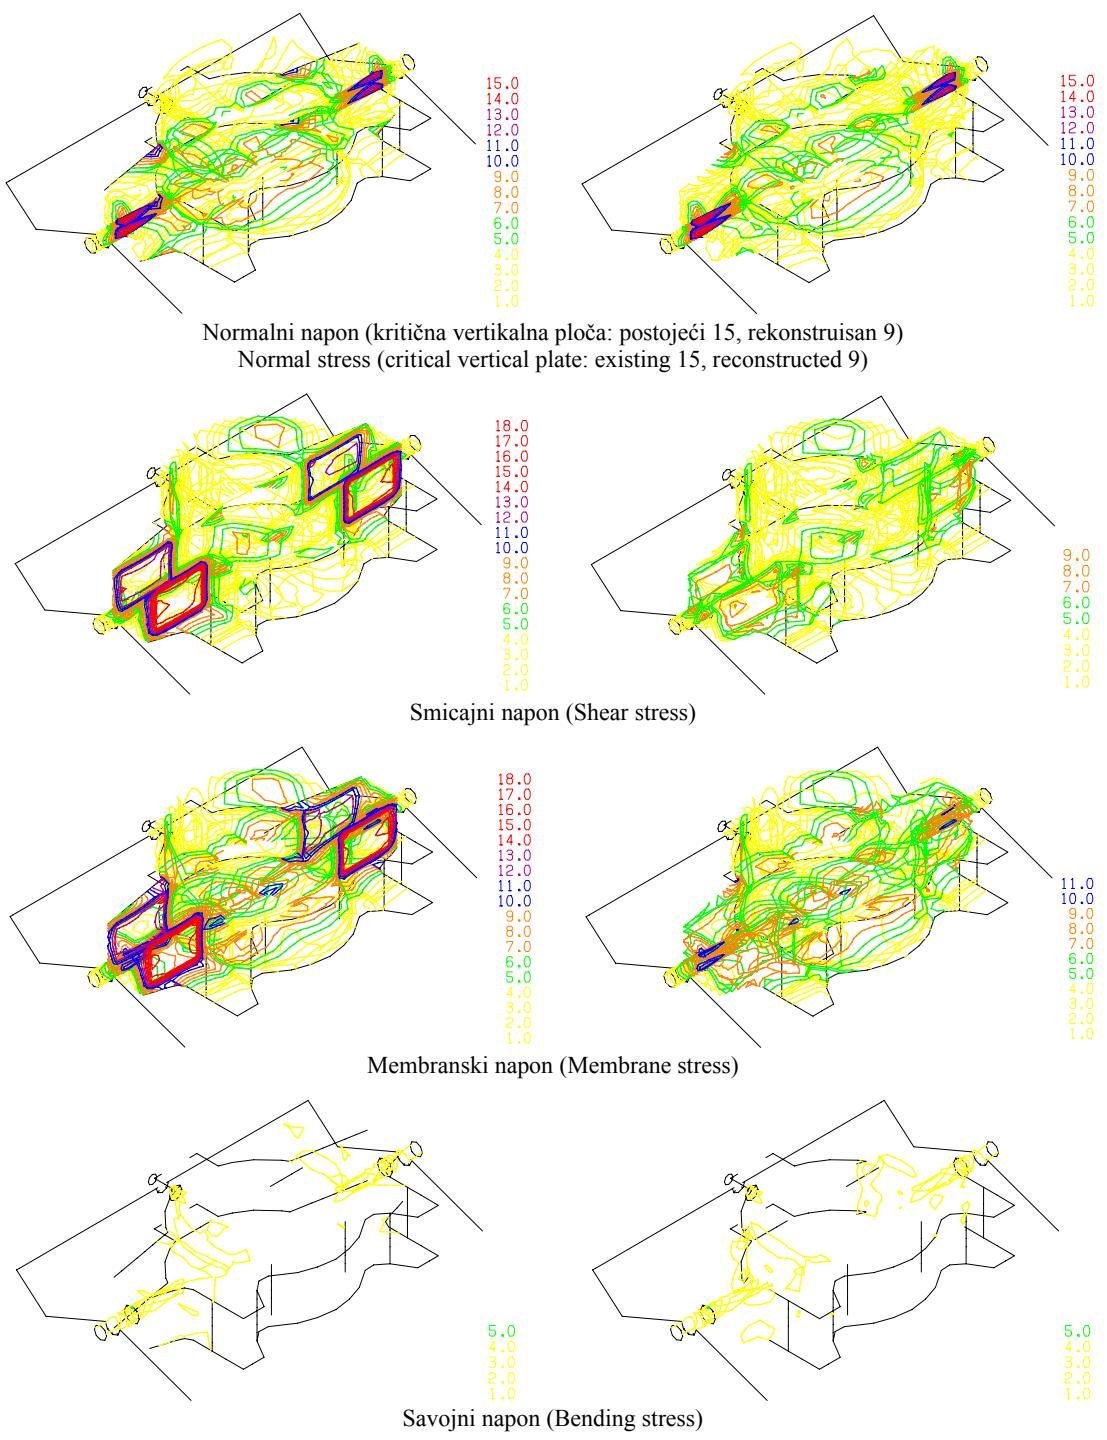
Slika 3. Raspodela napona [kN/cm²] i energije deformisanja [kNcm] (nastavak) Figure 3. Stress [kN/cm²] and strain energy [kNcm] distribution. (continued)

Stress and energy distributions are shown in Fig. 3.

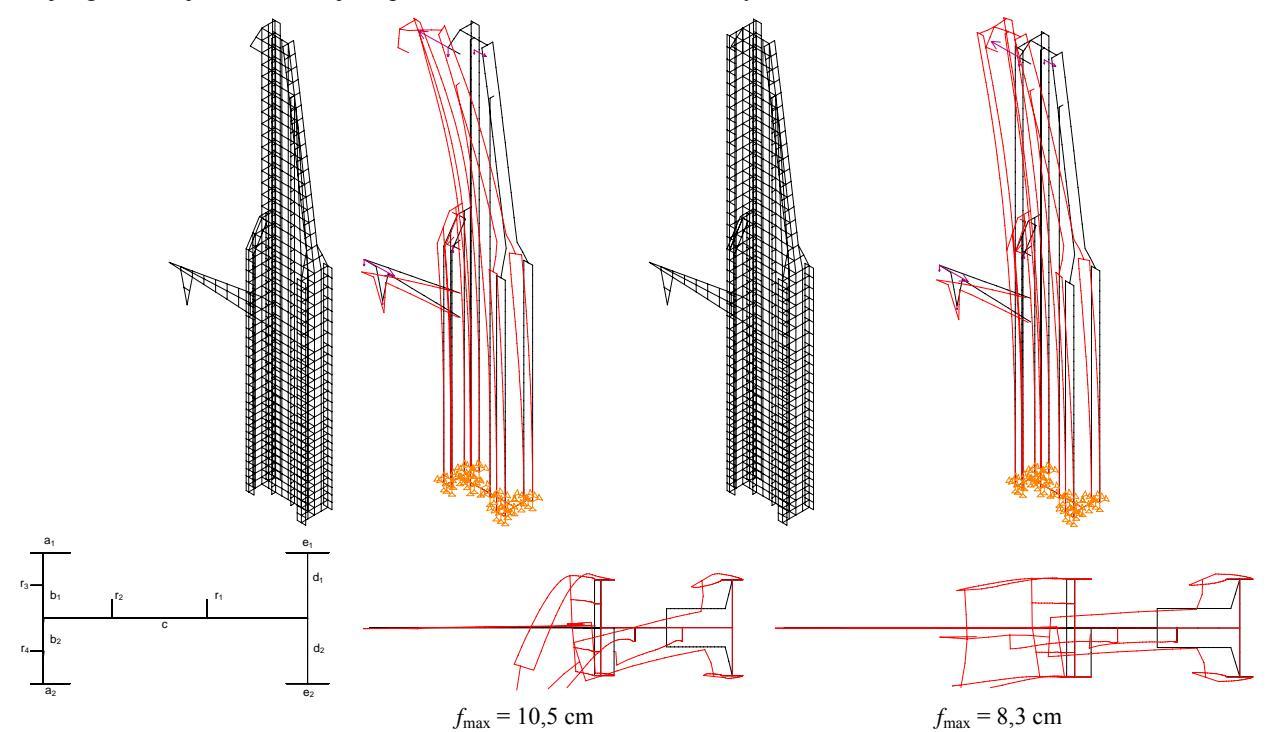
Postojeći – stari model (Existing – old model) Rekonstruisani – novi model (Reconstructed – new model) Slika 4. Računski modeli stuba odlagača (postojeći i rekonstruisani).

Figure 4. Numerical models of the stacker support (existing and reconstructed).

Rekonstrukcija je dovela do uklanjanja uvijanja stuba, značajnog smanjenja savijanja, smanjenja napona za 37,5% i značajnog ublaženja koncentracije napona. The numerical model is shown in Fig. 4. The suggested reconstruction was performed by extending the plate b_2 and its reinforcement a_2 (thickness of both plates is 10 mm) up to the top of the support, and also by partial plate reinforcements d_1 and d_2 with plates $500 \times 1500 \times 20$ mm.

The reconstruction led to the elimination of torsion on the support, a significant reduction of bending, decrease of stress by 37.5%, and reduction in stress concentration.

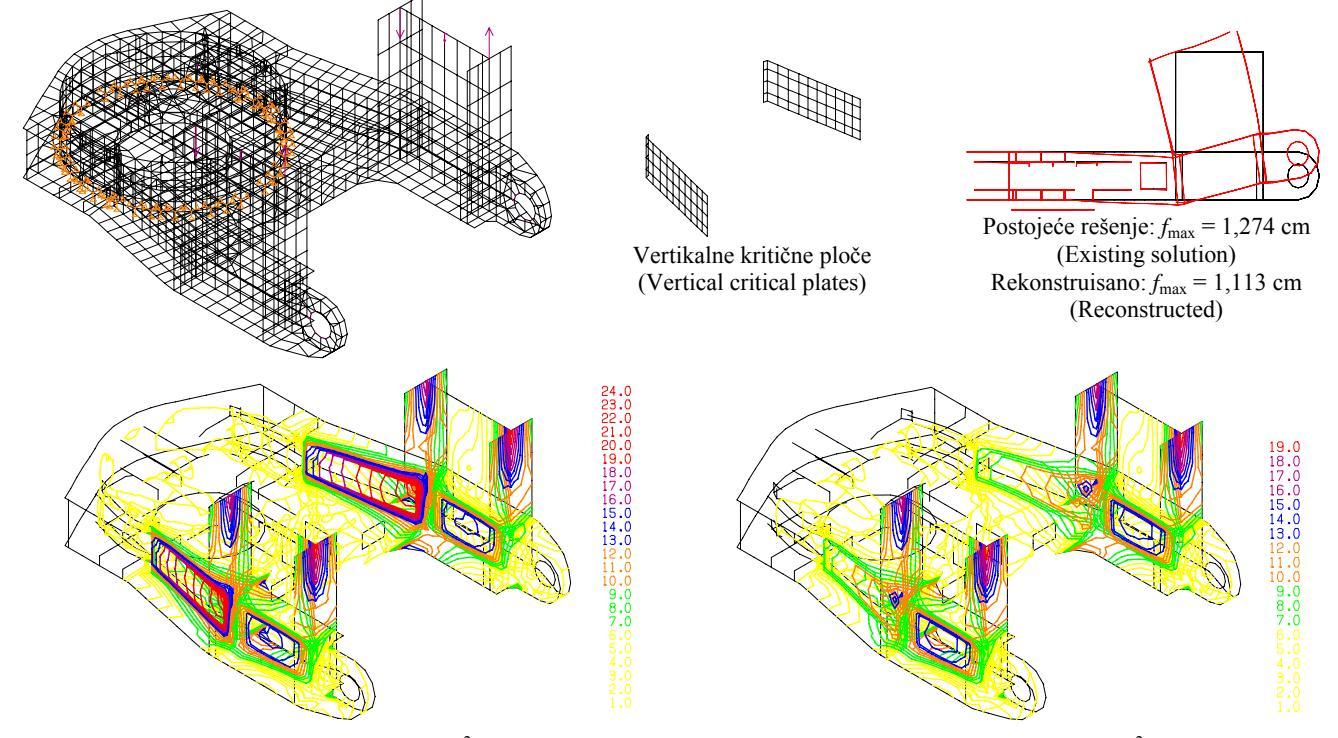
The vertical (critical) plate of the rotating stacker platform (ARS) experienced in-service buckling. The numerical model of the platform including few supports, in the worst case of load, strain and equivalent stress, for existing and reconstructed platforms is shown in Fig. 6 and Table 2.

Vertikalna kritična ploča $\sigma_{max} = 24 \text{ kN/cm}^2$. Postojeće rešenje. Vertical critical plate $\sigma_{max} = 24 \text{ kN/cm}^2$. The existing solution.

Slika 6. Računski model obrtne platforme odlagača Figure 6. Numerical model of the rotating stacker platform.

Vertikalna kritična ploča ima najveću vrednost napona, koncentraciju napona i energiju deformisanja. Ovakvo ponašanje se u celini odgovara sa ponašanjem konstrukcije u eksploataciji. Značajno smanjenje napona i eliminisanje koncentracije napona dobijeno je samo povećanjem debljine vertikalne ploče. Sem toga, malo prisustvo napona savijanja u konstrukciji ukazuje na dobro projektovanje.

Vertikalna kritična ploča $\sigma_{max} = 14 \text{ kN/cm}^2$. Rekonstruisano. Vertical critical plate $\sigma_{max} = 14 \text{ kN/cm}^2$. Reconstructed.

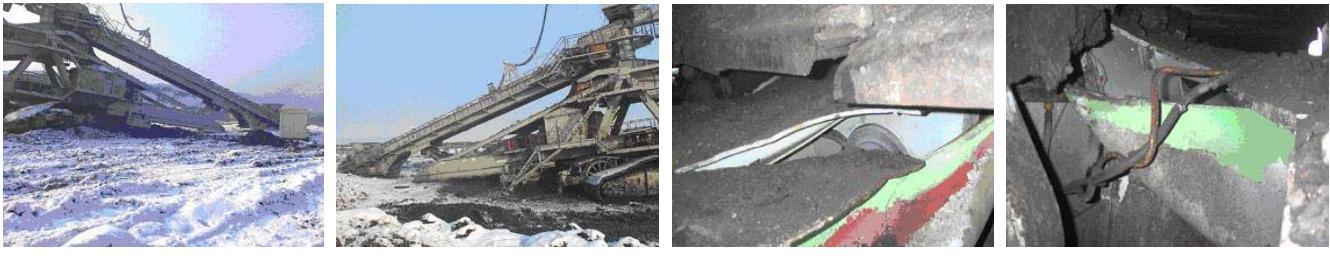
The belt wagon on crawlers failed at its support (Fig. 7).

Slika 7. Havarija transportera u osloncu Figure 7. Failure of the belt wagon at the support.

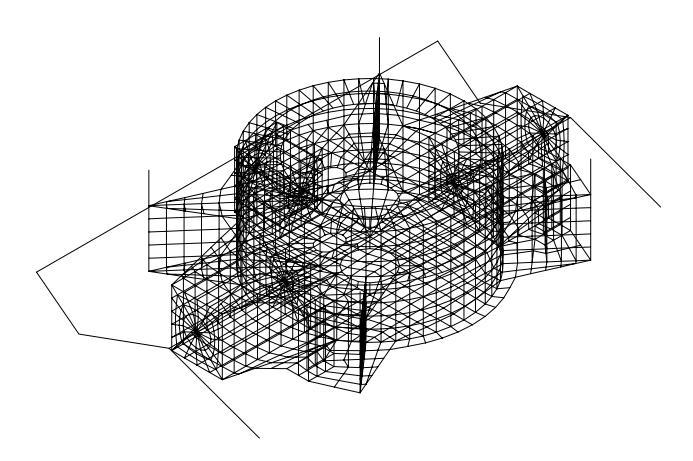
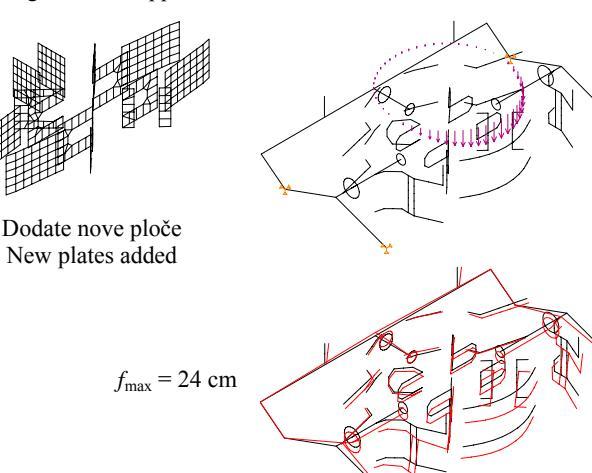
Slika 8. Model i predložena rekonstrukcija donje gradnje transportera Figure 8. Model and proposed reconstruction of the lower belt wagon assembly.

Komentar rezultata proračuna glasi: opterećenje je zahvatilo skoro celu konstrukciju donje gradnje; vrlo visok nivo napona u vertikalnim pločama prvog i drugog kutijastog nosača osovine za spoj sa balanserom i veoma izražena koncentracija napona; smicajni naponi su dominantni; dominantan uticaj navedenih kutijastih nosača (preuzeli su najveći deo membranskih i smicajnih napona, a spoljašnje opterećenje najviše energije je potrošilo na njihovo deformisanje), navedene ploče radile su u veoma nepovoljnom naponskom polju.

Parts of upper and lower plates, and intermediate plates form a girder box (2 pieces), connecting cylindrical part to the mobile mechanism through the axle. This beam is called the critical box beam. The suggested reconstruction of the lower assembly includes placement of plates (Fig. 8).

Predložena rekonstrukcija obezbeđuje drastično smanjenje napona (posebno smicajnih) i energije deformisanja.

The proposed reconstruction provides drastic decrease in stress (especially shear stresses) and strain energy.

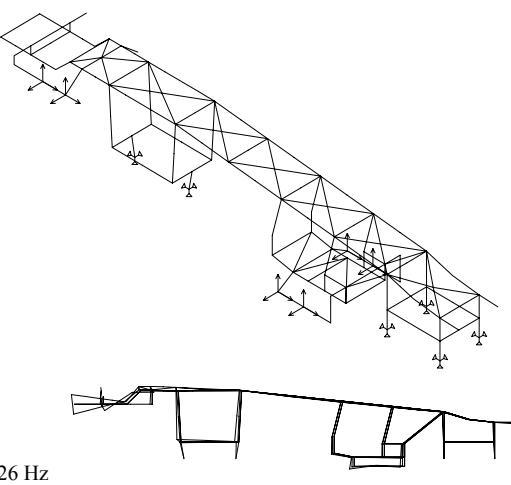
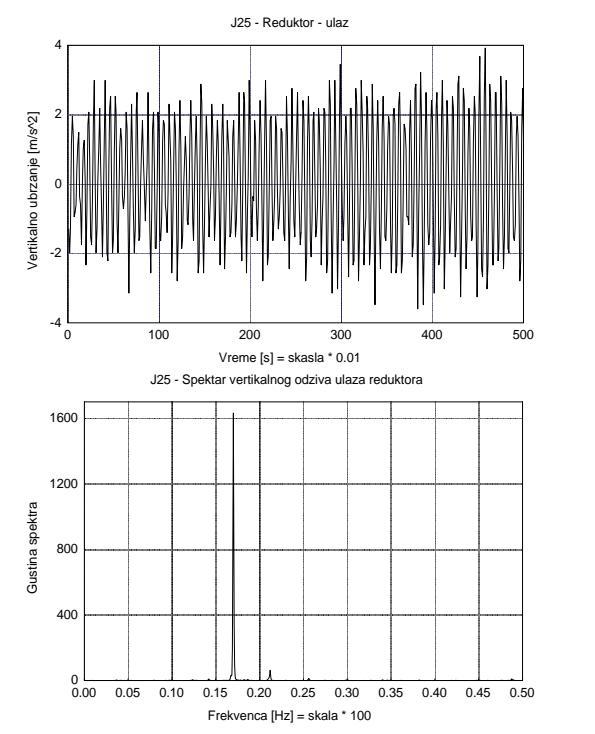
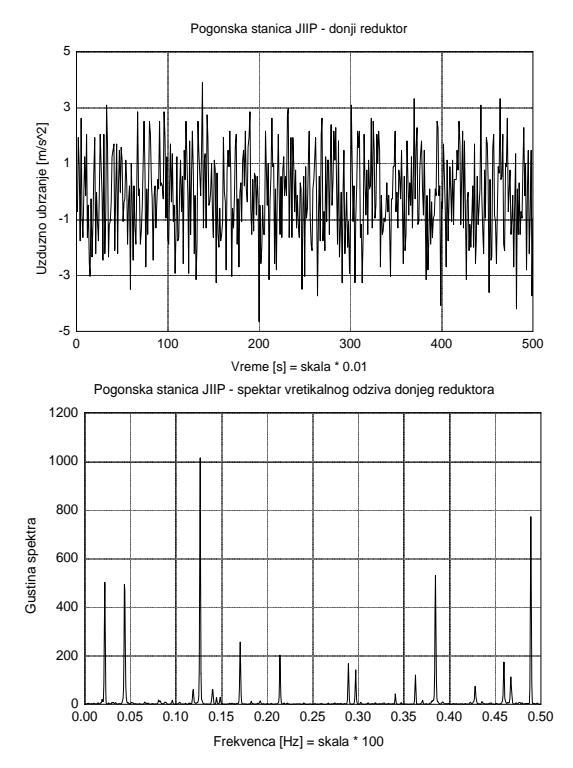
The reduced dynamic model of the drive unit, certain major oscillations and acceleration measurements are shown in Fig. 10. The motor starting frequency is 16.33 Hz.

Figure 10. Reduced dynamic model of unit (top), vertical acceleration (middle left) and longitudinal acceleration (middle right) in frequencz domain, and spetrum density in time domain (bottom).

Na osnovu proračuna, merenja i analize rezultata konstatujemo da je uzrok problema koji se javljaju u radu pogonske stanice njena nedovoljna prostorna krutost koja se manifestuje tako što noseća konstrukcija stanice ima sopstvene frekvence bliske pobudnim frekvencama.

This serious setback in the structure is a global characteristic. Eliminating it entirely is not technically justified, since it would require large reconstruction. Therefore, it is necessary to re-enforce locally the unit structure and reduce the unwanted effect of poor structural design.

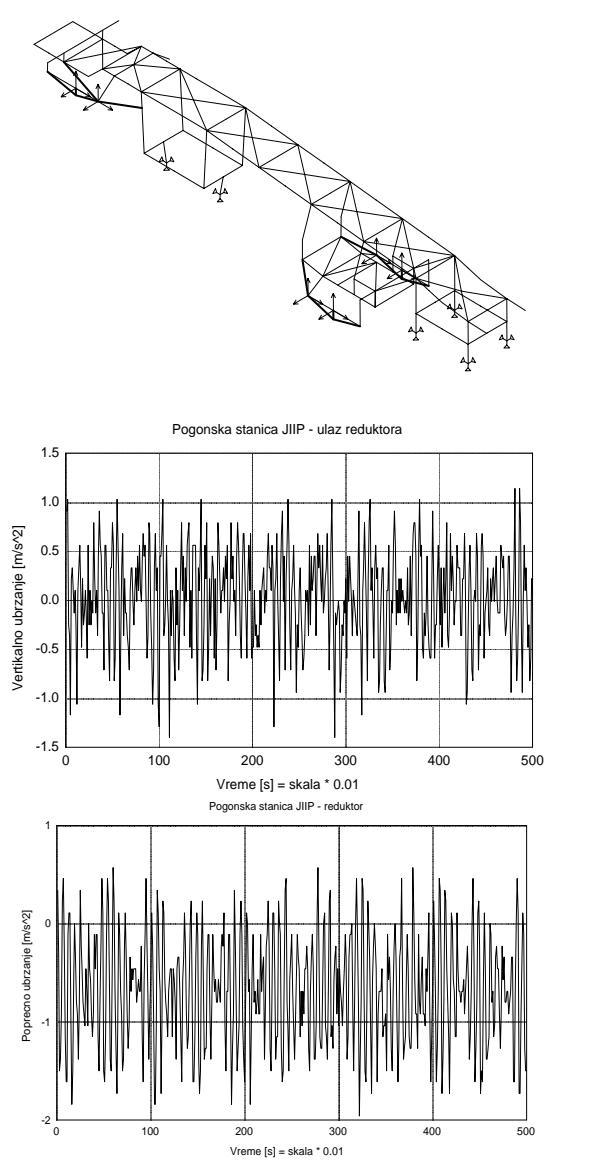
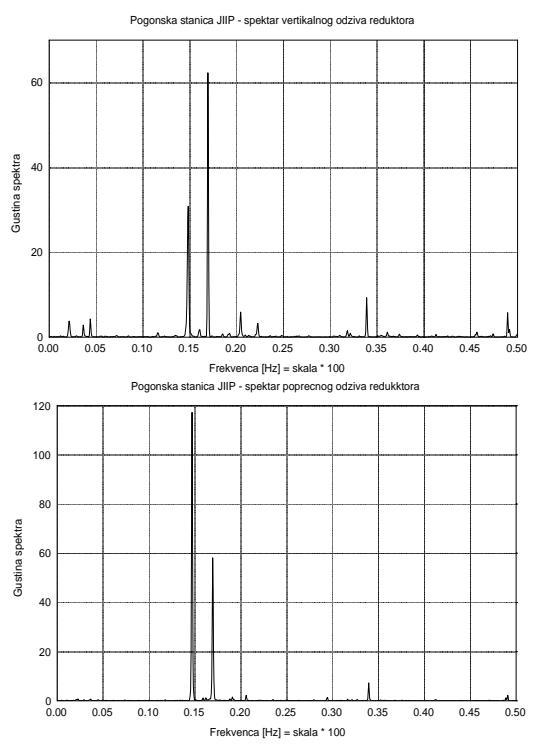
Calculations show only 8 (instead of 12) main oscillation

forms below the motor starting frequency with no

oscillations near it, and so the unfavourable dynamic

behaviour of the structural unit is significantly reduced.

The cause for failure and its effects were minimized.

Figure 10. Numerical model of the reconstruction (top), vertical acceleration (middle left), and transversal acceleration (bottom left) in time domain, and spetrum density in frequency domain (right, middle and bottom).

A proposed solution for reinforcement was obtained by computer calculation, based on a number of models.

Repeated acceleration measurements on the reinforced structural unit verified the correct reinforcement solution.
