SKORAŠNJA ISPITIVANJA NA ZAMOR REALNIH SKLOPOVA F/A-18 U AUSTRALIJI RECENT AUSTRALIAN FULL-SCALE F/A-18 FATIGUE TESTS

Originalni naučni rad / Original scientific paper
UDK /UDC: 629.735.3.018.4
Rad primljen / Paper received: 15.02.2009.

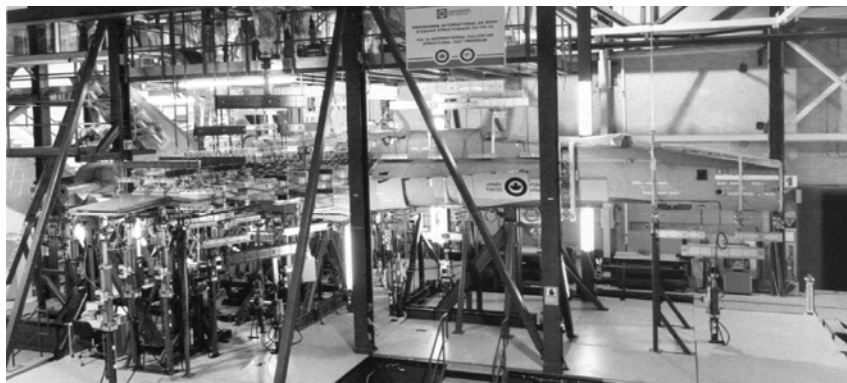
Slika 3. CF-18 IFOSTP ispitivanje na zamor centralnog dela trupa (FT55) u prirodnoj veličini u laboratoriji Bombardir (sada L3)
Figure 3. CF-18 IFOSTP Centre Fuselage Full Scale Fatigue Test (FT55) at Bombardier Aerospace Defence Services (now L3).

The centre fuselage test rig is shown in Fig. 3, with the sample in place. The test piece, of about 700 hours of service life, was taken from the CF fleet. A total of 64 hydraulic actuators, the two main landing gear retract actuators and six static reaction points were used to load and restrain the aircraft. For each of the spectrum load conditions, actuator loads past an optimisation process to best match the calculated loads of the test section. Typically, wing root shear, bending moments and torque and fuselage vertical bending moments were matched to 1.5% of target strains.

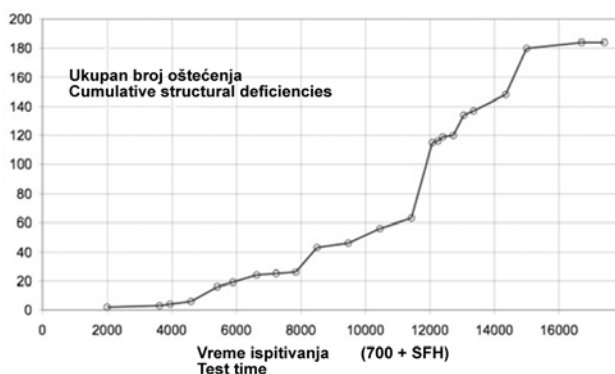
Slika 4. Ukupan broj oštećenja u FT55 u funkciji sati naleta
Figure 4. Summary of FT55 deficiencies vs. flight hours.

Active cycling was finished when the specimen accumulated 17,335 test hours (of which 700 hrs were service flight hours). Residual strength testing was performed and the article was torn-down. Accumulated structural deficiencies vs. test hours are given in Fig. 4. A total of 184 deficiencies were recorded. Fifty-two were found at the 12,000 spectrum flight hours (SFH) and 32 after 15,100 SFH, /8/.

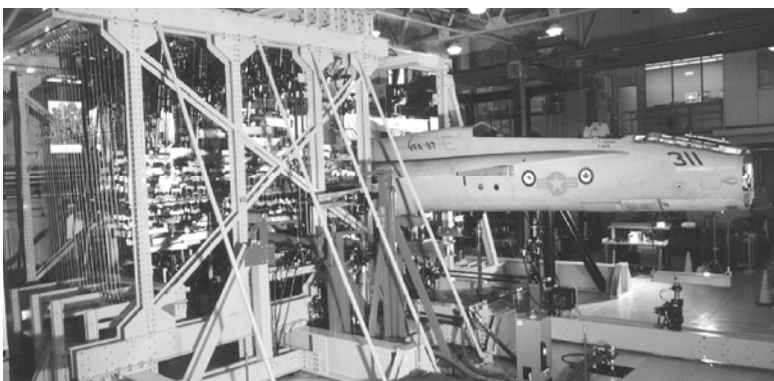
Slika 5. IFOSTP ispitivanje krila (FT245) u Kanadskom nac. savetu za istraž. (NRC) Figure 5. IFOSTP Wing Test (FT245) at Nat. Research Council of Canada (NRC).

The view of the wing test structure at National Research Council of Canada (NRC) is shown in Fig. 5. The primary test article was an ex-service right hand inner and outer wing box. To ensure that loads were properly introduced into this structure, all loading other than direct loads on the wing surfaces was introduced through representative structure (ex-service USN fuselage), including all control surfaces and pylons, which are representative F/A-18 structure.

Loads were introduced via 63 servo-hydraulic actuators: 10 on the fuselage, 12 on three sets of stores, 6 on left stub wing, 2 horizontal and 33 vertical on right wing and control surfaces.

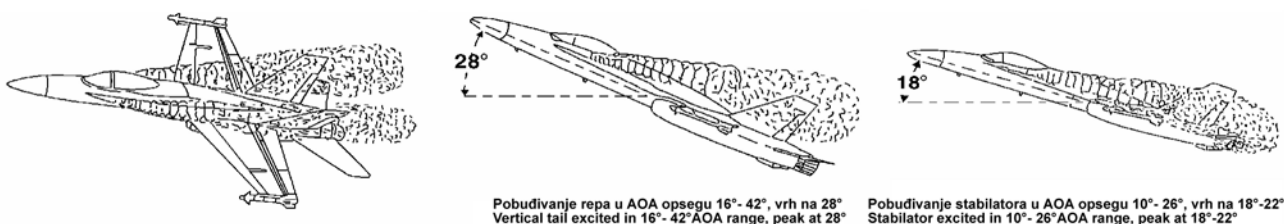
Slika 7. Bafting repa pri visokim AOA
Figure 7. Empennage buffet at high AOA.

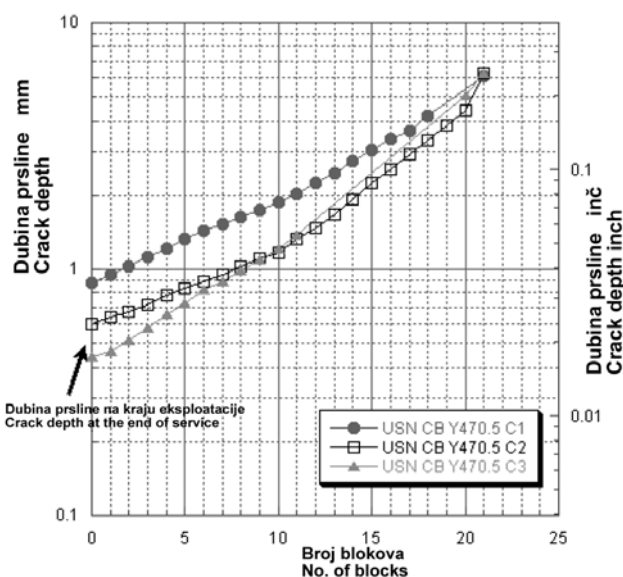
Slika 15. Krive rasta prsline izvedene pomoću QF za sub-prsline na prsline otkaza okvira Y470.5 druge CB
Figure 15. Crack growth curves derived with QF for the sub-cracks at the crack failed the second CB's Y470.5 bulkhead.

also to note that the crack growth appears to be an approximate straight line on a log crack depth vs. life curve, an observation generally found for many fatigue cracks grown in fighter structure loaded with service like loads, /25/.

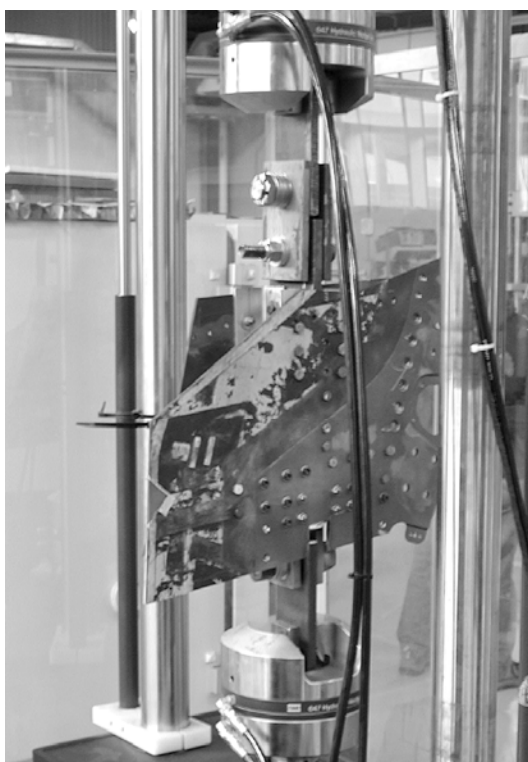
Slika 18. Epruveta druge prekomere (specijale) na 100 kN servo-hidrauličkoj kidalici (levo). Zamorna prsline na zadnjem ligamentu uške.
Bele tačke pokazuju ponavljanje blokova (desno gore). Oblik male prsline (desno dole).

Figure 18. The 2nd oversize specimen in the 100 KN servo-hydraulic test machine (left). The fatigue crack in the lug aft ligament. The white dots indicate the repeats in the blocks (right up). The shape of the small crack (right down).
