## CREEP-FATIGUE INTERACTION ASSESSMENT OF 16Mo5 STEEL PROCENA INTERAKCIJE PUZANJE-ZAMOR ČELIKA 16Mo5

The paper presents an analysis of reliability and remaining life assessment of the reactor (coxing box) from a petrochemical plant, after the failure of the welded joint of the plated shell made out of W1.5423 (16Mo5) steel, 25 mm thickness, plated with W1.4002 stainless steel. The reactor failure has been associated with initial flaws from the welding process, which have accelerated remaining life exhaustion. The assessment was made in two steps. The VII section of ASME code specifications and iRis-Thermo expert system for preliminary remaining life assessment was used. Concomitantly, experimental creep and thermal fatigue testing was performed. The programme results have defined creep and thermal fatigue exhaustion and the remaining life due to creep-fatigue interaction, under the condition of safety exploitation. The possibility to use an extra 40,000 hours of rehabilitated reactor under the safety condition of normal parameters was emphasized.

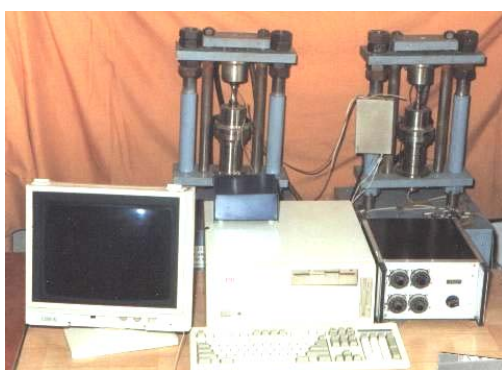
Figure 2. The thermal fatigue testing ISIM's installation.  
Slika 2. ISIM instalacija za ispitivanje termičkog zamora.

Experimental programmes were done using installations, designed and made in ISIM (Fig. 2), /1, 2/. The control programme, signal acquisition for temperature, force and strain, as well as the data processing programme were produced by the Automation Department of the Politehnica University Timișoara, according to ISIM's specification.

The installation is endowed with five interchangeable elastic elements (arcs) with different rigidity in the range 60–300 kN/mm, which provides five imposed levels of the total (or plastic) strain amplitude for the same size of the testing specimen. The installation runs by cyclic loading of a tubular cylindrical specimen or with the calibrated cylindrical section (Fig. 3) with compression mechanical stresses in the heating semi-cycle and tensile in the cooling one. The size on the working section of the specimen is  $\phi 13/\phi 12$  and the fixing ends are M16.

The installation is designed to work with two independent testing groups. Each testing group receives the command for the heating semi-cycle by the software from the PC by means of a CAN channel of the interface to the power adjusting system by thyristors of the specimen heating element.

The heating is achieved through radiation from a halogen lamp. Each testing group receives the command for the cooling semi-cycle through the software of the computer. It is made by means of some CAN channels of the interface to the control system of a pneumatic distributor coil, which allows the air access (or the access of an inert gas) on the calibrated section of the testing specimen. The command to hold the time at  $T_{max}$  and  $T_{min}$  is given through software with the corresponding adjusting of the heating element. As a consequence of the cyclic variation of temperature and of the partial blocking of the ends of the testing specimen, stresses and deformation appear, which exceed the material yield limit in the elastic-plastic field.

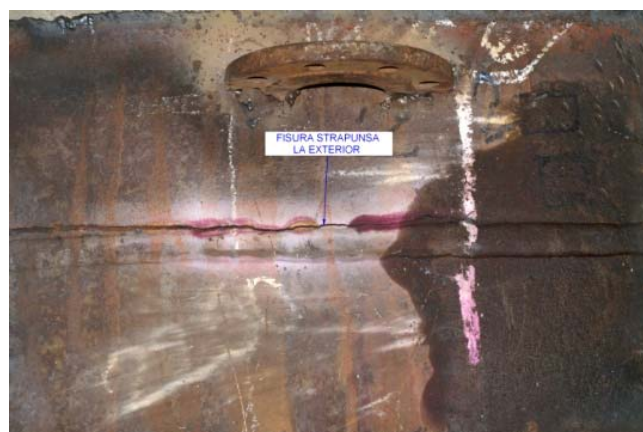
Figure 4. Coupon 2 – exterior view, with crack.  
Slika 4. Presek 2 – spoljni izgled, sa prslinom.

After 60.000 hours of exploitation, failure occurred. The welding defects, amplified by the hydraulic pressure test, lead to propagation of initial cracks to macroscopic dimensions. The result was the interruption of operation. Defects were detected by inspection (Figs. 4 and 5).

From supplementary macroscopic examinations, the area presenting cracks was identified as damaged, thus imposing the repair welding between the rings. In the cracking and fracture zone, the tampon layer is in contact with the working medium and it is unprotected to a charge welding compatible with the plate.

The bend test of the welded joint with the plate on the tense fibre shows a low capacity to cold deformation. This can be another complementary cause of the cracks to initiate in the passing zone between the plate and the welding to the plate. The high thickness of the tampon layer characterised by hardness, high mechanical resistance and with the fragile constituents, leads to the propagation of the initial cracks in the corrosion protective layer.

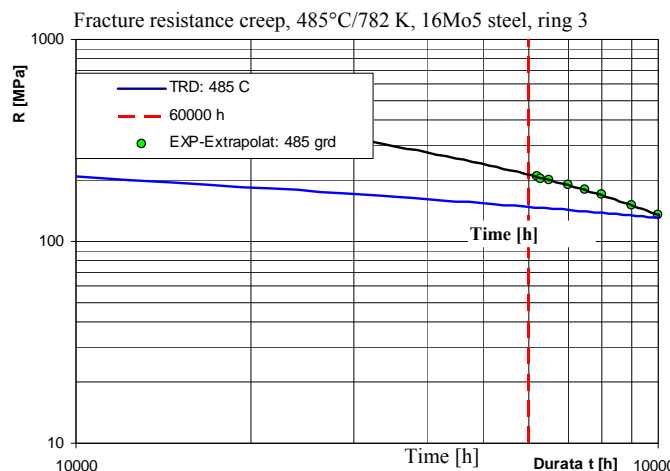
Figure 8. The creep results for ring 3.  
Slika 8. Rezultati puzanja za prsten 3.

The conclusions of the remaining life – the final creep data – step 3, are presented in comparison with the TRD curves at 485°C/782 K. The creep fracture curves are experimentally determined on 34 samples from the reactor (rings 2 and 3) (Figs. 7 and 8). The evaluations present the exploitation durations which are less than 60 000 hours.

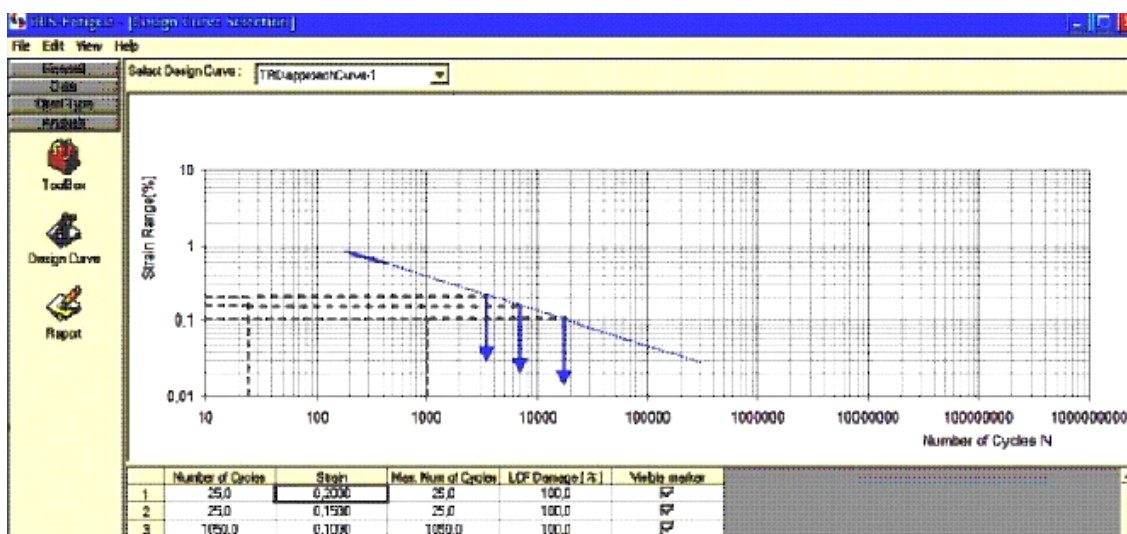
Figure 10. The projection curve to thermal fatigue from the thermal fatigue tests, according to TRD 301 method.  
Slika 10. Projektna kriva za termički zamor na osnovu ispitivanja termičkog zamora, po metodi TRD 301.

Fig. 9. Tests were made on the IIOT-2 installation designed and produced by ISIM Timisoara, /1, 2/, respecting the requirements of the test standard ASTM E606 and of statistic calculation /6, 7, 8/. In Fig. 10, results from the expert system for the projection curve determination TRD 301 method, are presented.

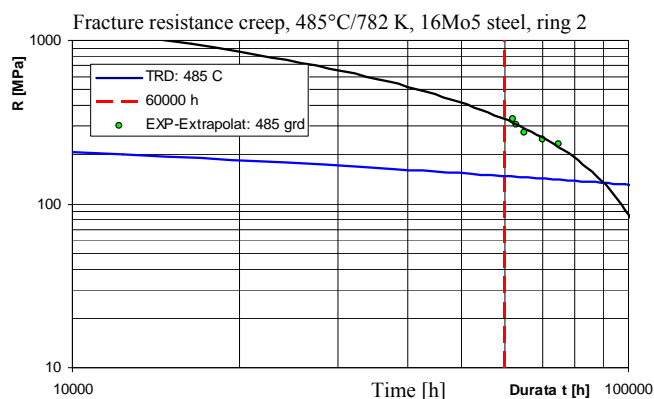
Figure 11. Creep results for ring 2.  
Slika 11. Rezultati puzanja za prsten 2.

Results of the remaining life assessment from creep tests are presented in Figs. 11 and 12, in comparison to the TRD curves at 485°C/782 K, of fracture resistance creep curves determined experimentally on 27 samples from the reactor. The evaluations allude to the exploitation durations which are less than 60 000 hours.

Analysing the creep results, Figs. 11 and 12, it is evident that the inspected material has creep characteristics superior to the TRD projection curve for other 40 000 exploitation hours in respect to the designed condition.

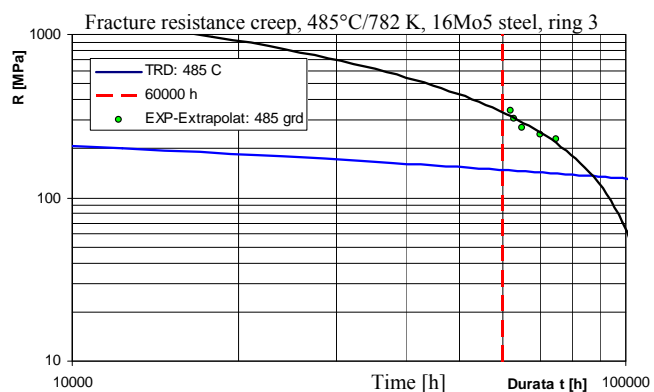
Figure 12. The creep results for the ring 3.  
Slika 12. Rezultati puzanja za prsten 3.
