A. Sedmak¹, K. Čolić², Z. Burzić³, S. Tadić²

STRUCTURAL INTEGRITY ASSESSMENT OF HIP IMPLANT MADE OF COBALT-CHROMIUM MULTIPHASE ALLOY

Originalni naučni rad / Original scientific paper
UDK /UDC: 669.295, 615.46:616.314
Rad primljen / Paper received: 02.07.2010

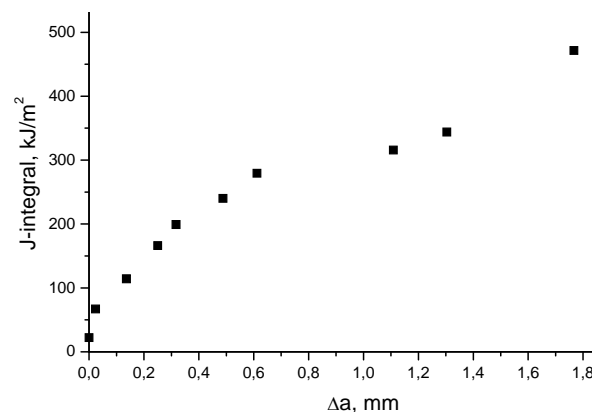
Figure 7. J-R curve for MP35N alloy.

Elastic-plastic fracture mechanics parameters were tested in three point bending (standard Charpy specimen, pre-cracked: $a_0/W = 0.545$; $L = 4W = 40$ mm, $B = W = 10$ mm). Results are given as J - Δa static curve, both in graphical form, Fig. 7, and in Table 3. The $J_{Ic} = 130$ N/mm and corresponding $K_{Ic} = 165$ MPa \sqrt{m} (for $E = 210$ GPa).
