DAMAGE OF PIPELINES BY SANDBLASTING AND HYDROGEN OŠTEĆENJA CEVOVODA PESKIRANJEM I VODONIKOM

Original scientific paper
UDC: 620.169.1 : 621.643.2
Paper received: 31.01.2011

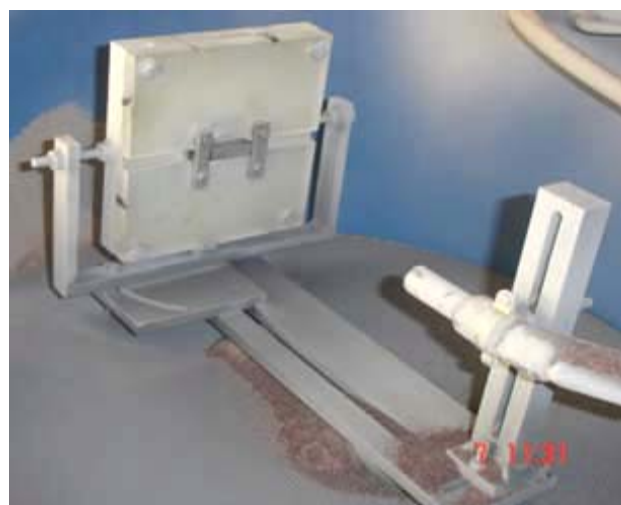
Figure 4. Specimen holder assembly.

In order to adjust the projection angle of the abrasive and to concentrate the particle impact on a predefined area, an assembly is made, Fig. 4, with the following properties: nozzle diameter of 8 mm, an average sand feed during the erosion tests is about 1.57 g/s, an impact angle between the sand particles and the specimen surface is 90° , a distance between the nozzle and the specimen is 200 mm (allowing for sand particles to impact all of the notch area), an air pressure of 4 bar and a sandblasting duration varying between 60 and 480 min.

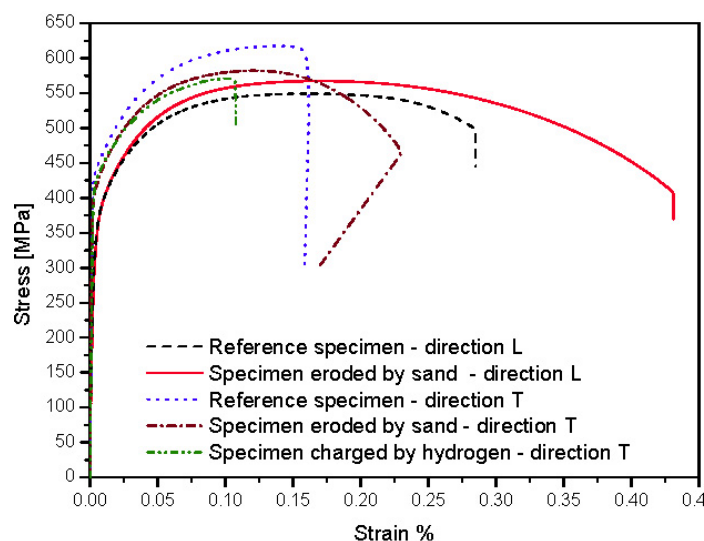
Figure 7. Behaviour law of pipeline API 5L X52 steel in both L and T directions.

The stress strain curves, Fig. 7, represent one test of each configuration. The average values of all tests are presented in Table 4.

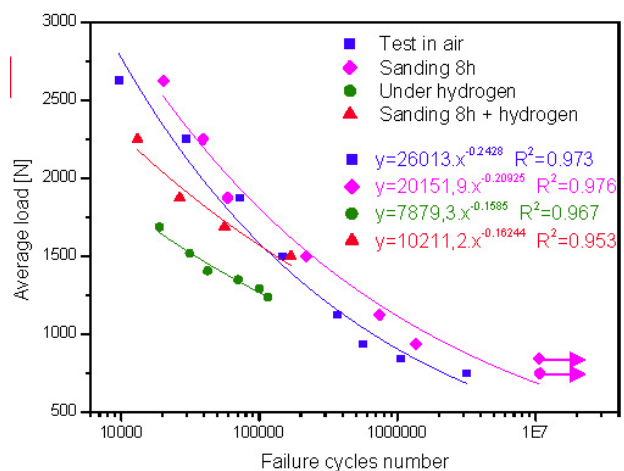
Figure 11. Wöhler curves for pipeline API 5L X52 steel.
Slika 11. Velerove krive za čelik cevovoda API 5L X52

Wöhler curves obtained from 3 point bending tests, for different cases, are presented in Fig. 11. These curves show that sandblasting increases life duration and hydrogen decreases it. The beneficial effect of sandblasting is due to three main parameters: a) local hardening; b) residual stresses are in compression at the notch bottom (Fig. 12); c) notch radius increases during sanding. After 8 hours of sanding, the radius increased from 0.15 to 0.44 mm, Fig. 9.

The gain in material lifetime by sandblasting, compared with the reference one (fatigue test in air carried out on reference specimens), is a function of applied load. This value varies from 32% at the highest load (more than 2250 N) to 143% for a load less than 1000 N.

By comparing the lifetime curve under hydrogen with the other one in air, we notice that hydrogen is very harmful to the material life. It causes reduction to 81% for a load of 1688 N and 58% for a load of 1238 N. During three point bending test in hydrogen, the large density of dislocations in the middle of the specimen, where stresses are highest, act as traps for hydrogen. The hydrogen influence and material microstructural change (in terms of grain size, Fig. 13) are responsible for the severe drop in material lifetime.

Concerning the material affected by hydrogen and sand impact, lifetime depends on the applied load. For a high load, lifetime decreases (Fig. 11); it is -55% for a load of 2250 N. The more the applied loading decreases, the less important is the drop in lifetime. From a load of 1500 N, life duration is equivalent to that obtained for a specimen tested in air. The combined effect of hydrogen and sandblasting is then cancelled.
