**THE STRUCTURE FAILURE OF THE DISCHARGE BOOM OF BUCKET WHEEL  
EXCAVATOR C 700 S DUE TO DYNAMIC EFFECTS**  
**LOM KONSTRUKCIJE STRELE ODLAGAČA ROTORNOG BAGERA C 700 S USLED  
DINAMIČKIH UTICAJA**

Originalni naučni rad / Original scientific paper  
UDK /UDC: 621.879.48.016  
Rad primljen / Paper received: 21.01.2012.

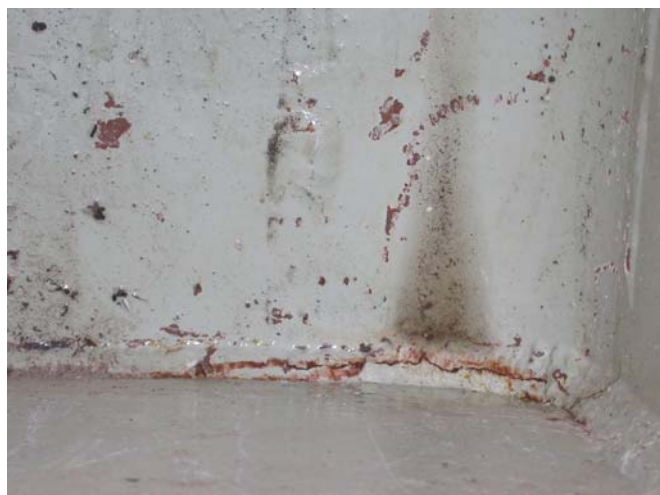
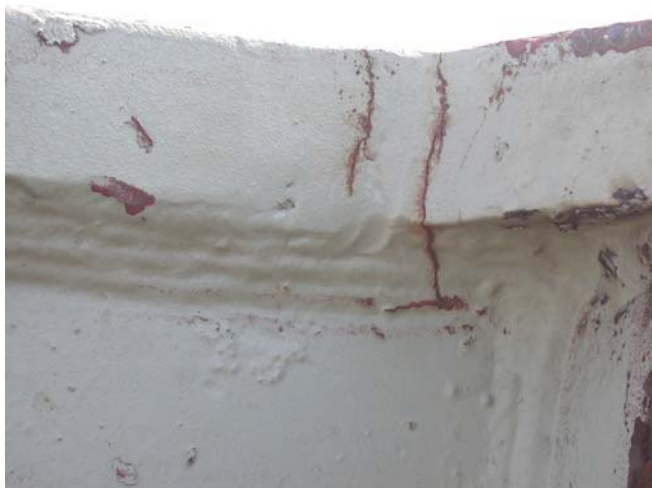
The operation of the BWE (Bucket Wheel Excavator), Figure 1, is often tracked with a very bad dynamic behaviour of the discharge boom. In the case of C700 S BWE, bad dynamic behaviour is reinforced by the appearance of resonance, where the amplitude of oscillations reaches up to 60 cm. This has led to a deterioration (cracking phenomenon) of the elements of the discharge boom, Figure 2.

This is especially emphasized on the supporting structure of the lifting boom cylinder.

Figure 2. Cracks on the mast of BWE.

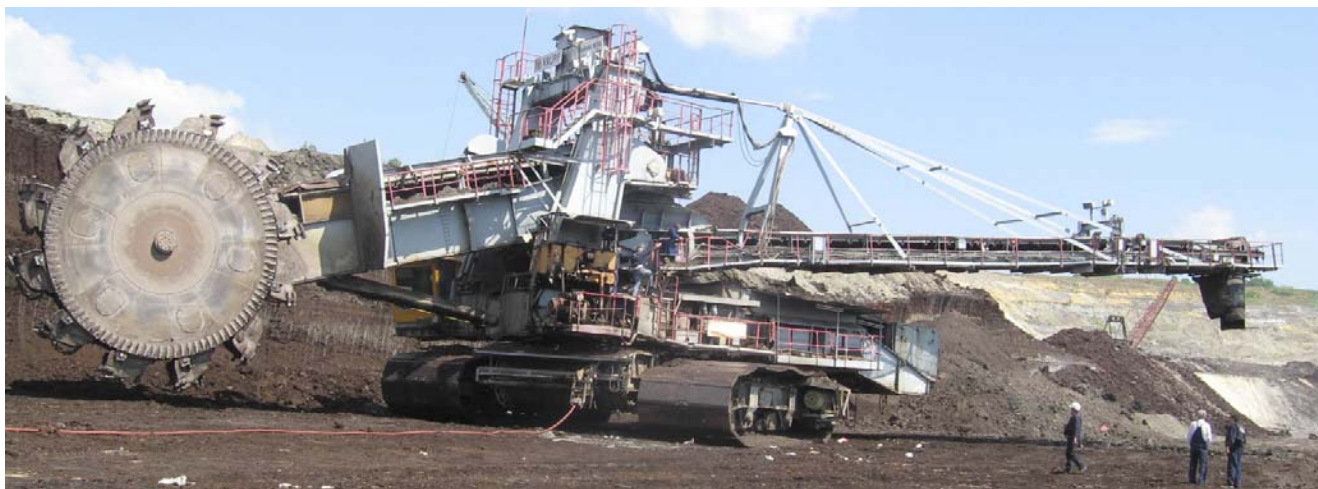
As we can see in Figure 9, reconstruction is carried out successfully, according to research, as it is shortly shown above. There are no cracks at critical points.

Figure 9. BWE C700S after reconstruction with added new tension rods.  
Slika 9. BWE C700S posle rekonstrukcije sa dodatnim novim zategnutim elementima (štapovima)

- 1) installation of two new tension rods, and
- 2) the removal of the small house for harmonisation of conveyor work.
