## CASE STUDY OF THE CHAIN EXCAVATOR STUDIJA OŠTEĆENJA LANČANOG BAGERA

Originalni naučni rad / Original scientific paper  
UDK /UDC: 620.17:621.879.4  
Rad primljen / Paper received: 21.01.2012

The chain excavator is the main technological part of a cleaning machine which is used for technological operation of railway maintenance. The purposes of the sub-assembly are to excavate the crushed stone (ballast) from the railway, under the sleeper and to transport it to the screen, where it is cleaned, sorted and reused. The chain excavator is loaded in bending, abrasive wear, shock, tension and other stresses. Due to these stresses, the chain excavator has defects as fractures, fatigue, wear and other. These defects can lead to a dangerous malfunction, defects, or immobilizations of the cleaning machine with risks for safety work and important losses of productivity and value. In this paper we establish and present the stress system, wear zones and some defects and fractures of elements of the chain excavator. Another important novelty is the FEM analysis using CAD for some extreme stress cases and the comparison of this analysis with experimental conclusions in situ. Effects of some

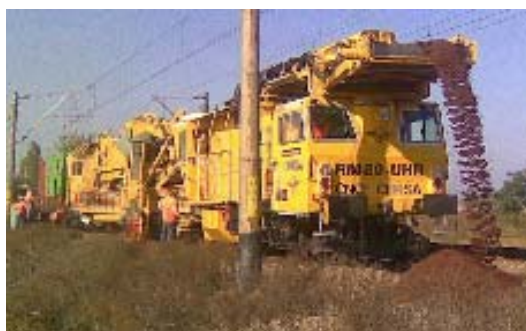
Figure 2. Ballast cleaning machine.

The technological operation by cleaning of the ballast prism is made by the ballast cleaning machine. The chain excavator takes the ballast bed material from the track. A cleaning railway machine is presented in Fig. 2. This type of excavation chain uses five exchangeable scraper fingers. The chain links are made of high-alloyed steel (Fig. 3).

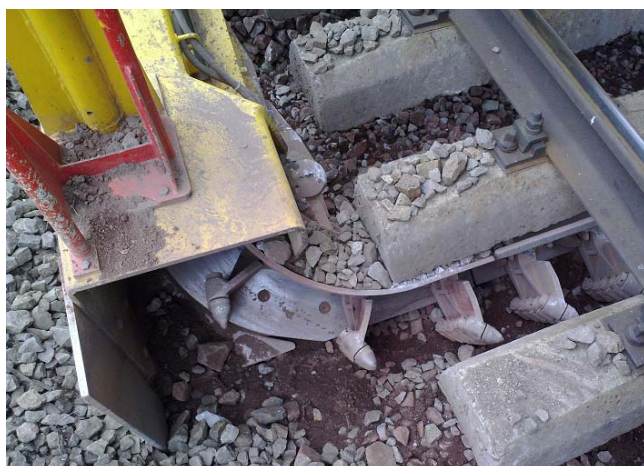
Figure 3. Chain excavator.

The high-alloyed steel is of 120Mn12 or TMn13. The chemical composition (% wt.) and mechanical properties are given below in Table 1.

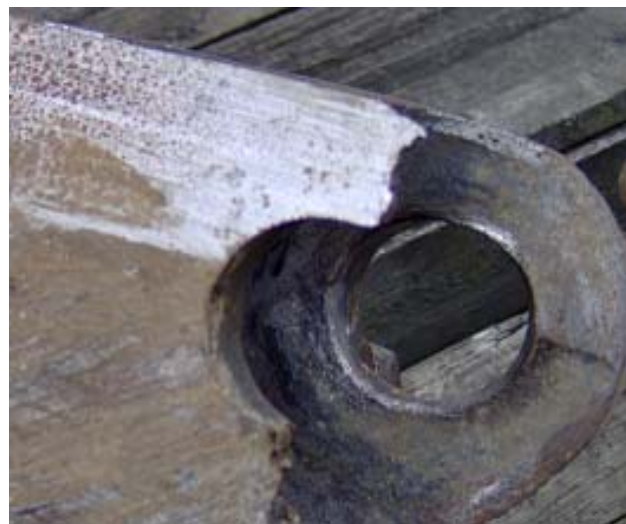
a. In the contact zone, between the surfaces of chain elements with the ballast prism, the stones forming the “wall” behind the chain excavator have a wear-like action on the metallic elements of the chain that are in motion. If the contact between the metallic elements and the stone is made through a corner or a sharp edge, in favourable stress conditions, a cutting type phenomenon occurs that leads to the removal of a portion of the metal. This removal of metallic material will produce a scratch, whose dimensions will depend on several factors (Fig. 4). The scratch may act as a tension accumulator, with corresponding consequences on the maximal tension state of the analysed area, or it may contain a crack/microcrack. In the interior of the scratch, it is possible that microcracks may exist, which in favourable conditions can evolve over time. The wear phenomenon has been previously studied [2-5].

Figure 4. Wear of the chain elements by micro cutting.

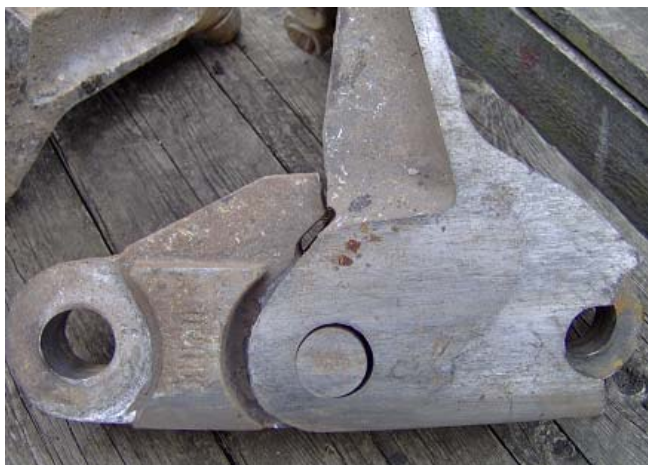
b. If the contact takes place on larger surfaces and is smaller in intensity, then a normal wear phenomenon occurs (Fig. 5), which over time reduces the dimensions of metallic elements that form the chain (Fig. 10).

c. Wear can also appear at the contact between metallic elements that form the chain. In this type of joint, the dust (dry or wet), in the beginning having dimensions of a very small particle, enters in between the moving elements (Figs. 5, 6, 7). During the movement time, the wear phenomenon increases the space between moving elements, so larger rock particles may enter. In this way, the wear phenomenon continues to accelerate.

Figure 5. Normal wear of chain elements on contact surfaces (sliding).  
Slika 5. Normalno trošenje elemenata lanca, na dodirnim površinama (klizanjem)

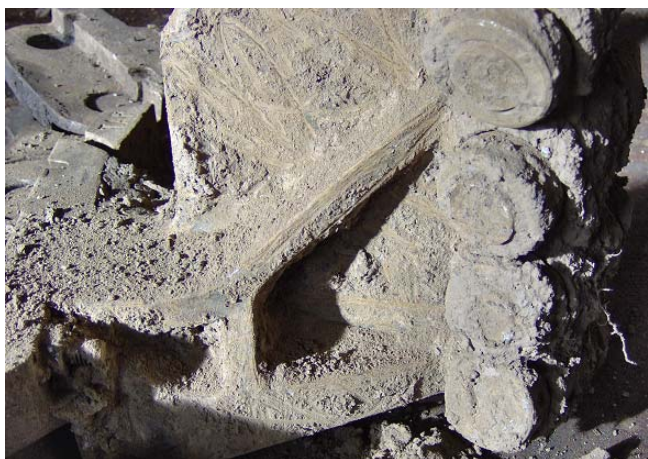
Figure 6. The chain excavator where there are deposits of particles that favour wear.  
Slika 6. Lančani bager na mestu naslaga čestica koje izazivaju trošenje

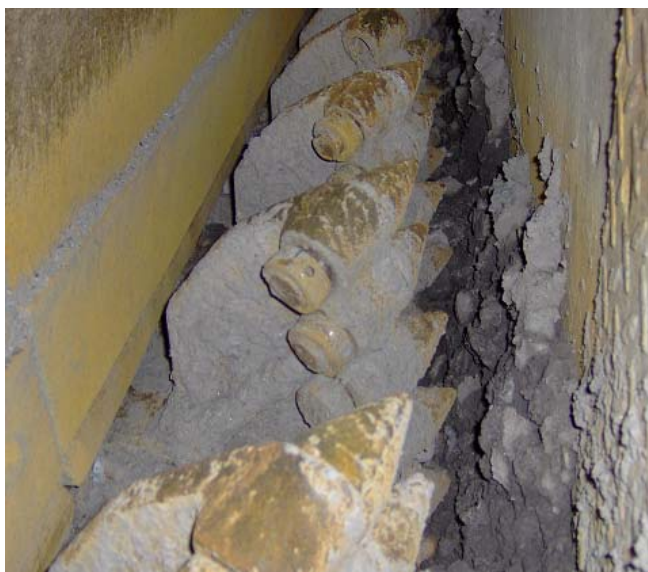
Figure 7. The chain excavator where there are deposits of particles that favour wear.  
Slika 7. Lančani bager na mestu naslaga čestica koje izazivaju trošenje

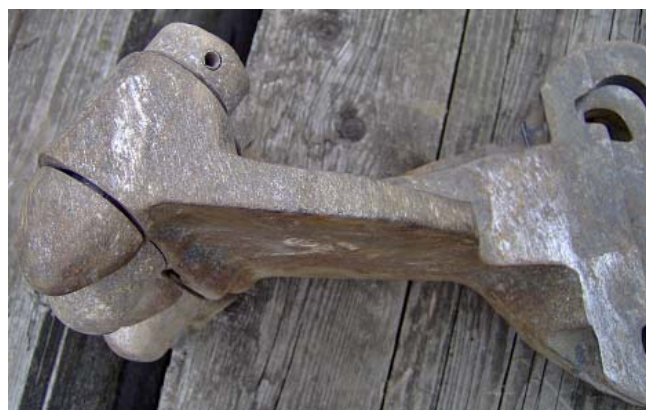
d. Wear at the corner of scrapers. The scrapers have a conic shape with a corner at the end. The contact between the scrapers and crushed stone produces wear, which leads to the increasing of the corner's radius (Fig. 8).

Figure 8. Wear of the scrapers.  
Slika 8. Trošenje strugača

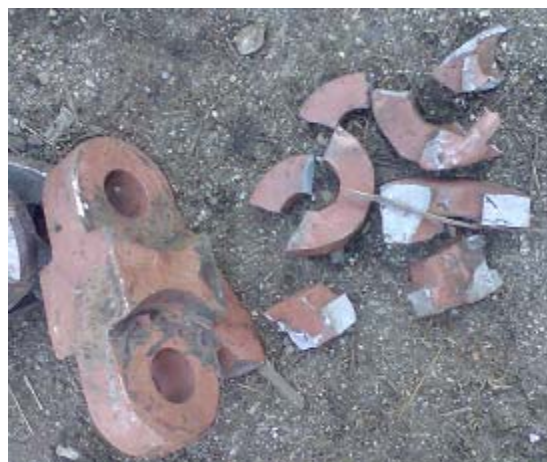
e. Fracture of metallic elements of the chain. This phenomenon has been observed in the connecting chain links and scraper shovels, also. (Figs. 9, 10).

Figure 9. Fracture of chain elements (connecting chain links).  
Slika 9. Lom elemenata lanca (vezne karike)

In general, the majority of fractures occur in the bolt assembling area. From analysing the fractures, we observe:

- fractures occur in the case of overloads determined by foreign elements in the ballast or by stones from the ballast which are joined (“glued together” or clogged) by dust mixed with water, oil and similar processes;
- fractures appeared only in areas of high wear in the presence of concentrators leading to the decrease of dimensions in the assembling bolt areas (Figs. 4, 5 and 10);
- when fracture did not occur in an area with high wear, the structure of the material was analysed, and structural defects in the material were noticed (Fig. 9);
- fracture does not occur in normal functioning conditions;
- the wear is at an acceptable level in normal functioning conditions.

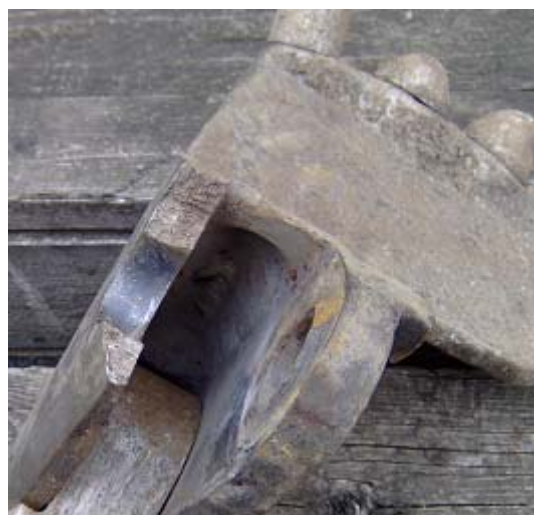
Figure 10. Fracture of chain elements (scraper shovel).  
Slika 10. Lom elemenata lanca (kašika strugača)

The plating of the areas that are exposed to strong wear phenomena with materials that have a high resistance to wear can be a solution, especially for the scraper shovel.

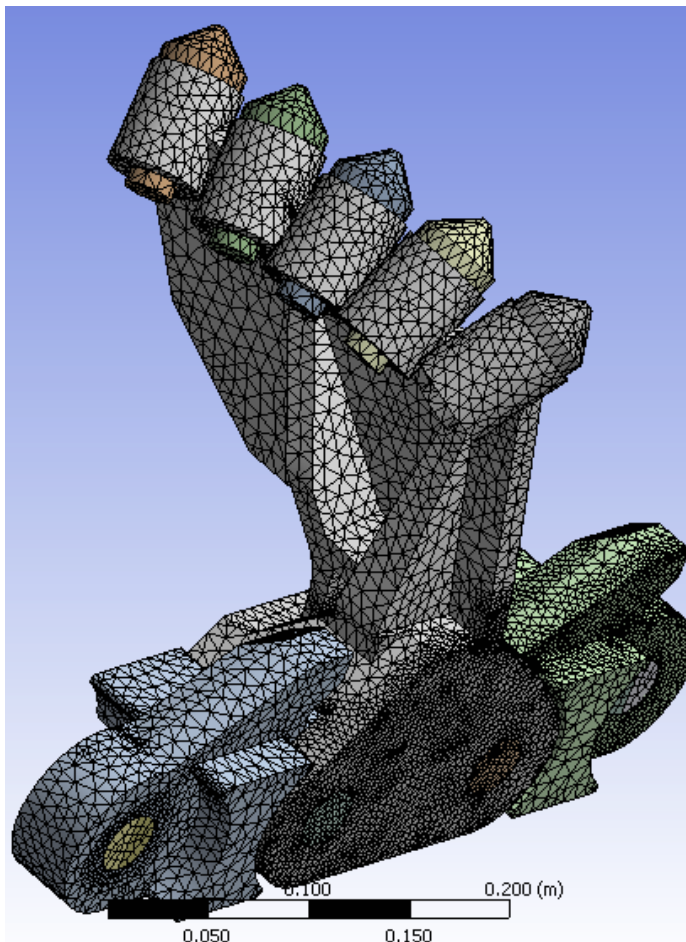
The simulation of stress states using the finite element method (FEM) is realised through Ansys Workbench 12, Academic version. A fine mesh (Fig. 12) is used with the refining of the areas of interest. Over 1 million finite elements are used.

Figure 12. Meshing of the chain excavator elements.  
Slika 12. Mreža elemenata lančanog bagera
