## **NON-DESTRUCTIVE SMALL DEFECTS DETECTION OF GFRP LAMINATES USING PULSED THERMOGRAPHY**

Originalni naučni rad / Original scientific paper  
UDK /UDC: 620.179.13  
Rad primljen / Paper received: 21.01.2012.

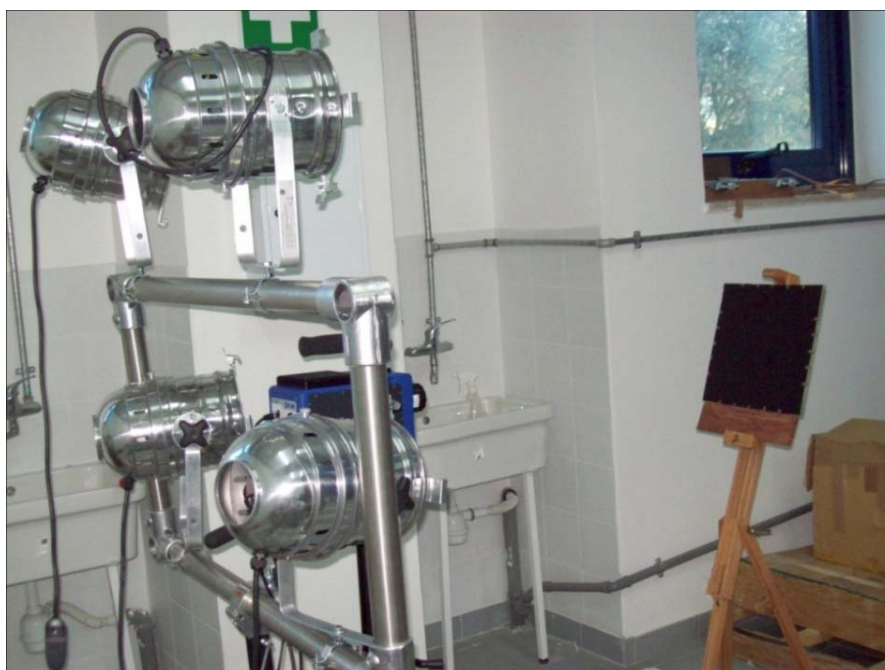
The analysis on specimens 1 and 2 is realized with a reflection thermographic set-up, with the light source and the thermal camera from the same side, and the simultaneously turning-on of three 1000 W halogen lamps, located at a distance of 1 m from the specimen (Fig. 1) at specific and optimised angles.

Figure 1. Thermographic set-up for specimens 1 and 2.

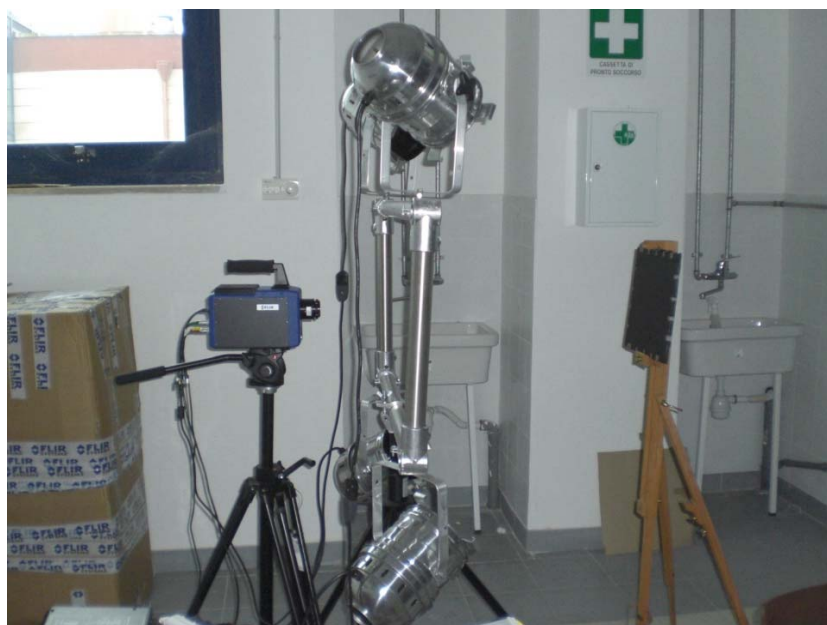
Figure 3. Thermographic set-up for specimen 3.
