## WAYS OF DETERIORATING THE BALLS WITH STRUCTURAL GRADIENT FROM THE VALVES USED IN THE OIL EXTRACTION INDUSTRY

Originalni naučni rad / Original scientific paper

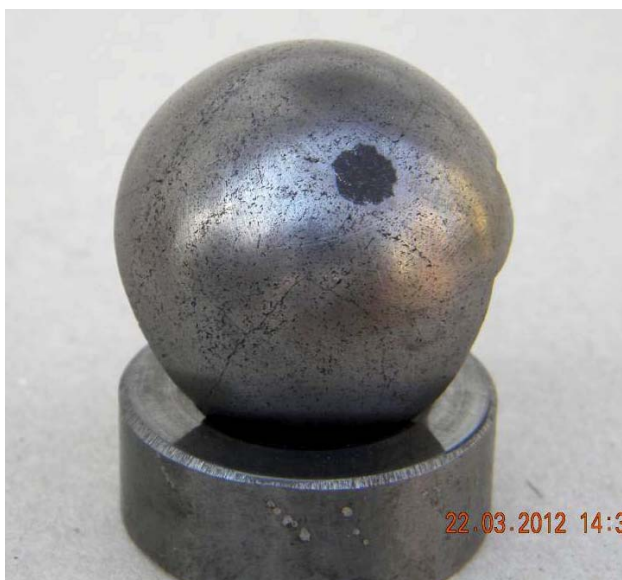
Figure 3. The valve (ball and seat) of piston pump for oil extraction.  
Slika 3. Ventil (kuglica i sedište) pumpe za izvlačenje nafte

Figure 3 shows abrasion areas more or less pronounced.

The extracted oil contains a number of solid abrasive materials (e.g. sand). These granules, many of which have sharp edges, produce a phenomenon of abrasion. Small scratches get worse during operation and produce a preferential flow of the fluid. In this case an accelerated wear with undesirable effects on the sealing ability of the ball-valve seat assembly occurs. The phenomenon can occur both on the ball and on the valve seat. The type of material chosen for manufacturing the two components has a major influence on the life of the assembly. The decommissioning of the whole assembly, or of a component, is made when it is no longer possible to ensure the sealing. Note that areas with accentuated wear contain micro-cracks. In the corresponding situation of a state with thermo mechanical stresses, these micro-cracks can join or increase, stable or unstable.

The most dangerous situation occurs when the “scratch/lack of material” on the ball and/or the seat is in the sealing area of the ball/seat assembly valve. In this case, the fluid that leaves the little channel has a much higher speed than if the seal is open. Abrasive materials in the fluid have a greater effect in the case of flowing through the little channel with high speed. Deterioration is also increased by the superposition of corrosion and abrasion produced by abrasive fluid flow with stress effect due to the contact in the sealing area. In this case, cracks/wear open and the

aggressive/corrosive/abrasive environment increases the depth of deterioration. The most possible situation is produced by exposing the tungsten carbide crystal so much that it is pulled from the remaining binder. In the first phase, the tungsten carbide crystal has an abrasive effect on the adjacent area.

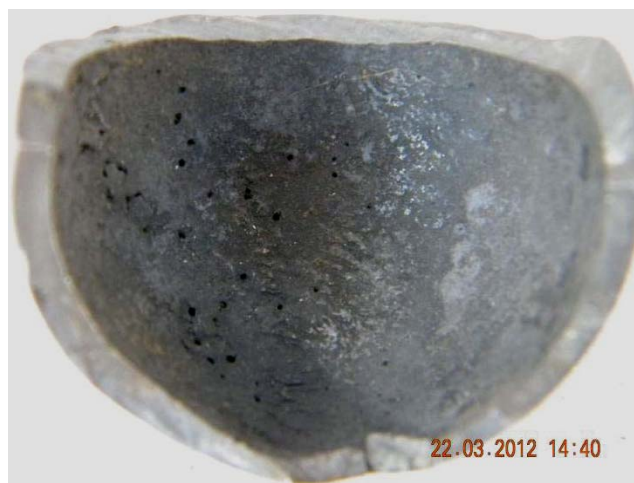
e.1. the appearance of a separation surface (poor sintering between manufactured layers when the ball is made using multilayer technology). This type of defect can be detected by using CND so that the balls with manufacturing defects

are not introduced into use (Fig. 4); Pores occur due to the poor preparation of the contact surfaces which allow the occurrence and capture of gases (generally produced when the temperature rises).

Figure 4. Defect of the ball by breaking of the outer layer.

f. Deterioration by separating the bodies in two or more pieces, deterioration of fragile type produced by already existing cracks which rapidly grow to critical size when the sudden rupture occurs (Fig. 4 and 5).

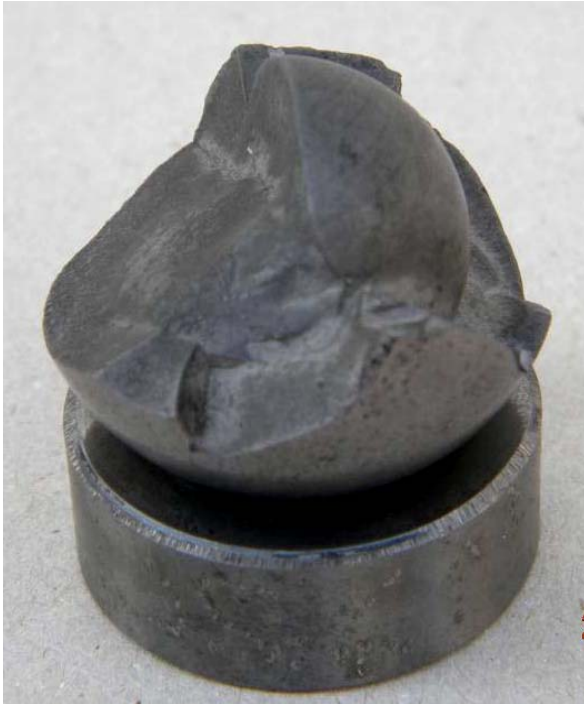
Figure 5. Defect of the ball made by the breaking of the outer layer and a piece of initial ball.
