REHABILITATION OF RESIDENTIAL BUILDING WITH CORROSION DAMAGE: CASE STUDY IN AMMAN (MARJ - ALHAMAM), JORDAN

Originalni naučni rad / Original scientific paper
UDK /UDC:

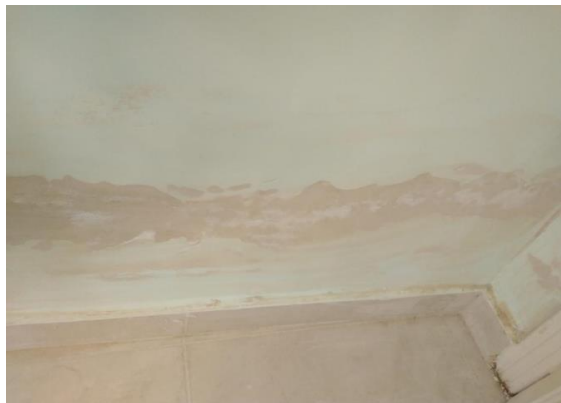
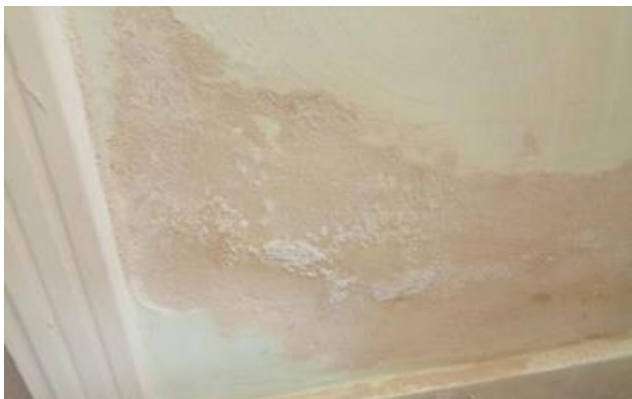
Aggressive damp attack can be seen in the following photos on the interior walls of the building in June 2019, (Fig. 4).

Corrosion and damp damage resulted as a lack of drainage system surrounding the foundations, where water remains around them without being discharged using appropriate technique.

Figure 4. Damp on different locations of the internal walls.

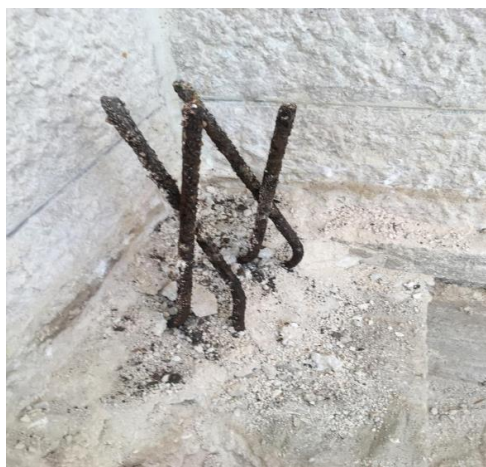
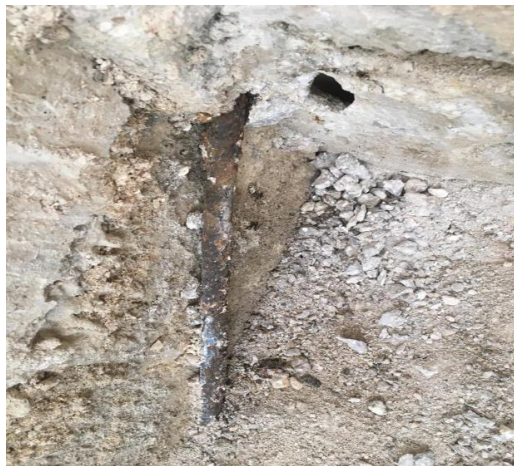
The following photos (see Fig. 5), illustrate the corroded steel reinforcement of foundation and structural parts. As can be noticed, the rebar is totally corroded.

Figure 5. Corroded steel reinforcement bars.

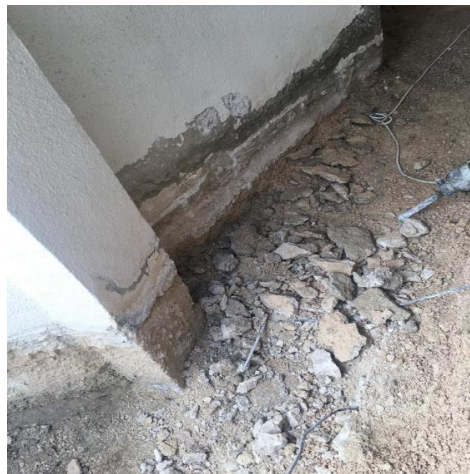
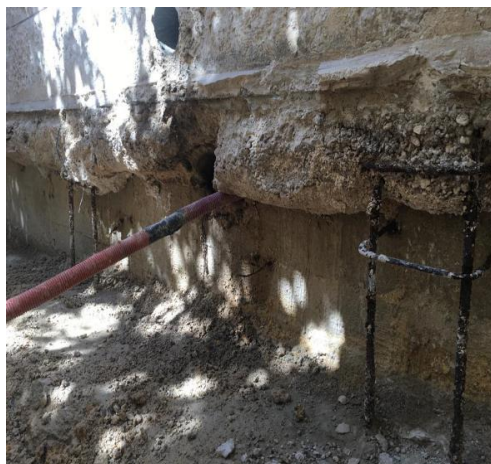
Figure 6. Excavation works.

The first step is to uncover the damaged part of columns, foundations, walls, and their surroundings, as shown in Fig. 6.

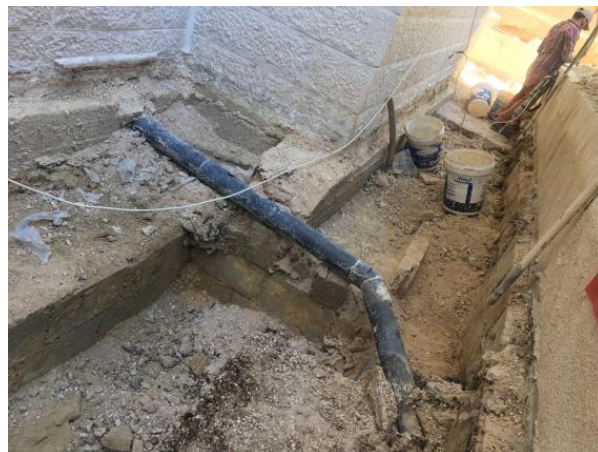
Figure 7. Water channel.

Secondly, A water drainage channel is created along the side of the building to provide a path for water to follow, as shown in Fig. 7.

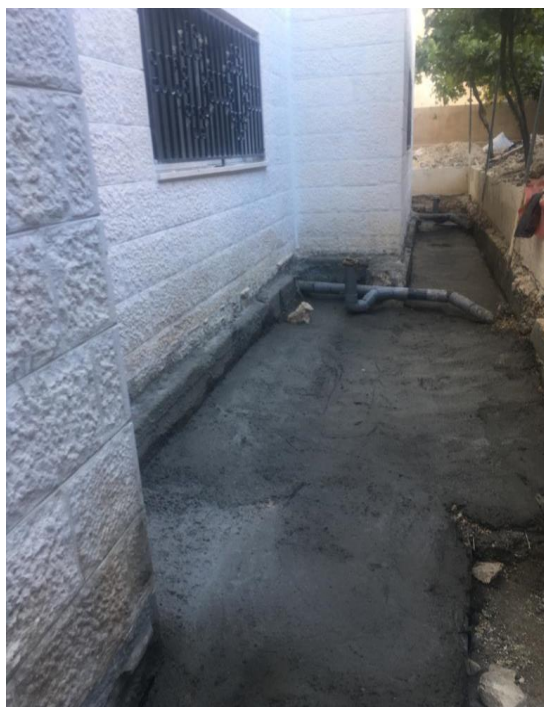
Figure 8. Casting of concrete before flooring.

Then, the two retaining walls are constructed on both sides to work as a barrier for the water seepage. The fourth step is to construct a sloped base that forces the water to flow towards the channel onto the other side of the foundation. As the isolation is an important part of the construction, columns and foundations are isolated by bitumen.

Apparently, the whole system is isolated by concrete covering it as shown in Fig. 8.

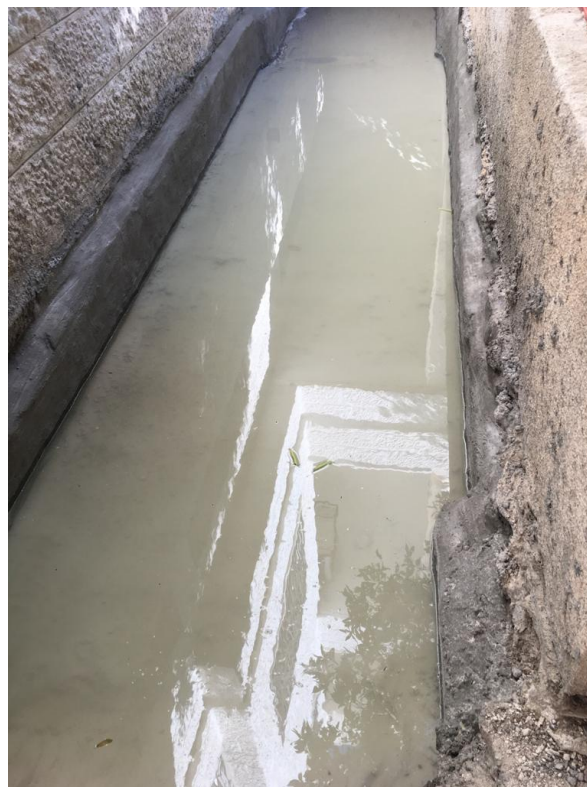
Figure 11. Seepage testing technique.

To test the seepage and if there is any leaking in the system, a massive amount of water is pumped into the constructed system, where it was left for about two weeks, Fig. 11. No seepage, leaks or damp have been seen around the system which has proved it was a successful process of isolation.
