OILY-WATER TANK OPERATIONAL RELIABILITY ANALYSIS IN AN OIL AND GAS FACILITY

Originalni naučni rad / Original scientific paper
UDK /UDC:

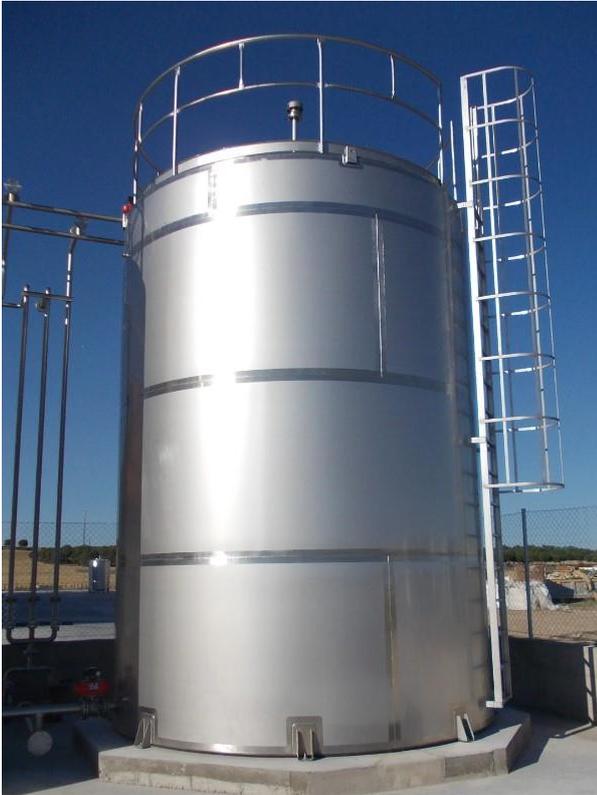
Figure 1. External view of tank with cone roof.

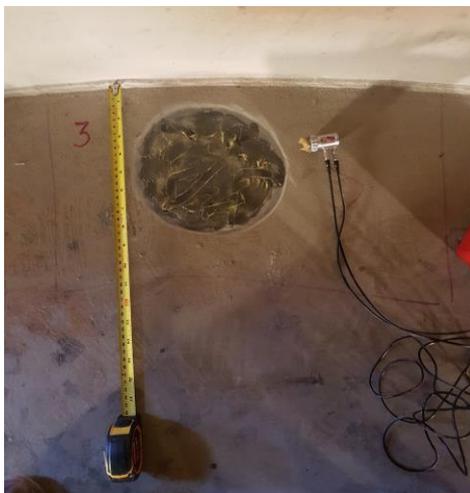
According to the created ultrasonic thickness schemes, ultrasonic thickness measurements are conducted on the cylindrical shell and tank bottom. Figure 5 is related to tank cylindrical shell while Fig. 6 is related to tank bottom. Tank bottom measuring points are shown in Figs. 7 and 8, according to the prepared random ultrasonic scheme. Values of measured thicknesses are shown in Tables 3-4. Obtained values of tank bottom thicknesses are additionally analysed and it is concluded that the inspected tank bottom is near the end of its service life, so tank bottom repair is strongly required in order to avoid possible fluid leakage in the future.

Figure 7. Thickness measuring points according to the created random ultrasonic schemes.

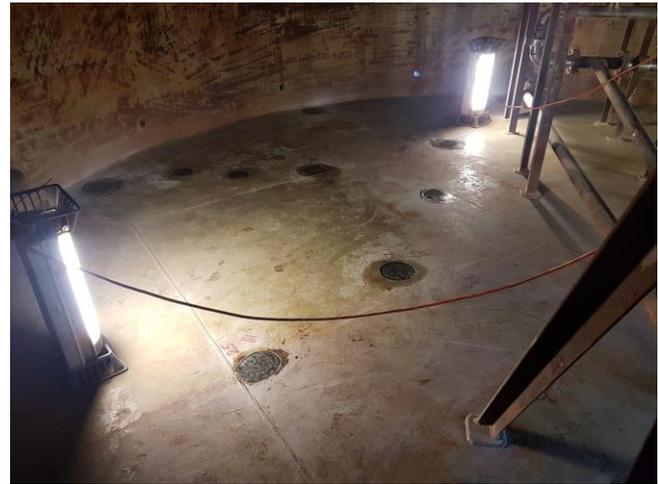
Figure 8. Thickness measuring points according to created random ultrasonic schemes.

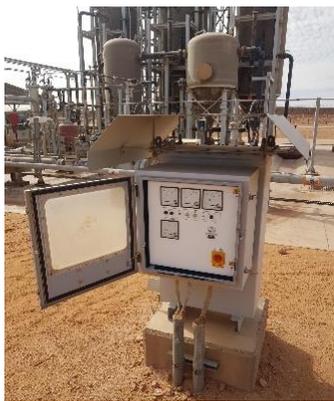
Together with thickness values, internal coating thickness is measured and found to conform to design specifications. According to the previously presented, it is concluded that decreasing of thickness is coming from the 'soil side' of the tank bottom, because the coating on the internal side of the tank bottom is found to be in good condition in time of inspection. For finding the root causes of tank bottom decreasing thickness, additional analysis of the cathodic protection of operating devices has been undertaken. The cathodic protection system cabinet (Fig. 9) was opened, and current and voltage values were found at zero value.

Figure 9. Cathodic protection cabinet after opening and current stimulation from control room.

The main power switch was put in appropriate positions and additional stimulations of currents from the plant control room were performed for determining impressed current anodes. According to current/voltage values in control room displays, it is established that sacrificial anodes were fully spent. Considering these facts, the root cause of accelerated corrosion of tank bottom is found. Functionality of the overflow protection system is tested during cathodic protection system analysis. According to instrumentation values in the control room, the system is found to be working properly.

For needs of tank bottom full repair, full cutting of existing tank bottom plates and their replacement with new ones is required, and installation of the new cathodic protection system. It should also be mentioned that before starting tank bottom repair processes and installing a new cathodic protection system, a detailed techno-economic analysis of the new cathodic protection system should be prepared that should determine the future place for installing new anodes in terms of their efficiency and reliability in service life. In terms of all previously mentioned, it should be established whether it is better to excavate a new deep ground bed for anodes near the storage tank or is it better to make a new tank bottom above the existing one, and place sacrificial anodes in space (filled with appropriate material) between two bottoms. An appropriate tank engineer and a cathodic specialist should be engaged for these estimations.

According to all previously mentioned, it is concluded that the inspected storage tank is not reliable for further long term continual service, and that tank bottom repair and installation of new anodes are strongly proposed in order to avoid near tank bottom fluid leakage, and thus pull out of service the whole unit where the storage tank is installed, also following huge financial loss. Here, it should also be mentioned that before any repair activities, a techno-economic analysis should be prepared for the new cathodic protection system in order to provide adequate solutions and further prolong continual operation. An appropriate tank engineer and cathodic protection specialist should also be involved in the preparation of this study.

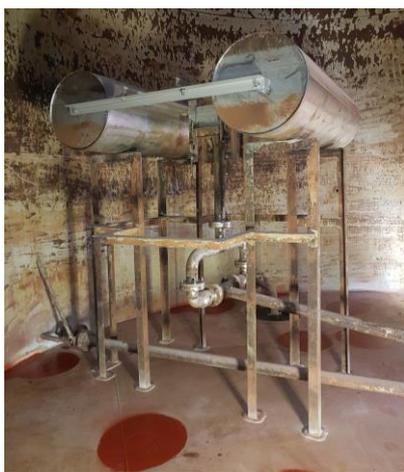
Figure 10. Overflow protection system was tested in detail and proper work is confirmed.
