TERMOGRAFIJA U KONTROLI OPREME U EKSPLOATACIJI THERMOGRAPHY IN THE INSPECTION OF IN-SERVICE EQUIPMENT

Stručni rad / Professional paper
UDK /UDC: 620.179.13
Rad primljen / Paper received: 15.3.2006.

The application of thermography in the inspection of in-service processing equipment and pipelines is analysed. Typical examples of equipment inspection in the processing industry are presented and explained.

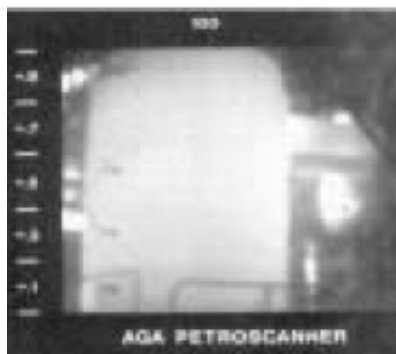
a. Ravnomerna raspodela temperature na južnom zidu sekundarnog reformera
a. Uniform temperature distribution on south wall of secondary reformer.

Results of reformer tests, that have enabled process optimization, are presented and shortly explained in Fig. 1, /3/.

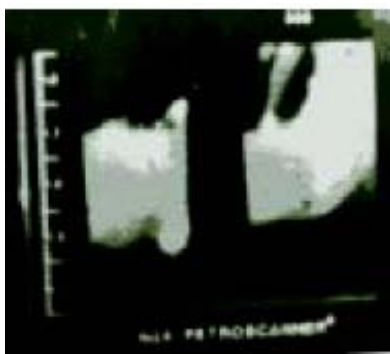
b. Toplo mesto na horizontalnom delu i kolenu transfer linije
b. Hot spot on horizontal segment and on knee of transfer line.

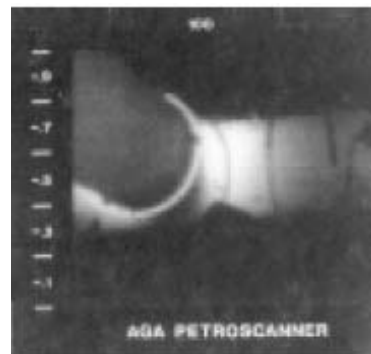
c. Detaljna raspodele temperature transfer linije sa slike b
c. Detailed temperature distribution on transfer line from figure b.

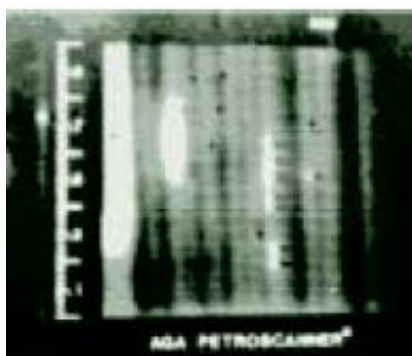
d. Povišena temperatura na tri reformerske cevi
d. Elevated temperature of three reformer tubes.

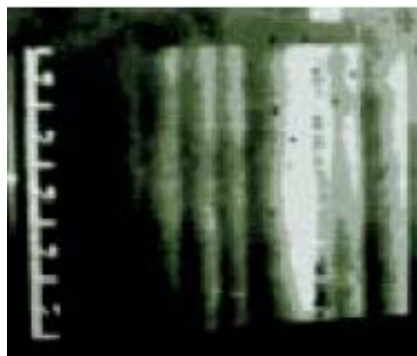
e. Snimak iz drugog ugla tri reformerske cevi
e. Image from another angle of three reformer tubes.

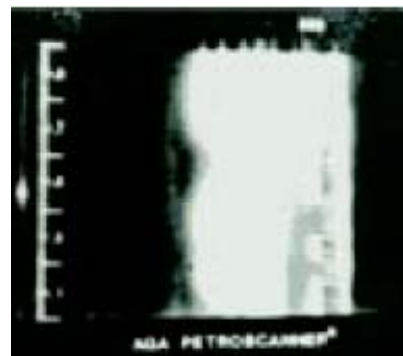
f. Povišena temperature cevi pre produvanja pare
f. Increased tube temperature before steam blowing.

Introducing steam enables basic chemical reaction in the reformer, and at the same time prevents occurrence of soot (coke) on the tube inner side. If coke deposits, the heat exchange between fluid and inner tube wall will be limited. Tube wall temperature in this case can locally increase to the level at which mechanical properties of tube material do not satisfy operating conditions. The increase of tube temperature is proportional to coke deposit thickness. Thermographic testing enables fast determination of coke presence as well as efficient monitoring of its removal by steam, /4/.

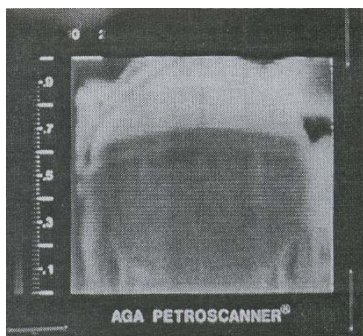
a. Određivanje nivoa u sfernom rezervoaru na osnovu različitih temperatura tečnosti i gasa
a. Determining the level in spherical storage tank based on different temperature of liquid and gas.

Figure 2 presents thermograms obtained from spherical storage tank- and pressure vessel tests, /3/.

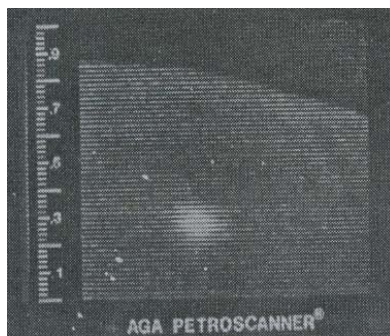
b. Zagrevanjem ispitivanog područja na sfernom rezervoaru određeno je mesto oštećene izolacije
b. Heating the tested region on spherical storage tank determines damaged insulation location.

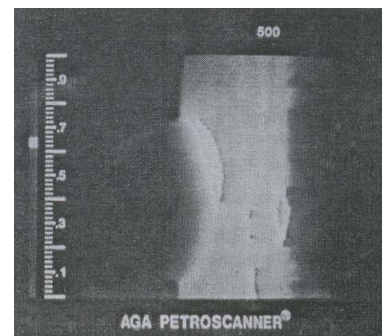
c. Vruće tačke na mestu priključka na plaštu posude
c. Hot spots at location of connection to the vessel mantle.

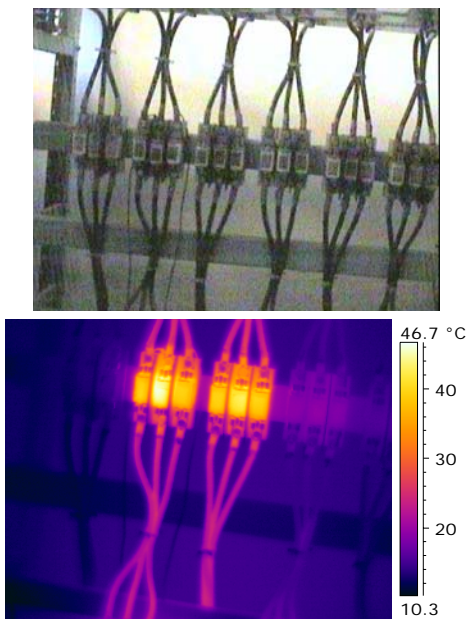
Slika 3. Izgled i termografski snimak električnih priključaka
Figure 3. View and thermographic image of electrical connections.

Findings: No significant deviations in the temperature field were discovered on the tested equipment. Temperature distribution on operating connectors is uniform (Fig. 3). Final left condenser was in operation, but the thermographic image shows that it is cold (Fig. 4), indicating the possibility of its damage. In Fig. 5 a zone of bad insulation on the vessel is visible. Redundant heat emission is detected on the vessel, Fig. 6.

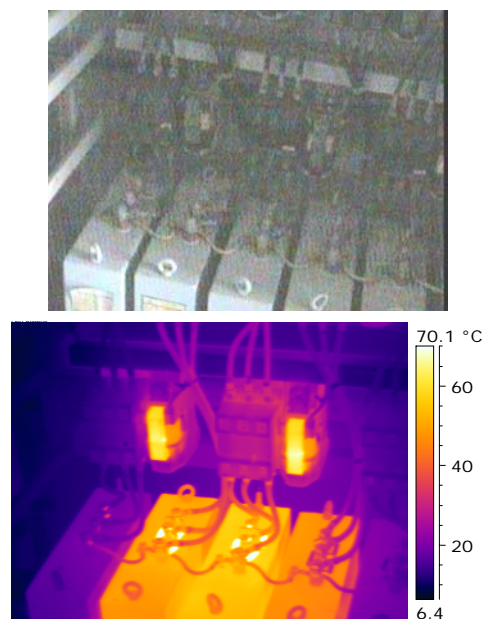
Slika 4. Izgled i termografski snimak kondenzatora
Figure 4. View and thermographic image of condensers.

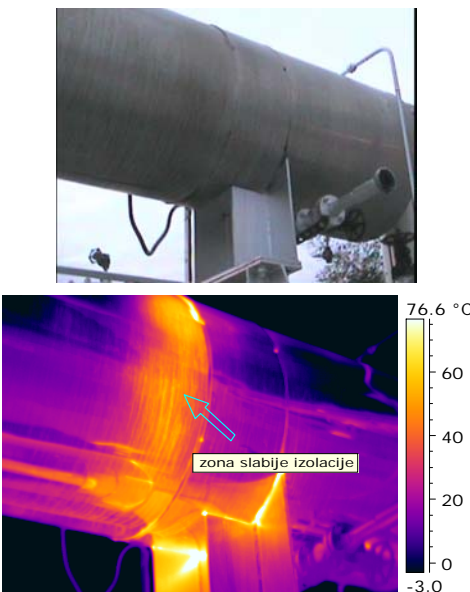
Slika 5. Izgled posude i termografski snimak izolacije
Figure 5. View of vessel and thermographic image of insulation.

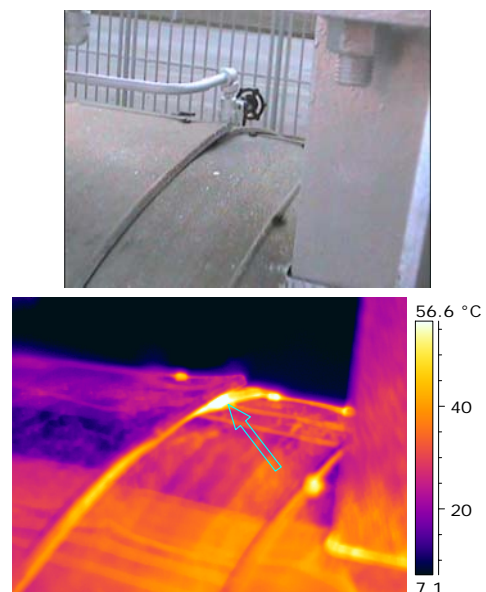
Slika 6. Odavanje toplote na spoju segmenta posude: izgled i termografski snimak
Figure 6. Heat emission at the vessel joint segment: view and thermographic image.
