RECONSTRUCTION OF DAMAGED ROTOR SPOKE IN RHPP BAJINA BAŠTA - PART II: WELDING

Originalni naučni rad / Original scientific paper
Rad primljen / Paper received: 29.04.2026
https://doi.org/10.69644/ivk-2026-03-0355

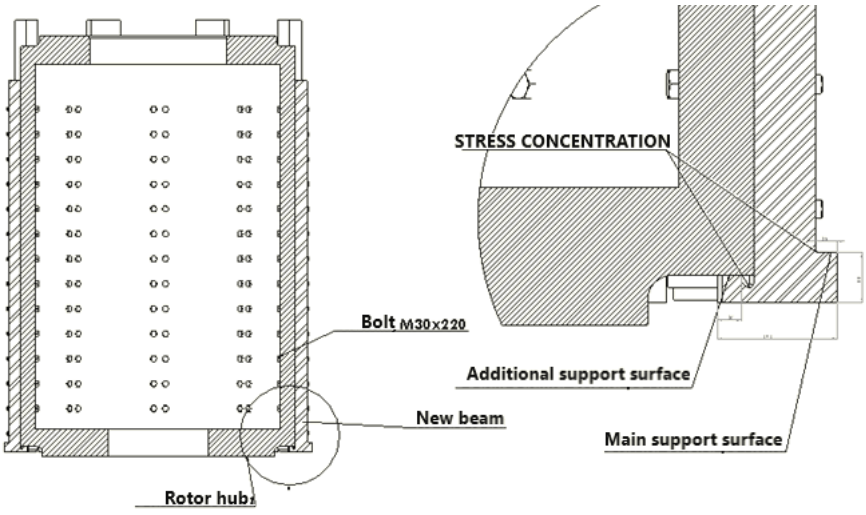
Cracks appeared on the rotor of unit R2 in RHE 'Bajina Bašta' at the points of support on the lower overhang of the beam, due to high stress concentration, spreading radially across the outer surface, Fig. 1, as shown with all necessary details /1/.

Figure 1. Rotor spoke, supporting beams and stress concentration area.

Due to geometric limitations, the repair of cracks was not possible, and so the rotor was reconstructed by installing new supporting beams that were joined by welding with the cracked beams and also by screws (not analysed here) with the rotor spoke, /1/. In this way, existing beams with cracks are relieved, and the new beams take over the load. The new beams were joined with cracked beams and the rotor casing into one unit by means of 4 welded joints, and the part of the rotor casing at reconstruction is shown in Fig. 2:

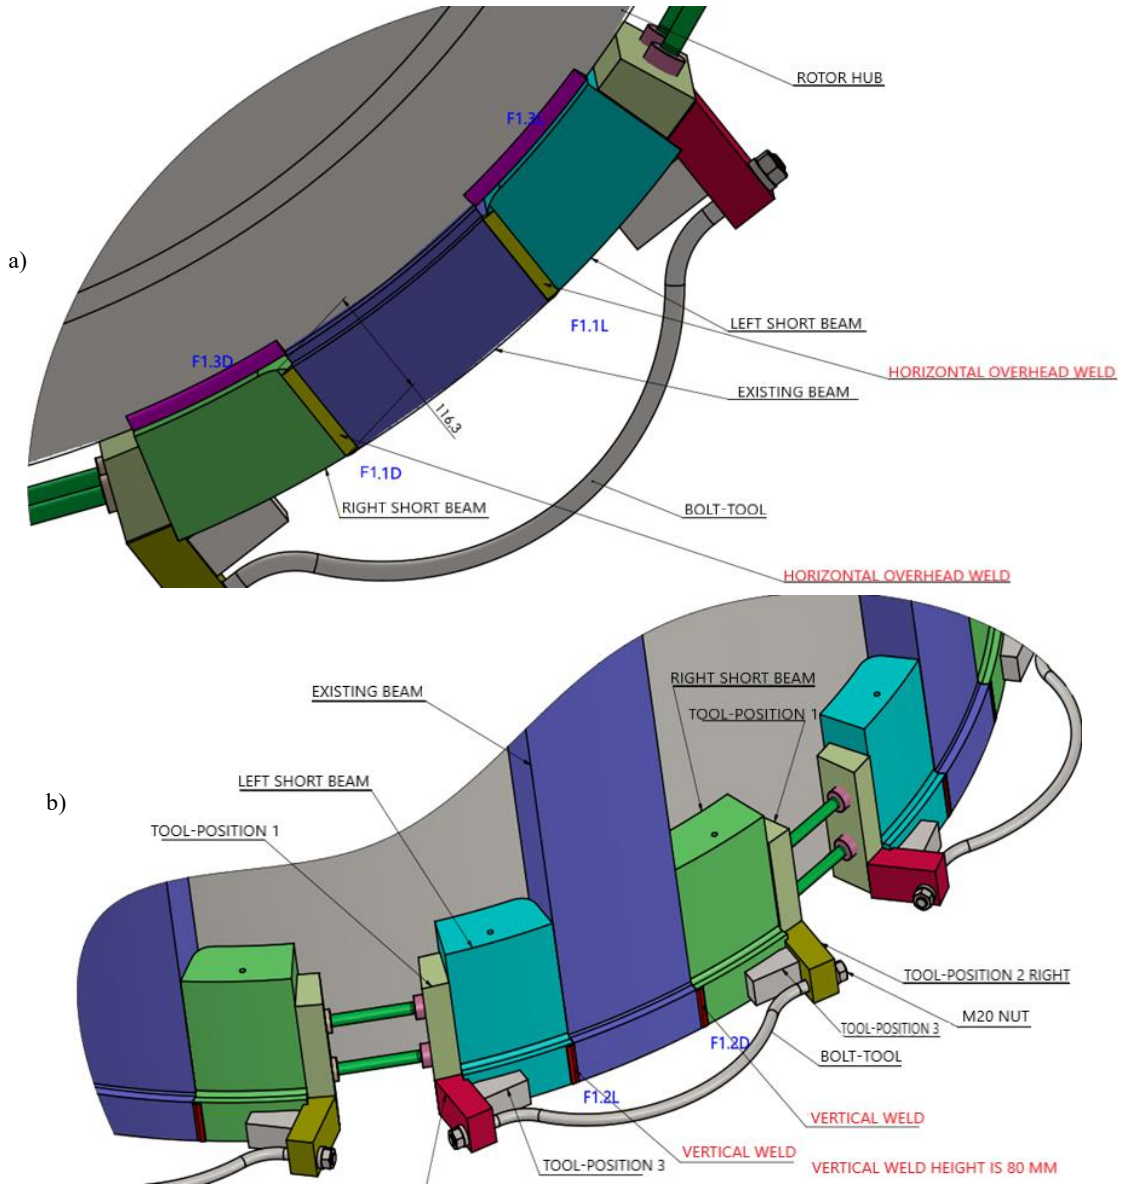
Figure 2. Isometric presentation of reconstructed part of rotor spoke: a) view from above; b) view in front.

F1.1 - overhead horizontal weld new beam - old beam,
F1.2 - vertical weld new beam-old beam,
F1.3 - overhead horizontal weld new beam-rotor,
F1.4 - vertical weld new beam-rotor.

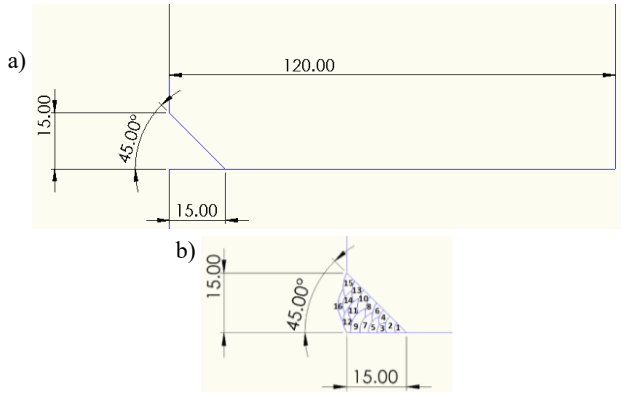
Figure 3. a) Welding groove; and b) sequence of passes.

In TIG welding, direct current of direct polarity is used to transfer most of the heat to the weld joint (approximately 2/3), while at the same time reducing the rounding of the electrode tip, which is important in the case of ½ V groove, Fig. 3. The EN ISO 21952-A: W MoSi wire, trade name BÖHLER DMO-IG, diameter Ø2.0, is used for root pass and Ø2.4 for filling pass. As an electrode, the tungsten with the addition of thorium oxide WT 20 (red) is used, with a diameter of 2.4 mm, that must be sharpened so that the length of the conical tip is 4-6 mm. The electrode tip is pulled out of the nozzle about 2-4 mm. The wire was added to the front of melt (not directly in the middle of the arc, i.e., not under the electrode) and inserted so that its tip contacts the melt. Sequence of passes and welding parameters are shown in Fig. 3b and Table 1, respectively, as an example of all welding procedures in this reconstruction procedure.

Pass no.	Filler metal diameter	Current	Amperage (A)	Voltage (V)	Welding speed (mm/min)	Heat input (kJ/mm)
1 (root)	2.0 mm	DC-	110-140	10.5-12.5	100-120	0.78
2-n (filler)	2.4 mm	DC-	115-155	15-17	115-145	1.00
cover	2.4 mm	DC-	115-145	14-16	115-145	0.90

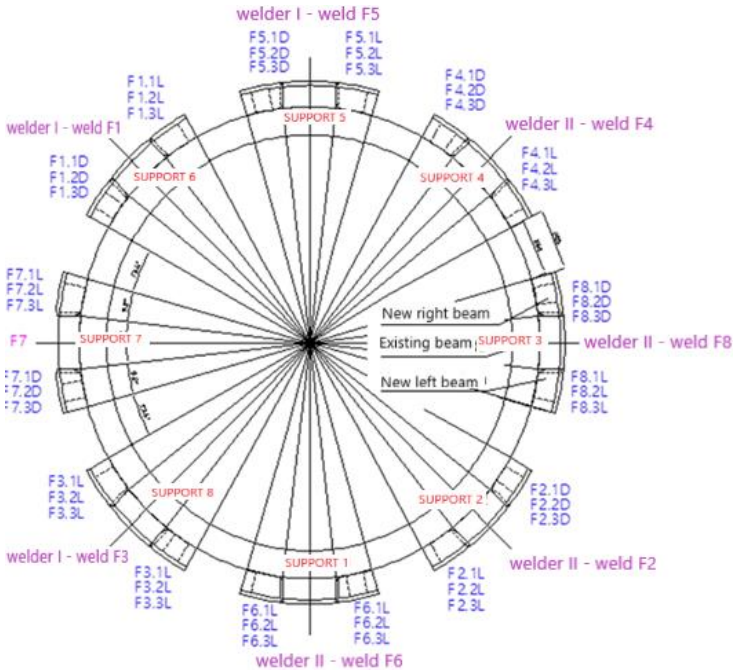
Figure 4. Welding sequence.

WELDING SEQUENCE (Fig. 4)

I Simultaneously weld F1 (F1.1-F1.3) and F2 (F2.1-F2.3), fill up to approx. 10 mm joint height

After all welds F1-F8, weld vertical corner weld F1.4, FW a7Δx260

Welding should be performed without time interruptions. Do not remove the tool for fixing and clamping new beams until it has completely cooled down, 24 hours after welding F1.1; F1.2; F1.3-F8.1; F8.2; F8.3. Grind the welds to the plane of the base material, taking care of controlled grinding and heat input.
