REMAINING LIFE ASSESSMENT OF LONG-TERM EXPLOITED St.35.8/II BOILER SCREEN TUBES VIA AN INTEGRATED MICROSTRUCTURAL DEGRADATION AND CREEP MODEL

Originalni naučni rad / Original scientific paper
Rad primljen / Paper received: 15.06.2026
https://doi.org/10.69644/ivk-2026-03-0387

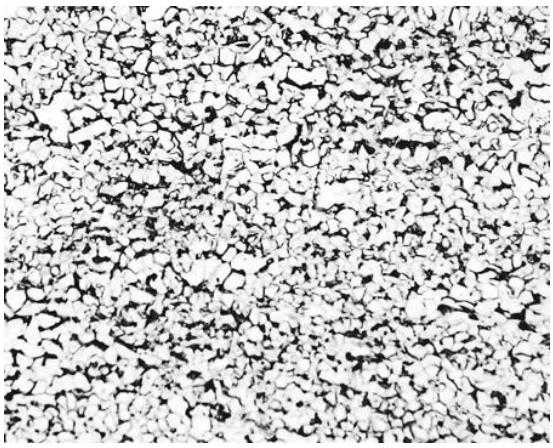
a) Replica R1. Original magnification 100×

Replica ID	Location/elevation	In-situ hardness (HB)	Wedel-Neubauer creep class	Proposed structural assessment & actions
R1	Tube 1 / 7 m (furnace side)	159	Class 0 (Undamaged)	Stable matrix, initial pearlite spheroidisation. No immediate action required.
R2	Tube 1 / 7 m (support side)	161	Class 0 (Undamaged)	Heat-affected zone (HAZ) exposure. Structure structurally acceptable.
R3	Tube 2 / 10 m (support side)	166	Class 0 (Undamaged)	Advanced spheroidisation. Monitor during scheduled overhaul.
R4	Tube 2 / 10 m (furnace side)	174	Class 0 (Undamaged)	CRITICAL! Continuous intergranular carbide network. Immediate tube replacement required.
R5	Tube 3 / 10 m (furnace side)	164	Class 0 (Undamaged)	High risk; semi-continuous carbide boundary decoration. Enhanced inspection interval.

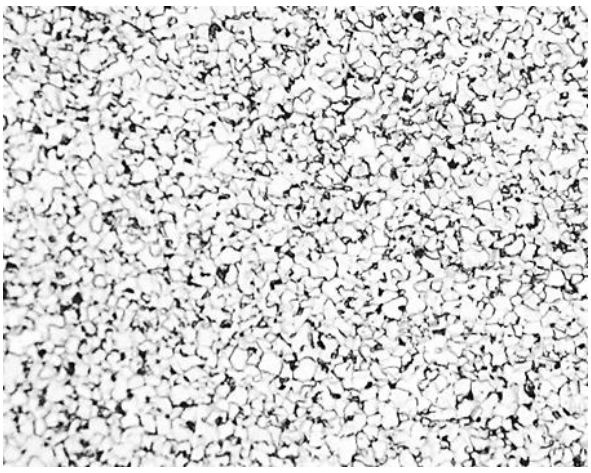
g) Replica R4. Original magnification 100×

In the metallurgy of boiler steels, the localised hardness peak of 174 HB at location R4 represents a structural response linked to advanced phase degradation and severe secondary carbide distribution along the grain boundaries which directly alters the local indentation resistance. Furthermore, such elevated *in-situ* hardness numbers in heavily aged low-carbon steels can be influenced by the shallow surface work-hardening layer introduced during portable mechanical grinding preparation. Consequently, these elevated hardness measurements must not be misinterpreted as a macroscopic strengthening of the component, as the grain matrix interior itself has become depleted of carbon and significantly softened.

The actual degradation mechanism is characterised by pearlite spheroidisation and the continuous precipitation of a brittle intergranular carbide network at the 10 m elevation furnace zone (R4), which severely embrittles the structure.

Immediate replacement of the tube sections corresponding to location R4 is strongly recommended, and a modified metallurgical assessment framework incorporating carbide network continuity must be implemented to ensure structural integrity.
