STRUCTURAL INTEGRITY ASSESSMENT OF A STEAM SUPERHEATER OUTLET HEADER

Originalni naučni rad / Original scientific paper
Rad primljen / Paper received: 15.06.2026
https://doi.org/10.69644/ivk-2026-03-0393

In this paper, the structural integrity assessment of the exit convective superheater steam collector at Unit 1 of the 'REK Bitola' thermal power plant is presented. The collector is newly fabricated as part of a reconstruction project intended to replace equipment that had exceeded forty years of service. Material verification is performed through mechanical, microstructural, destructive and non-destructive testing, while hydrostatic testing confirmed the pressure-tightness of the fabricated component. Integrity assessment is subsequently carried out using the Fracture Assessment Diagram (FAD) methodology in accordance with BS 7910 procedures. Influence of fully circumferential internal flaws and weld misalignment on structural integrity is analysed under operating loading conditions. Results demonstrate that the investigated collector possesses sufficient resistance to both fracture and plastic collapse, with acceptable flaw tolerance margins for the considered defect sizes. The

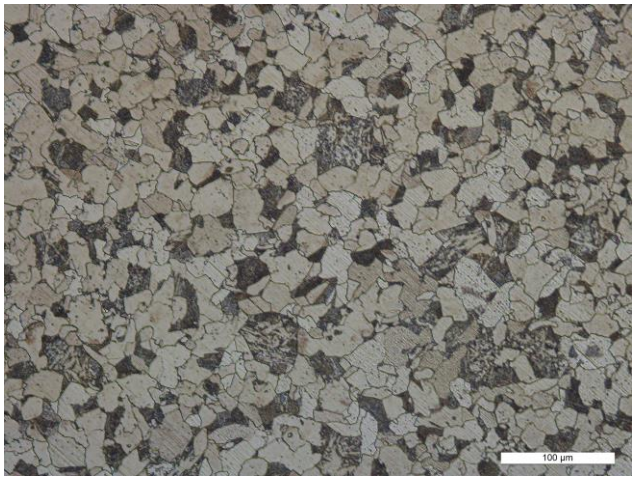
Figure 1 presents the microstructure of a ∅32×6 mm 12H1MF steel tube at a magnification of ×200, with a measured bainite content of 26.5 % (Grade 2). These tubes are used for the fabrication of pipe bends and branch connections attached to the header body. Figure 2 shows the microstructure of a ∅133×25 mm 12H1MF steel tube at a magnification of ×200, with a bainite content of 20.3 % (Grade 3). This semi-finished product is utilised for the fabrication of the drain connection located between the two

Figure 1. Microstructure of pipes Ø32x6 mm 12H1MF magnification 200x, proportion of bainite 26.5%.

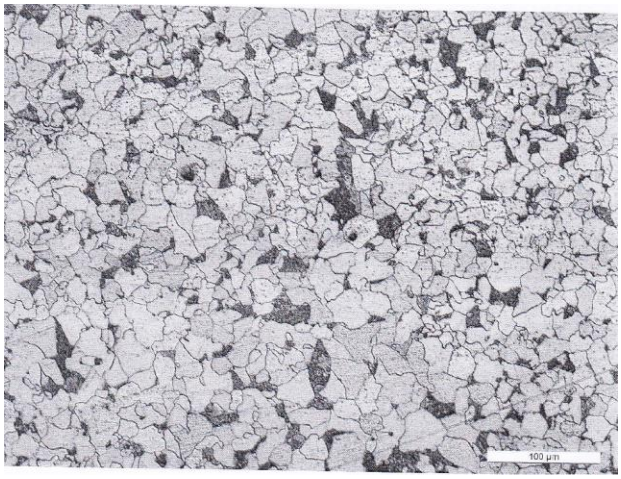
Figure 2. Microstructure of pipes Ø133x25 mm 12H1MF magnification 200x, proportion of bainite 20.3%.

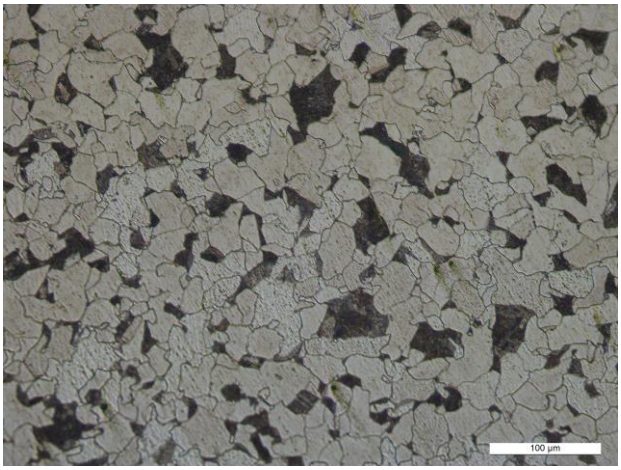
Figure 3. Microstructure of pipes Ø273x40 mm 12X1MF magnification 200x, proportion of bainite 17.4%.

end caps of the header. Figure 3 illustrates the microstructure of a ∅273×40 mm 12H1MF steel tube at magnification of ×200, with a bainite content of 17.6 % (Grade 4). This pipe section is employed for the fabrication of the main header body containing all branch and piping connections.

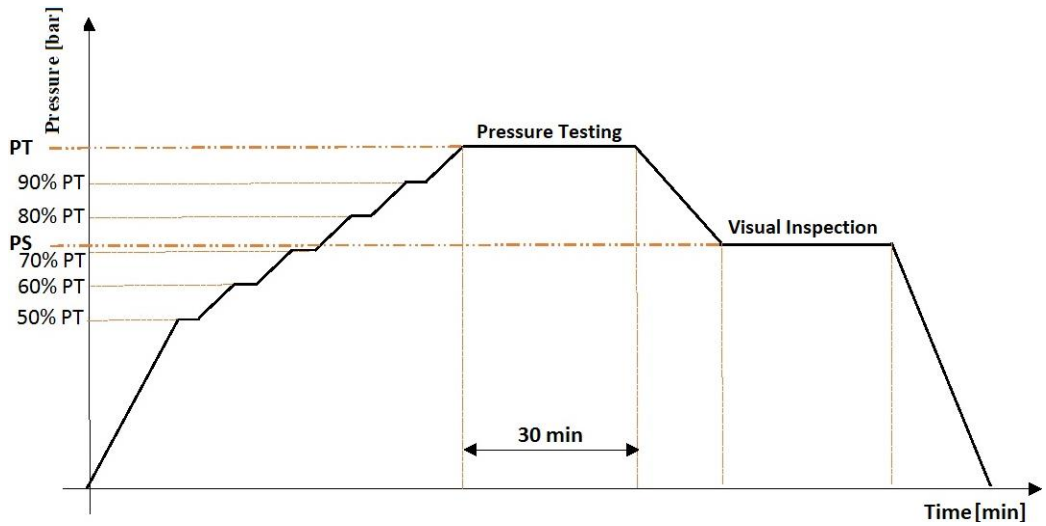
Figure 6. Pressure-Time Diagram of the Cold Hydrostatic Pressure Test.

Following the completion of the tests on the first-stage convective steam superheater, no signs of failure are observed during examination. No permanent deformation, leakage, local constriction, sweating, or other indications of loss of pressure boundary integrity are detected in either welded joints or base metal. Furthermore, no pressure drop is recorded on the calibrated pressure gauge during the test period.

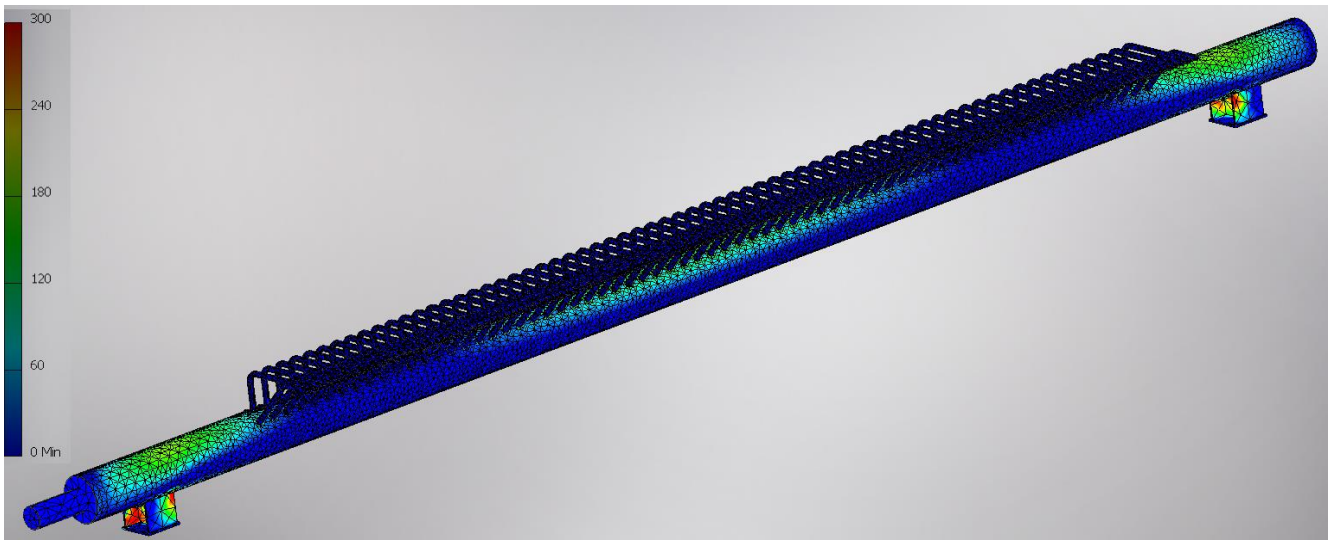
Following the numerical stress analysis, no regions with unacceptable stress levels are identified within either the welded joints or the base material. Furthermore, no indication of plastic deformation, associated with exceeding the material yield strength, are observed. The maximal equivalent stress, evaluated according to the von Mises criterion, is approximately 180 MPa. This value remains below the yield strength of 12H1MF steel at operating temperature, indicating that the component operates within the elastic range under prescribed loading conditions. The obtained stress distribution reveals no critical stress concentrations that could adversely affect the structural integrity of the outlet header. Therefore, the numerical simulation confirms the adequacy of the adopted design and provides additional verification of the safe operation of the reconstructed convective steam superheater header under service conditions, /7/.

Figure 7. Finite element model (FEM): stress distribution in the superheater.

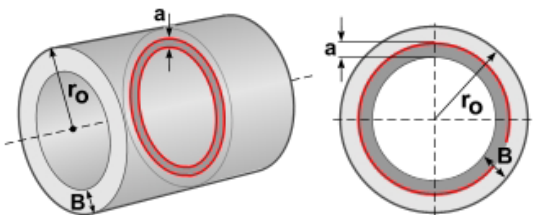
Figure 8. Geometry of a defect.

The assessment is conducted for a circumferential welded joint with circumferential internal flaw located at the weld root, Fig. 8. Initial defect size is assumed to be $a = 0.3$ mm.

Two axial weld root misalignments, namely 1.5 mm and 2.0 mm, are investigated to evaluate their effect on flaw tolerance and structural integrity margins. Selected values are used to represent realistic fabrication deviations that may occur during manufacture and assembly of steam piping systems. Relevant material properties at working temperature are: yield stress 225 MPa; tensile strength 450 MPa, Young modulus E = 183 MPa, fracture toughness K_{Ic} = 124 MPa√m. Loading is set as membrane stress 27.1 MPa. Results obtained by using Crackwise 5.0 /15/, are presented in Figs. 9 and 10 for weld root misalignment of 1.5 mm and 2 mm, indicating critical defect sizes 3.48 and 3.74 mm, in respect.

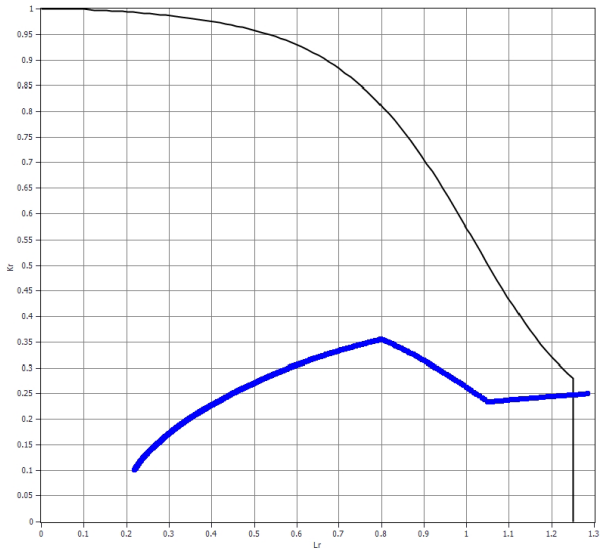
Figure 9. FAD for a weld root misalignment of 1.5 mm.

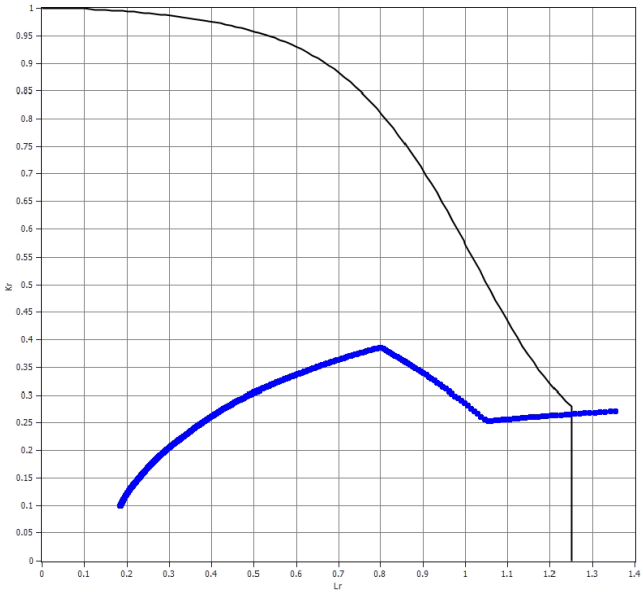
Figure 10. FAD for a weld root misalignment of 2.0 mm.
