Russell Wanhill

## KRTOST ARHEOLOŠKOG SREBRA I GVOŽĐA **EMBRITTLEMENT OF ARCHAEOLOGICAL SILVER AND IRON**

Originalni naučni rad / Original scientific paper UDK /UDC: 904(37):669, 620.179:669 Rad primljen / Paper received: 10.12.2008.	Adresa autora / Author's address: National Aerospace Laboratory (NLR), Amsterdam, the Netherlands, <u>wanhill@nlr.nl</u>		
Ključne reči	Keywords		
• arheometrija	• archaeometallurgy		
• srebro	• silver		
• gvožđe	• iron		
• krtost	• embrittlement		
konzervacija	conservation

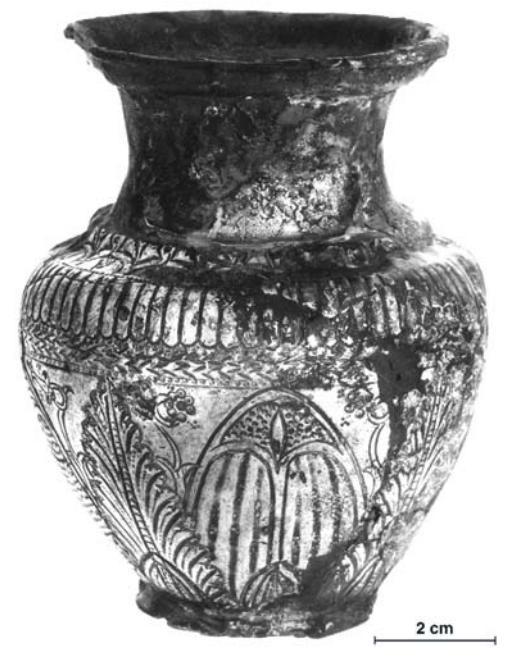
Slika 1. Egipatska vaza Figure 1. The Egyptian vase.

Figure 1 shows the Egyptian vase, which is from the Ptolemaic period and dated to between 300 and 200 BC.

Vaza je ukrašena ugraviranim i utisnutim ukrasima cveća i lotusa i bodljikavog lišća. Radiogram na sl. 2 pokazuje da je vaza detaljno obnovljena (to je stara restauracija, koja datira iz kasnih godina 19.-tog veka). Slika 2 takođe otkriva prsline koje prate spoljnje žlebove gravure i mesta ukrštanja na umreženim prslinama sličnim krtom lomu "ljuske jajeta".

- Pojave krtosti izazvane korozijom duž linija klizanja, deformacija na granicama dvojnika i traka segregacija.
- Krtosti izazvane mikrostrukturom; hemijski sastav (0,7% Pb, nema Bi) upućuje na olovo kao glavni uzrok, /1-4, 8/.
- Sinergijska krtost.

- Corrosion-induced embrittlement along slip lines, deformation twin boundaries and segregation bands.
- Microstructurally-induced embrittlement, chemical composition (0.7% Pb, no Bi) suggests lead as perpetrator, /1-4, 8/.
- Synergistic embrittlement.
- A link between retained cold-work and corrosion damage.

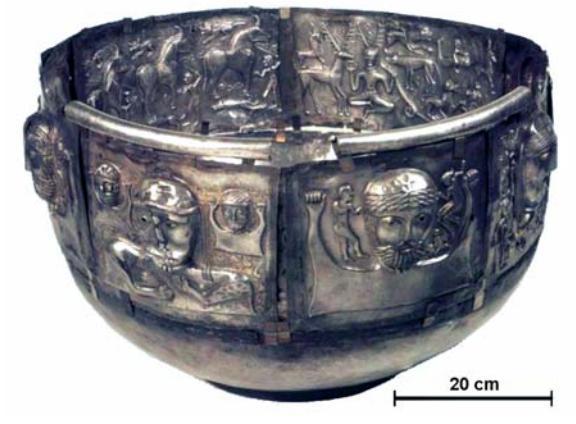
Slika 7. Ukrasni pehar (kondir) Gundestrup Figure 7. The Gundestrup Cauldron.

Figure 7 shows the reassembled Gundestrup Cauldron, which is the largest surviving silverwork object from the European Iron Age, dating to the  $2^{nd}$  or  $1^{st}$  century BC.

Zbog veličine, visokog kvaliteta izrade i ikonografske raznolikosti, pehar je bio predmet brojnih studija, naročito njegov izvorni oblik, koji je još uvek kontroverzan. Pehar se sastoji od dvanaest tanjira i korpe, sve od srebra 95– 98%. Hemijska analiza je odredila bakar kao glavni legirajući element (ili nečistoću), /10, 11/.

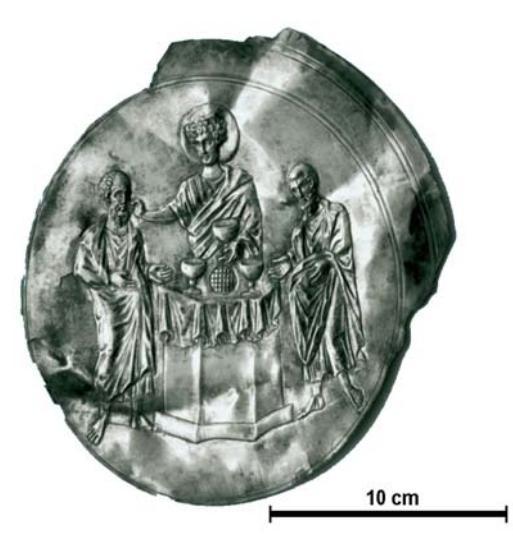
Slika 13. Vizantijski nafornjak: fotografija je vlasništvo Kolekcije Menil, Hjuston Figure 13. The Byzantine paten: photograph courtesy of The Menil Collection, Houston.

Mali uzorak sa nafornjaka je ispitan SEM metalografijom i pomoću EDX analize u prethodnom istraživanju Holandskog instituta za kulturno nasleđe (ICN) iz Amsterdama. Na uzorku je jasno vidljiva površinska (plitka) interkristalna korozija, sl. 14a, a pri većim uvećanjima se vide i isprekidani talozi bakra na granicama zrna, sl. 14b. Ovi talozi daju grani-

Figure 13 shows the Byzantine paten, which has been dated to about 600 AD. The paten is a rare and high-quality liturgical altar object. The important central tableau is well preserved, but there has been extensive breakage along the surrounding circular decorating grooves.

An important aspect particularly relevant to restoration and conservation is illustrated by the Egyptian vase and the Byzantine paten. This is the effect of decorative chasing and stamping on the corrosion damage. The cracks along the chasing grooves in figure 2, the interpretation of figure 6, and the breakages along the circular grooves of the paten, suggest that all thin-walled objects with chased or stamped decorations should be examined for corrosion damage especially at the corresponding *internal* or *rear surface* locations. If this is so, a possible remedial measure is to apply a protective coating to these surfaces, /4/.
