## KRTOST ANTIČKOG SREBRA IZAZVANA KOROZIJOM CORROSION-INDUCED EMBRITTLEMENT OF ANCIENT SILVER

Originalni naučni rad / Original scientific paper  
UDK /UDC: 620.18:669.22 620.193:669.22

*Corrosion-induced embrittlement of ancient silver is a complex phenomenon that can cause severe cracking and fragmentation of valuable objects. This damage may require irreversible methods of restoration and conservation. Detailed case studies to characterize the embrittlement are important for selecting the optimum methods to ensure conservation with a minimum of intervention. The paper describes the types of, and models for, corrosion-induced embrittlement in different ancient silver artefacts, and discusses the remedial measures that are or could be used.*

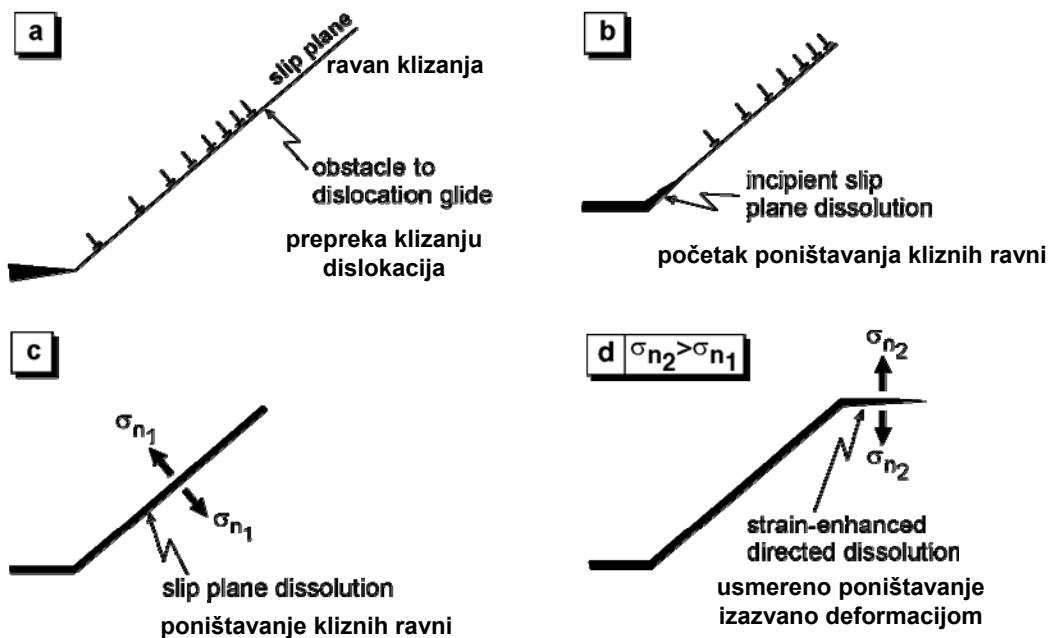
A schematic of the strain-enhanced dissolution model is given in Fig. 11. The proposed (and here abbreviated) sequence of events is:

(b, c) Crack initiation and growth by slip plane dissolution, enhanced by the strain associated with the local normal stress,  $\sigma_{n1}$ . The slip plane dissolution continues as long as  $\sigma_{n1}$  exceeds the local normal stress,  $\sigma_{n2}$ , on alternative crystallographic planes.

(d) Crack growth by strain-enhanced directed dissolution on an alternative plane whose local normal stress,  $\sigma_{n2}$ , exceeds  $\sigma_{n1}$  but is not high enough to blunt the crack tip by dislocation emission.

By proposing that the fracture planes do not always have to be the slip planes, as found for copper alloys and austenitic stainless steels, /18-22/, this model also provides an explanation for the transgranular fracture features in Figs. 9b and 9c. Figure 9b shows a 90° “dog-leg” crack which cannot be on a {111} plane, but must be on either a {110} or {112} plane. Figure 9c shows similar “dog-legs” that result in high-angle steps on slip plane fracture surfaces. There is no evidence of microfaceting similar to that found for copper alloys, /19/, and stainless steels, /21, 22/, but this was variable anyway, see stage (2) above.

Slika 11. Model transkrstalne SCC „rastvaranja ubrzanih deformacijom“, /23/  
Figure 11. The “strain-enhanced dissolution” model of transgranular SCC, /23/.
