Szabolcs Szávai, Tibor Köves

## RELIABILITY AND LIFETIME ANALYSIS FOR A CRACKED CYLINDER OF AMMONIA UNIT COMPRESSOR

Original scientific paper  
UDC: 621.51-192  
Paper received:

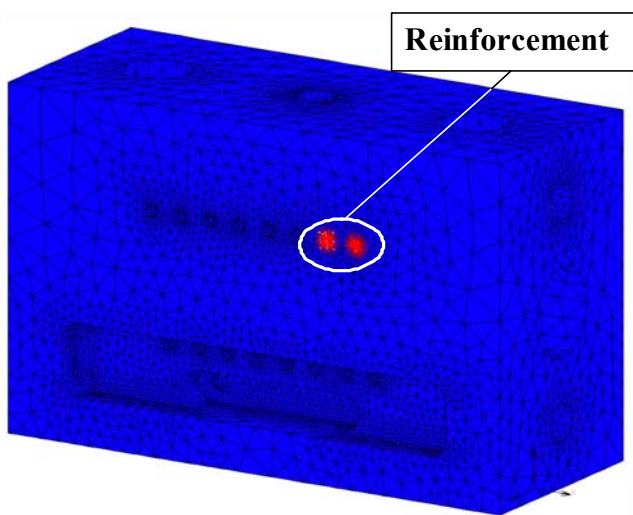
The mesh for FEM model of the linear elastic material is created by 10-node parabolic 3D tetrahedral elements (160 650 elements with 247 013 nodes). Figure 5 shows the crack face, loaded by outlet pressure (200 bar), as well as the surfaces (light blue colour). The light yellow surfaces in

Figure 5. FEM mesh and the reinforcement  
Slika 5. FEM mreža i ojačanje

Geometry data are given by the customer, who recommended to repair the cracked part by tighten joint increasing screw force. The cracked and adjacent cooling pipes had been enclosed, new bores drilled, threaded, and reinforced by M33 bolts. The reinforcement model is given in Fig. 4.

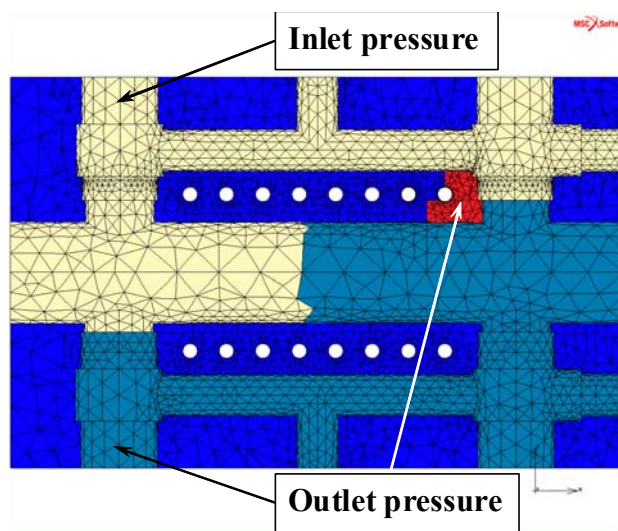
Fig. 6 were loaded by inlet pressure (80 bar). The crack face was situated 20 mm from the symmetry plane. The constraints were on the bottom plane.

Figure 6. Cross-section of cylinder with crack (red marked)  
Slika 6. Poprečni presjek cilindra sa prslinom (crveno)

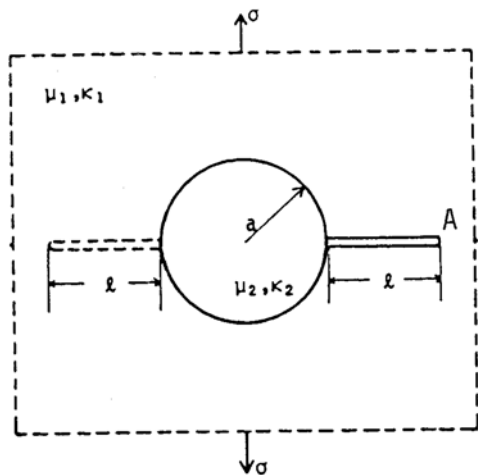
Fracture mechanics analyses were performed for brittle fracture and calculated crack propagation. The simplified plane-strain model (Fig. 9) is applied and verified by FEM for analytical fracture mechanics analysis.

Figure 9. Simplified model of the crack  
Slika 9. Uprošćeni model prsline

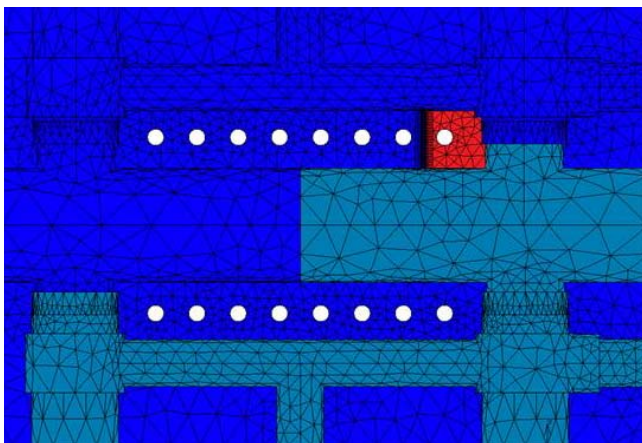
FEM analysis (Fig. 10) was applied to validate the model from Fig. 9 at minimal operational pressures, (outlet/inlet 120/60 bar). Difference in stress intensity factor is acceptable: for analytical model  $K_{Ianalytical} = 17 \text{ MPa}\cdot\sqrt{\text{m}}$ , for FEM calculation  $K_{IFEM} = 14.1 \text{ MPa}\cdot\sqrt{\text{m}}$ , indicating that the analytical model is applicable for this case.

Figure 10. FEM model for verification of simplified crack model.  
Slika 10. FEM model za verifikaciju uprošćenog modela prsline

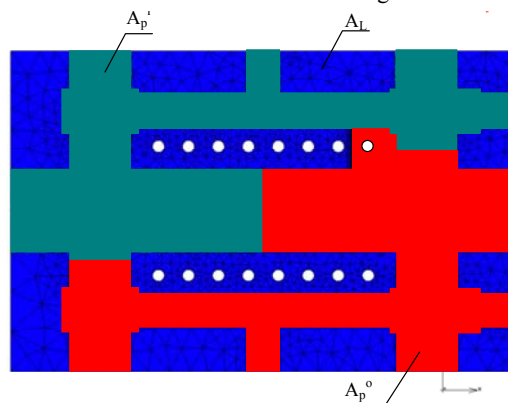
Figure 12. Cross-section of cracked cylinder for J-integral calculation  
Slika 12. Presek cilindra sa prslinom za proračun J integrala

The nominal stress is calculated based on the ratio of the inlet (i) and outlet (o) pressure  $p$  loaded area  $A$  to the ligament section (Figs. 12–14) as follows:

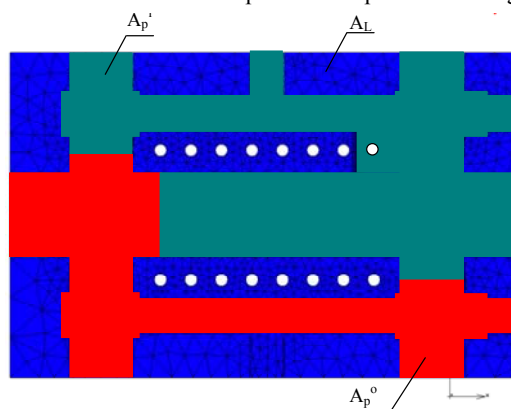
Figure 13. Minimum load for the cross section.  
Slika 13. Minimalno opterećenje u preseku

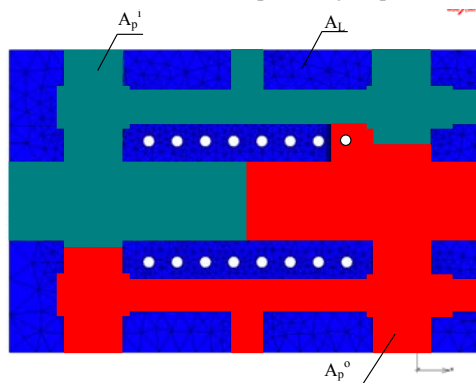
Figure 14. Maximum load for the cross section.  
Slika 14. Maksimalno opterećenje u preseku

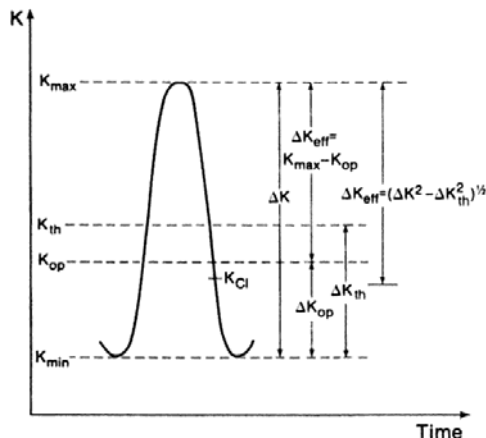
Figure 15. Dependencies for determination of  $\Delta K_{eff}$ , /5/.  
Slika 15. Zavisnosti za određivanje  $\Delta K_{eff}$ , /5/

It is clear that the range of threshold stress intensity factor  $\Delta K_{th}$  has to be considered. Operating the structure at normal pressures (200/80 bar), the crack propagation is probable and the crack can reach the next cooling pipe in 8 days. Crack growth vs. time is sensitive to the uncertainty in the  $\Delta K_{th}$ ,  $C$  and  $m$  due to very high cycles.

At minimal operating pressures (120/60 bar) crack growth is not expected since  $\Delta K$  is only  $4.58$  MPa√m  $< \Delta K_{th}$ , although the threshold value is uncertain. Operation at these pressures is not economical, so investigation is carried out after 15 days to check the crack size and position (Fig. 16): crack did not grow, so some load increase is possible, and a minimum economical operating condition (150/80 bar) is analysed, with  $\Delta K_{th}$  about  $5$  MPa√m, enabling acceptable
